E-Series	Model Description
G45	X3 Sports Activity Vehicle
G60	5 Series Sedan
G70	7 Series Sedan
G90	M5 Sedan
G99	M5 Touring

Reference the SIB number, the issue (briefly), and the work package (WP) number performed in the technician’s RO notes, and in the claim comments (For example: B51 11 25 Resecure hood release Bowden cable end WP 1), unless otherwise required by State law.

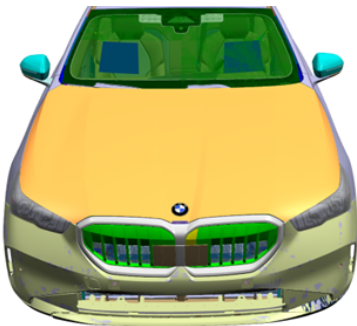
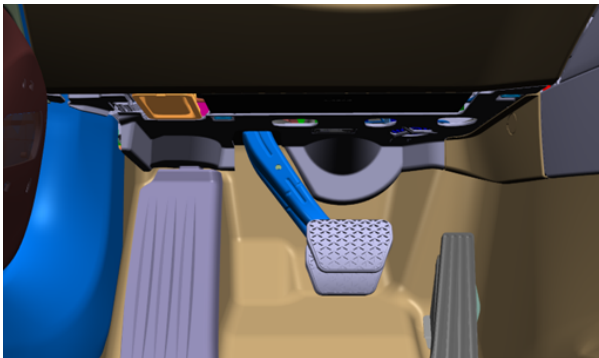
When pulling on the hood (**highlighted in orange in the top photo**) release lever (**highlighted in orange in the bottom photo**; driver’s footwell shown), there is a noticeable lack of cable tension; and the hood will not unlock.

Clip the Bowden cable back into the release lever and secure it using the base sealing tape.

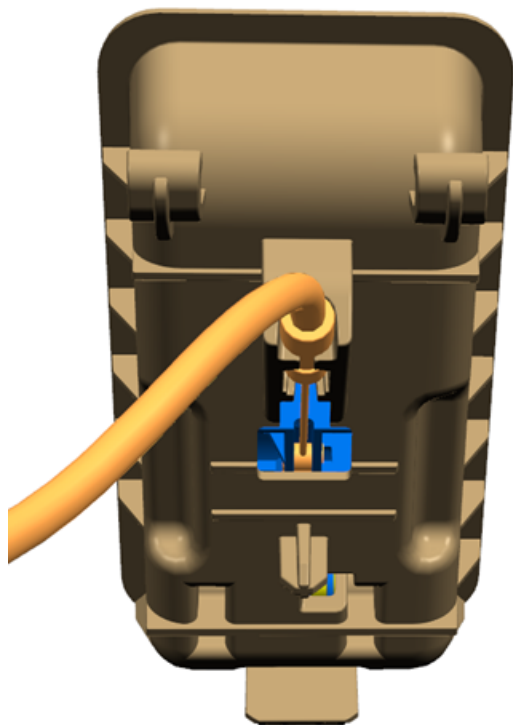
The Bowden cable (**highlighted in orange**) in the release lever becomes unclipped.
