SIB 51 12 25  
GROANING SOUND FROM THE TAILGATE

2025-08-20

| E-Series | Model Description |
|---|---|
| U10 | X2 Sport Activity Coupe |

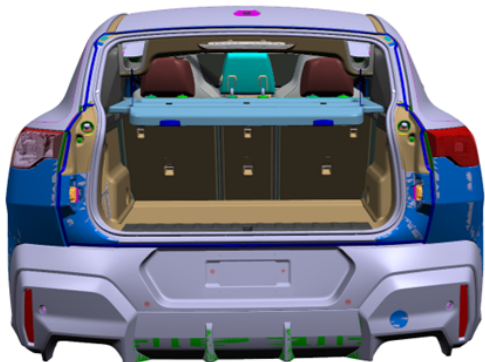
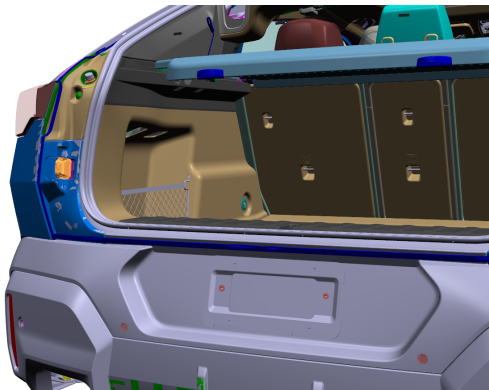
A “groaning” noise is heard from the tailgate when driving on rough roads.

Frictional vibration of the tailgate wedging elements (**highlighted in orange at arrows**).\_

Adjust the tailgate.

- 1. Verify the customer’s concern.
- 2. Adjust the tailgate following repair instructions listed in ISTA/AIR 41 62 014.
- 3. Reassemble the vehicle and verify the repair.
