# Service Information Bulletin

B52 09 20

## HEAD RESTRAINT AND/OR BACKREST OF 3<sup>RD</sup> ROW SEATS CANNOT BE FOLDED DOWN

E-Series	Model Description
G07	X7 Sports Activity Vehicle

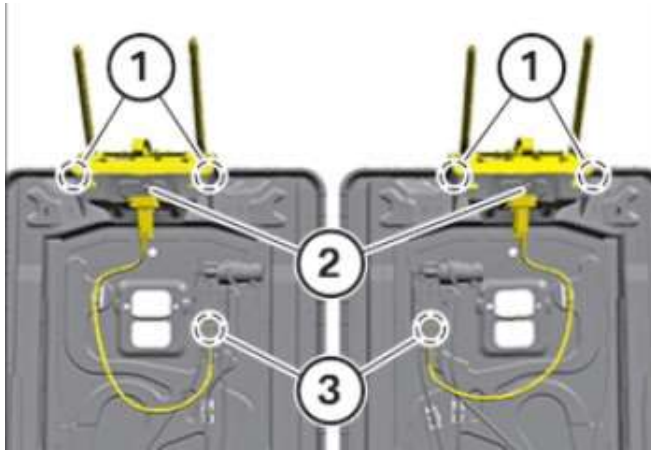
If the headrest is stuck in its upright position, can the head restraint be manually unlocked using the release loop beneath the headrest (see picture) and thus folded down?

**YES** = Head restraint mechanism is faulty or not being fully actuated.

- B. **ONLY IF** the cable is moving fully but the headrest is not folding, then replace the folding module of the head restraint (#2 in picture).

See **REP 52 30 118** Remove and install/replace folding module of left or right head restraint.

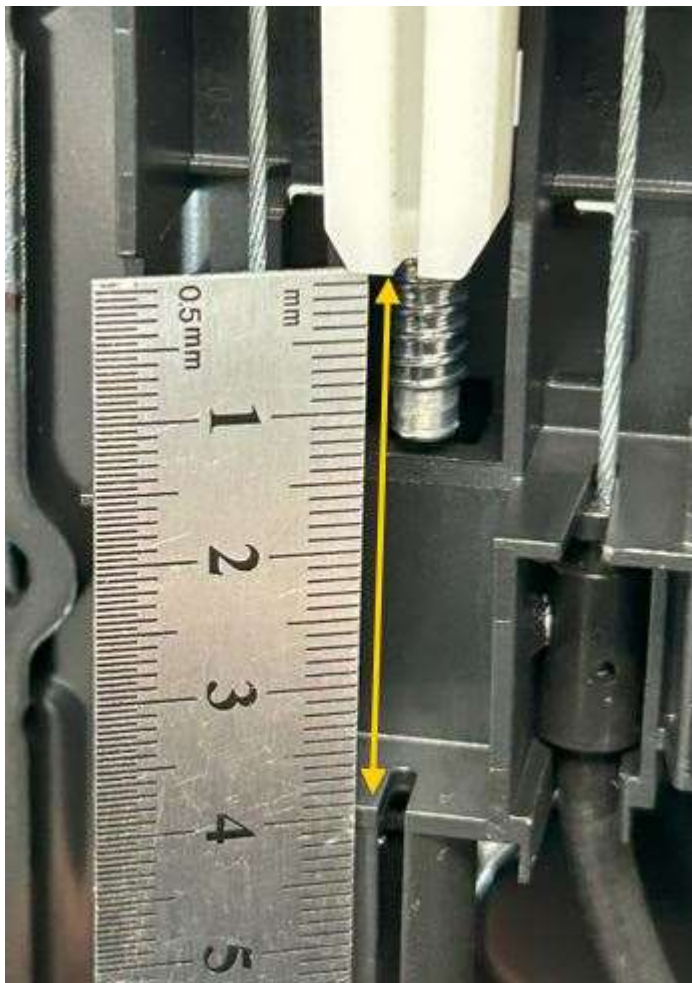
For the Headrest Bowden cable (center cable) to move fully the actuator will travel upwards **40 mm from the lower plastic housing** releasing the headrest mechanism.

If the actuator moves 40 mm and the Headrest Bowden cable was not able to fully actuate the folding module of the head restraint, then the Headrest Bowden cable may have stretched and will require replacement.

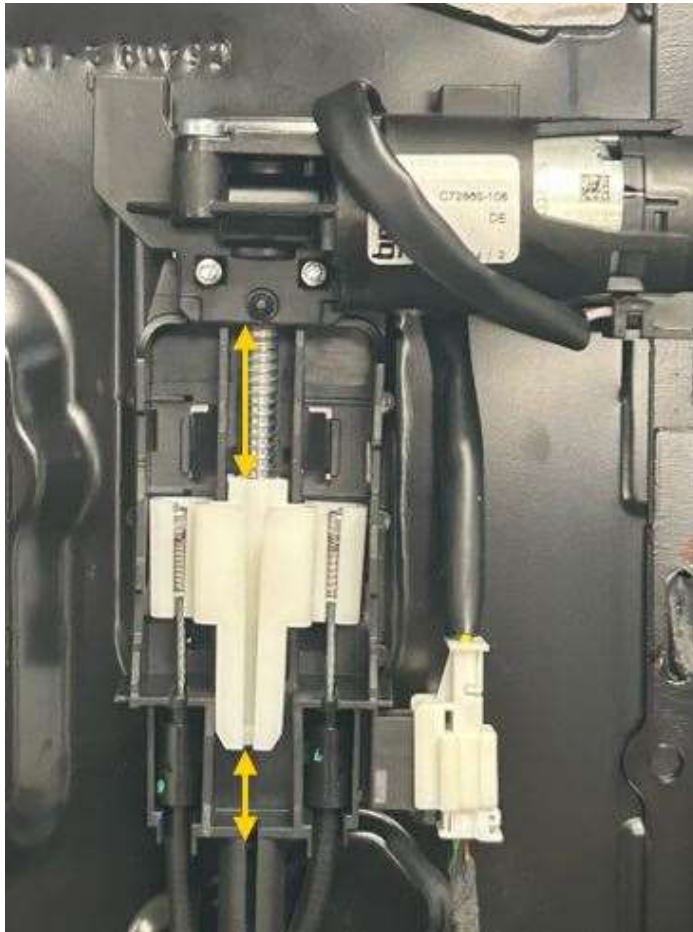
The white plastic housing will not travel its complete length if:

- something is binding the seat latches.
- the Bowden cables are not routed correctly.
- the supplied voltage to the actuator motor is **below 10 volts**.

**NOTE:** The Electric Actuator for third-row seat changed design and part number as of March 28, 2025. The improved part fits all production date vehicles. The new actuators' spindle drive turns in the opposite direction from the previous design requiring a change in vehicle software.

- When installing this improved actuator into a vehicle **built prior to March 28, 2025 you must replace the headrest actuators in both the drivers and passengers third-row seats at the same time AND perform ISTA/P conversion "Replace 3rd row actuator"**. This will add +AA3S into the Vehicle Order to reverse the spindle drive direction.
- There is a note about this retrofit added into Test Plans

- When installing this improved actuator into a vehicle **built after March 28, 2025 only replace the defective side**.
- See SI **B52 10 25** regarding the new design actuator.

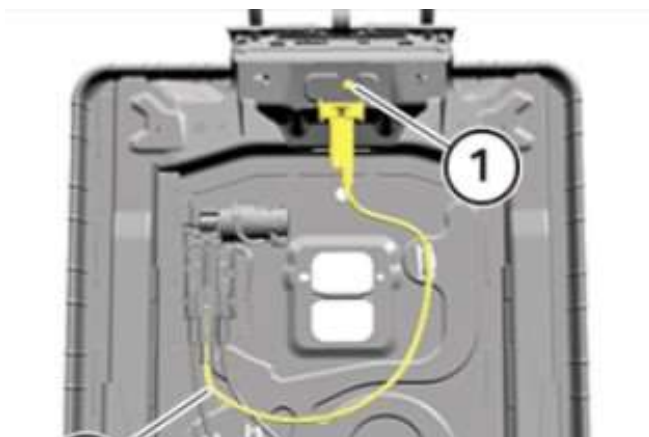
NO = Check if the Bowden cable is correctly mounted and properly routed.

If the Bowden cable is mounted properly and cable correctly routed and the electric motor moving the common housing fails to pull all 3 Bowden cables equally and to the end of travel, then see steps below about troubleshooting the actuator.

but the headrest Bowden cable does not travel far enough to release the headrest then

replace the Bowden cable for the headrest (shown in yellow in picture).

See **REP 52 30 253** Replace Bowden cable for left or right head restraint (Bowden cable unlocking device for head restraint).

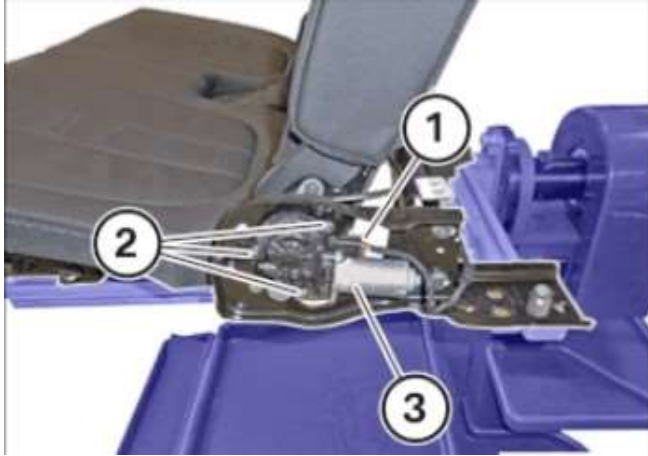
Check if the latch (the fastener on the left or right side) of the third row of seats is open or closed? (this is the hook/pin shown in green in picture)

If the head restraint stays in the seat position, the latch is closed.

If the head restraint falls into the folded position again, the latch is open.

**YES** (Latch is **open**) = Replace drivetrain of backrest tilt adjustment.

See **REP 67 31 635** Remove and install/replace drivetrain for backrest tilt adjustment of third-row seating (left or right) (according to vehicle diagnosis)

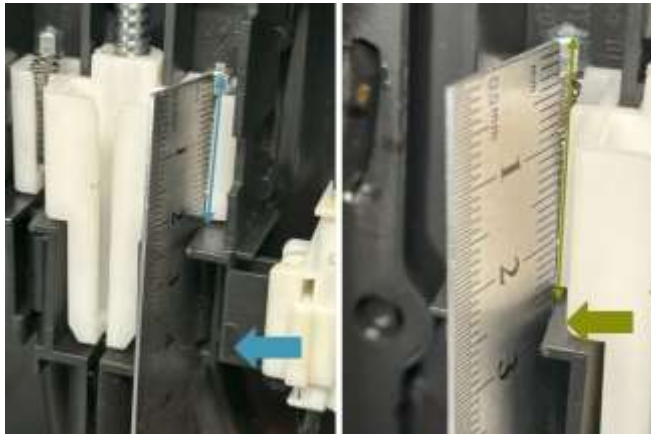
When the seat is in the upright latched position so the EKHV Motor is not energized and both latches are in the CLOSED position you will measure **27 mm from the lower plastic to the top of the outer Bowden cable(s)**.

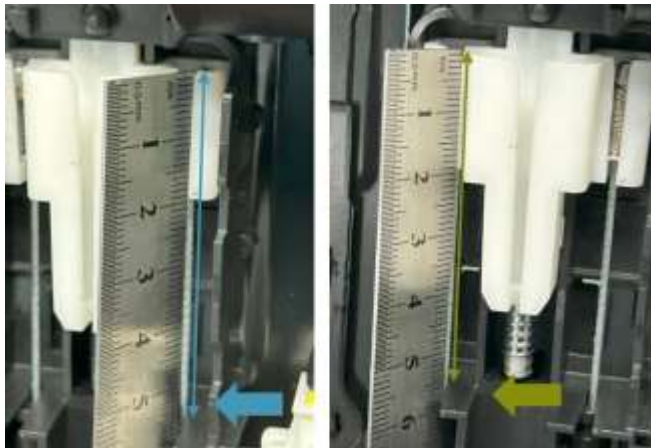
When the EKHV Motor actuates and spins the worm gear to pull upwards on the white plastic housing it will then measure **56 mm from the lower plastic to the top of the outer Bowden cable(s)**. This will OPEN the seat latches.

The white plastic housing will not travel its complete length or pull up equally on all 3 cables if:

- something is binding the seat latches.
- the Bowden cables are not routed correctly.
- the supplied voltage to the actuator motor is **below 10 volts**.

- A. Check for foreign object in latch mechanism.

- B. The Bowden cable for one of the latches has stretched. Replace the Bowden cable. See appropriate repair instruction:  
**REP 52 30 256** Replace Bowden cable for left or right rear seat backrest (Bowden cable for outer backrest release)  
**REP 52 30 255** Replace Bowden cable for left or right rear seat backrest (Bowden cable for inner backrest release)

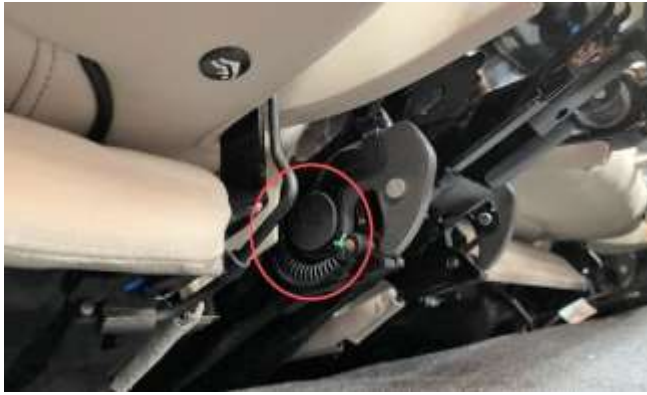
- C. Compression springs are required for the electric fold function and to fully seat the latch assembly.

An improperly positioned or missing compression spring prevents the seat backrest from locking completely.

Reference **B52 05 22** for further information.

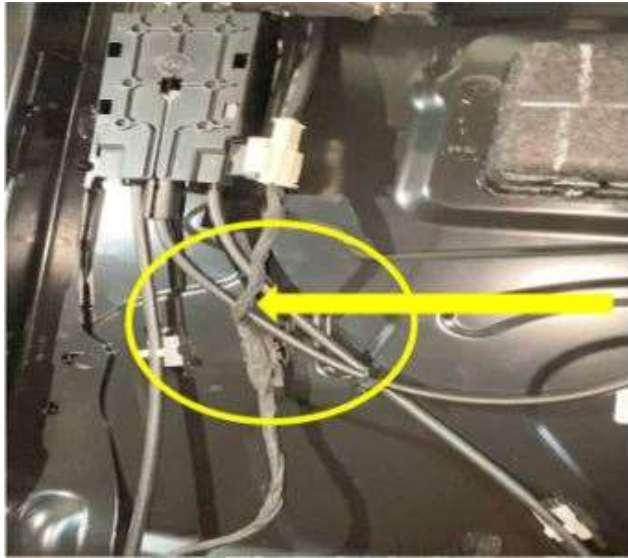
3. Noise from third-row seat backrest when vehicle goes over bumps:

- A. The wire harness going to the electric motor for the Bowden cables is supposed to be routed underneath the Bowden cables to keep the cables from vibrating against the back metal panel.

If necessary, unplug electrical connector, route harness between Bowden cable and metal seat backrest assembly. Reconnect electrical connector.

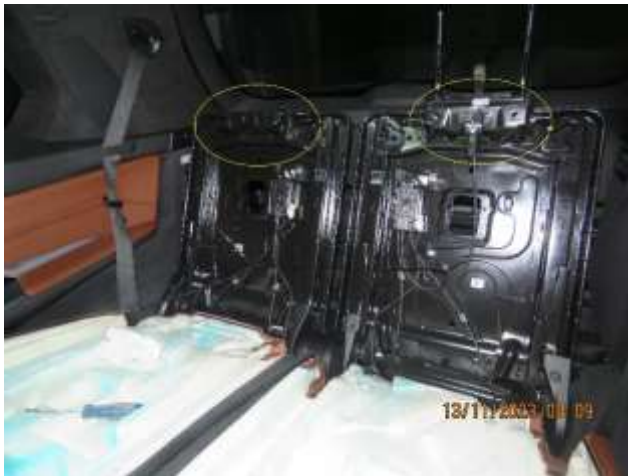
- B. The metal bracket that holds the headrest assembly is welded to the seat backrest assembly.

If any of the welds did not penetrate well this bracket may make noise.

Replace seat frame assembly if necessary.

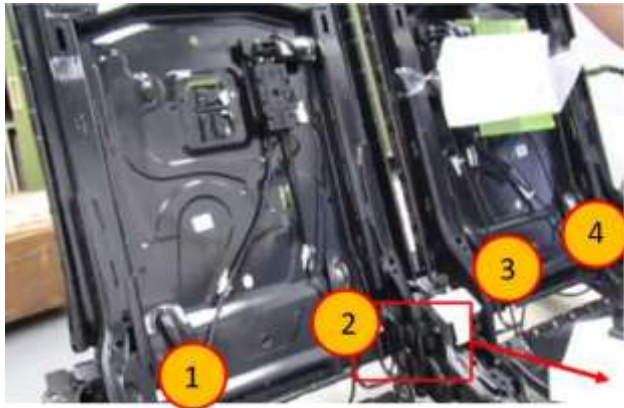
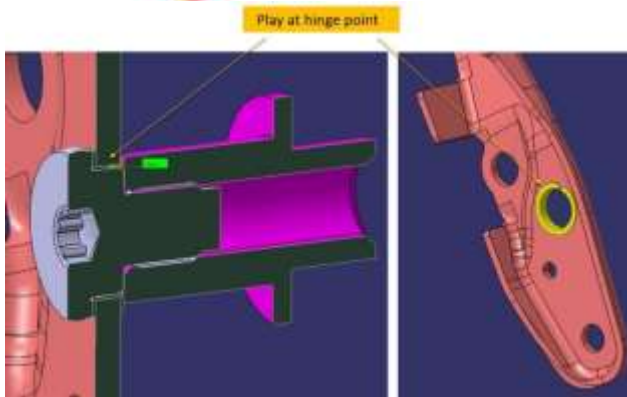
- C. Movement between the seat backrest bolts and their bushing can cause a noise over bumps from one or more of the 4 seat backrest bolts.

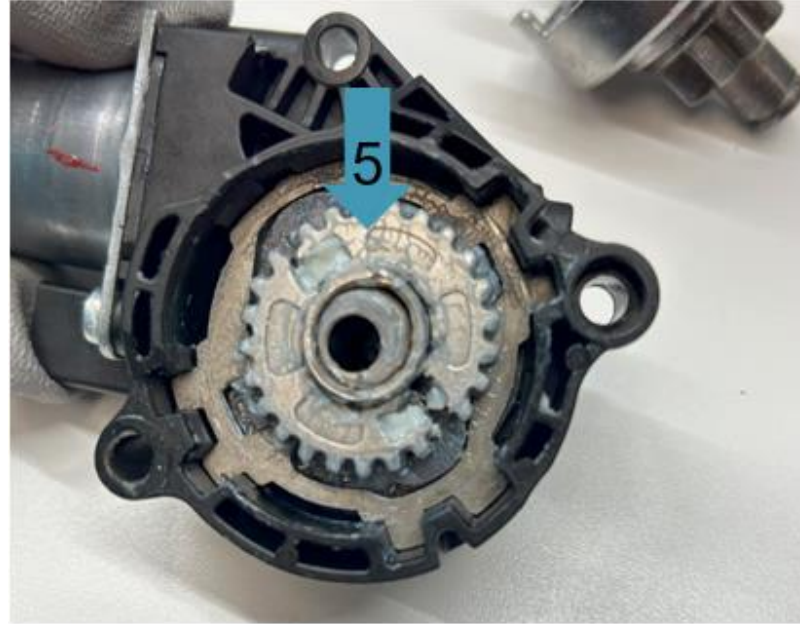
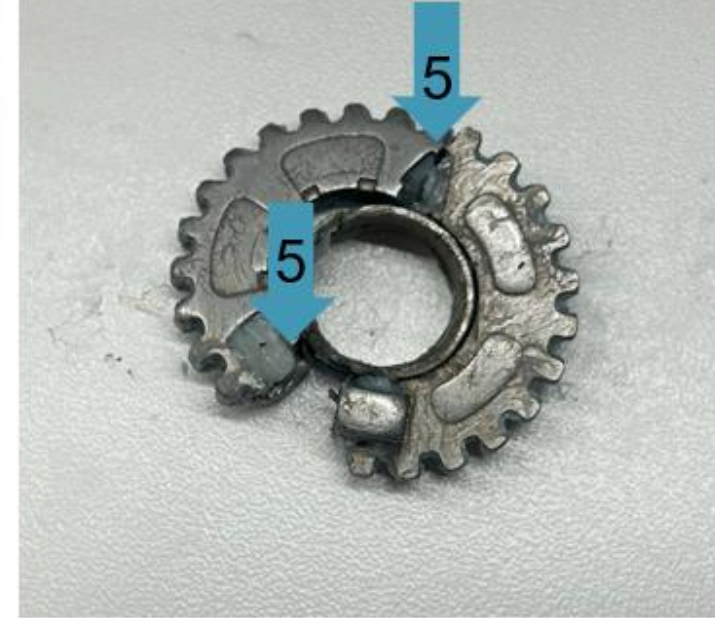
5. The gear tooth assembly may be damaged.
