SIB 52 10 25

THIRD SEAT ROW ELECTRIC BACKREST ACTUATOR DESIGN CHANGE

2025-08-19

| E-Series | Model Description |
|---|---|
| G07 | X7 Sports Activity Vehicle |

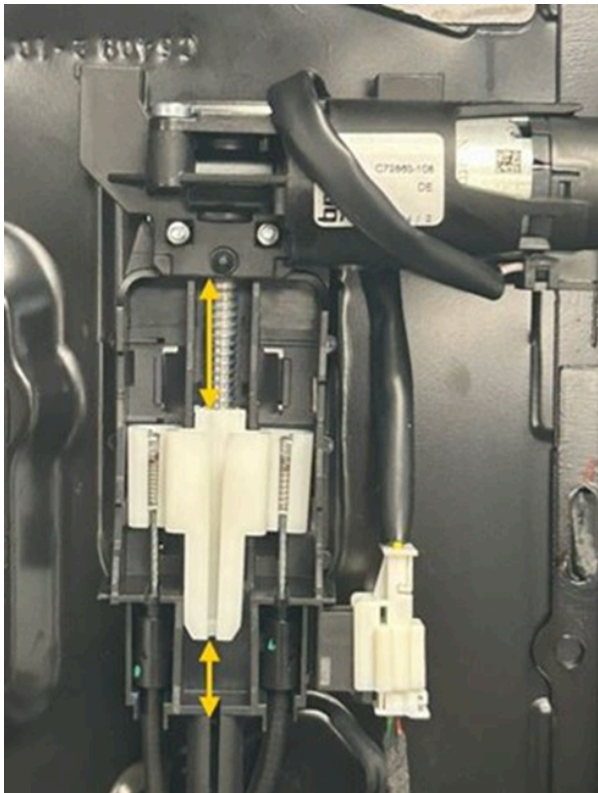
This design improvement ensures the seat back latches and headrest will release even when the actuator is experiencing a low voltage condition.

The improved part fits vehicles of all production dates. The new actuator’s spindle driver turns in the opposite direction from the previous design, requiring a change in vehicle software.
