E-Series	Model Description	Production Date	Affected Option Code
G45	X3 Sports Activity Vehicle	July 24, 2024 – May 02, 2025	552 (Full LED Lights with Cornering Lights) or 3MF (M Shadowline Lights)

On G45 vehicles built with option codes 552 (Full LED Lights with Cornering Lights), or 3MF (M Shadowline Lights), the headlights’ height setting might not be adjusted correctly.

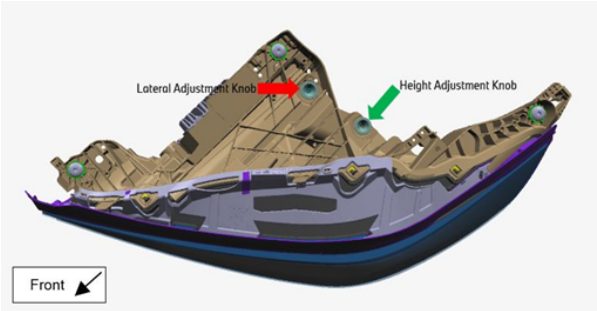
Photo is showing two adjusting knobs, but **ONLY** the height adjustment knob (green arrow) needs to be adjusted.

Note: There is no need to adjust the lateral adjustment knob (red arrow).

Driver’s side unit shown, looking downwards.
