SIB 63 10 23

2025-08-19

MOISTURE/CONDENSATION IN THE REAR TAILLAMPS

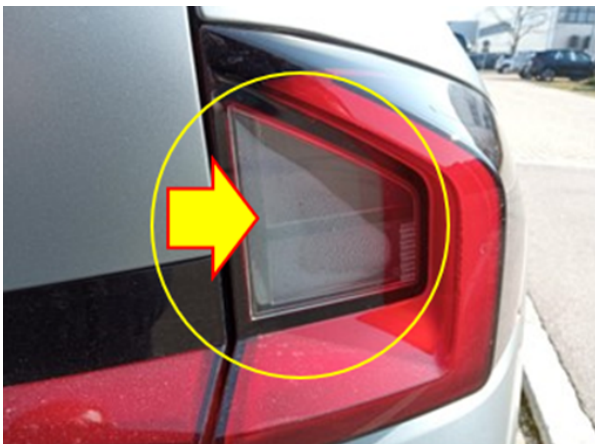
A. Normal/natural condensation.

- The taillamps will dissipate the condensation through venting. This venting process should be completed within 24 hours with the vehicle sitting in temperatures of 68 – 77 degrees Fahrenheit.

If normal environmental conditions are the cause of the condensation, no correction is required.

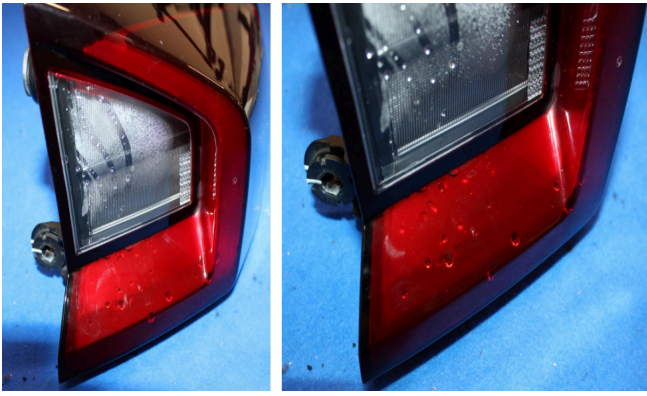
B. Water/moisture in the taillamp.

If the taillamps do not vent/dry within the described time frame, inspect the taillamp for leaks/damage and replace it if necessary.
