SIM 63 01 25

MOISTURE/CONDENSATION IN THE TAILLAMPS

E-Series	Model Description
U25	MINI Countryman

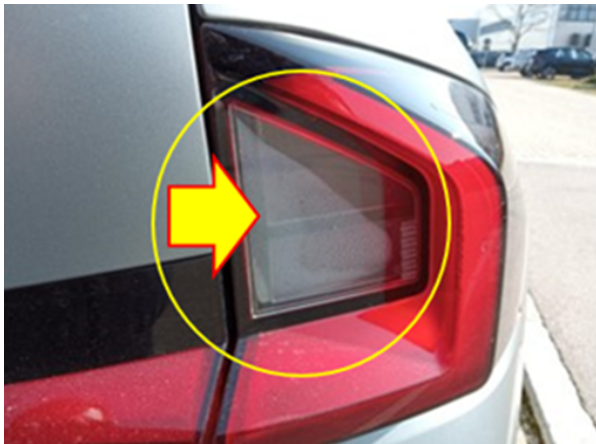
- A. Thermal/environmental conditions that result in the formation of condensation is not a defect.
- B. Water/moisture in the taillamp housing is considered a defect.

A. Normal/natural condensation.

- Note: The taillamps shown here are not from a U25, but the different condensation patterns are indicative

- A. If moisture is being caused by normal environmental conditions, no correction is needed.
- B. If moisture is determined to be caused by a defect, repair as needed.

If normal environmental conditions are the cause of the condensation, no correction is required.

- The taillamps will dissipate the condensation through venting. This venting process should be completed within 24 hours with the vehicle sitting in temperatures of 68 – 77 degrees Fahrenheit.

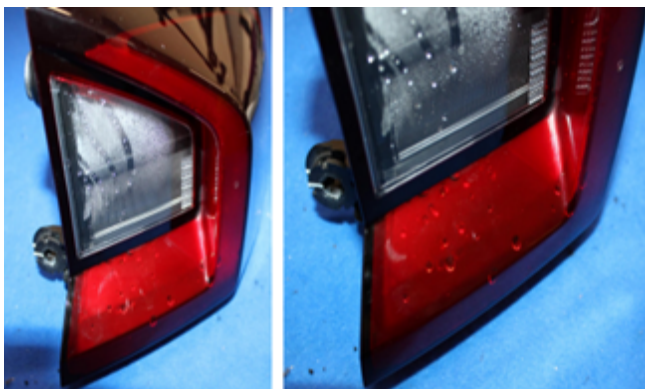
B. Water/moisture in the taillamp.

If the taillamps do not vent/dry within the described time frame, inspect the taillamp for leaks/damage and replace it if necessary.

- Note: The taillamp design does not utilize a separate seal. The seal is integrated into the replacement taillamp unit.
