SIB 84 05 25

## REPLACEMENT TELEMATICS MODULE CANNOT BE PROGRAMMED BY ISTA

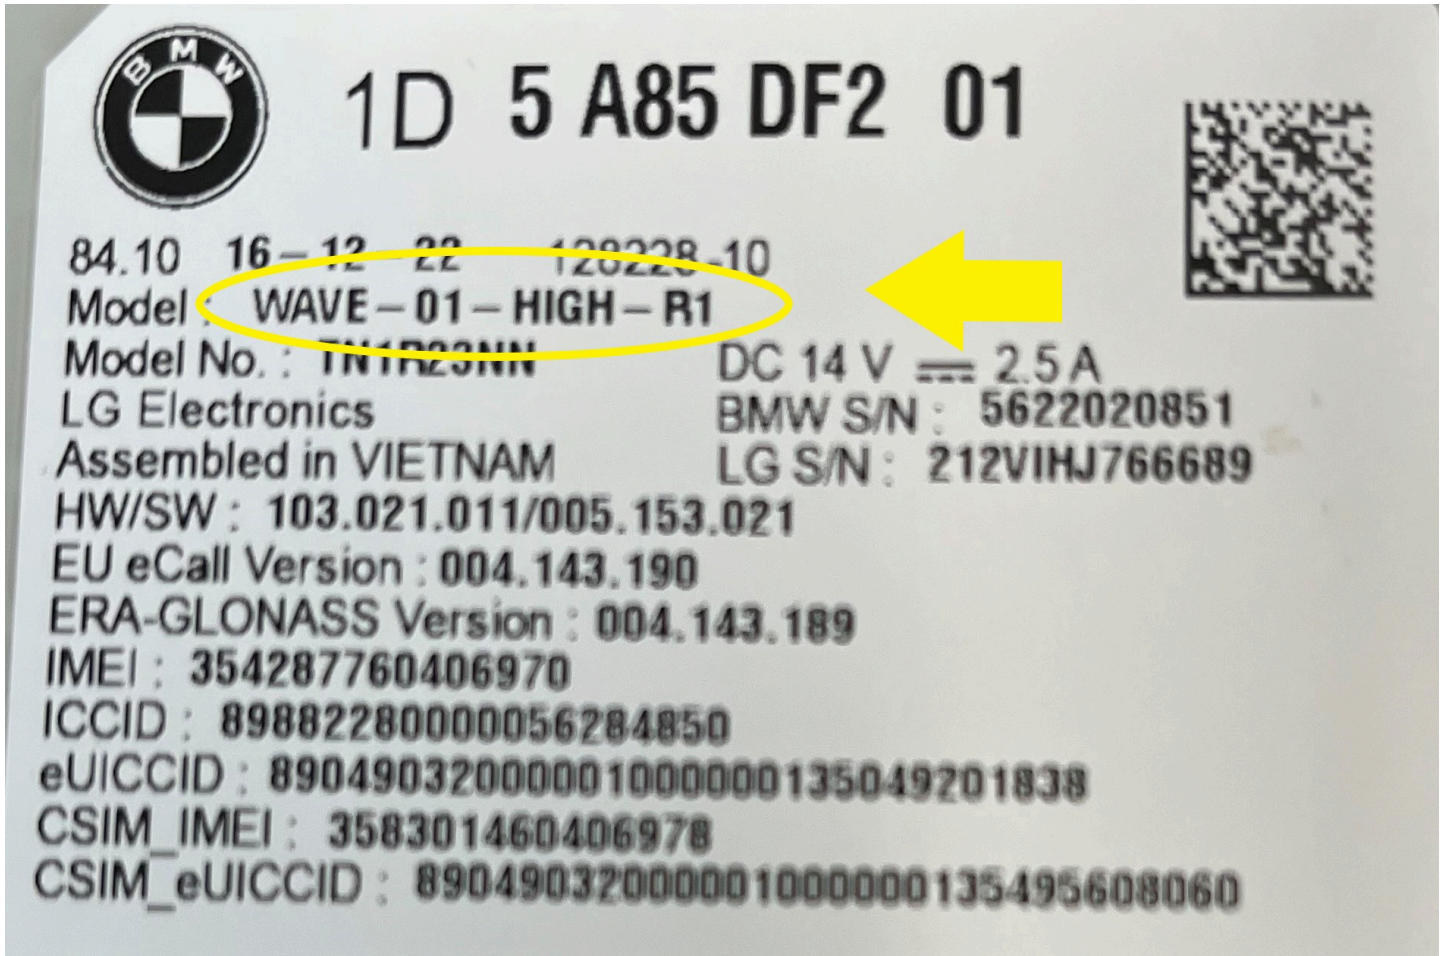
The TCB4 replacement parts are changing supplier versions from WAVE-11 High to WAVE-01 High. This change in hardware will not be accepted in ISTA when performing programming for replacement.

When replacing the TCB4 due to a failure, make sure to check the information sticker in the replacement module for the version.

For ISTA to accept the hardware change from WAVE-11 to WAVE-01, the programming conversion “Replacement of WAVE11 to WAVE01” will need to be performed AND the vehicle will need to be programmed to I-level ...25-07-500 or higher.
