HYUNDAI Technical Service Bulletin

GROUP BODY	NUMBER 25-BD-011H
DATE AUGUST 2025	MODEL(S) SANTA CRUZ (NXT)

SUBJECT: TONNEAU COVER FUNCTION: INSPECTION & REPAIR

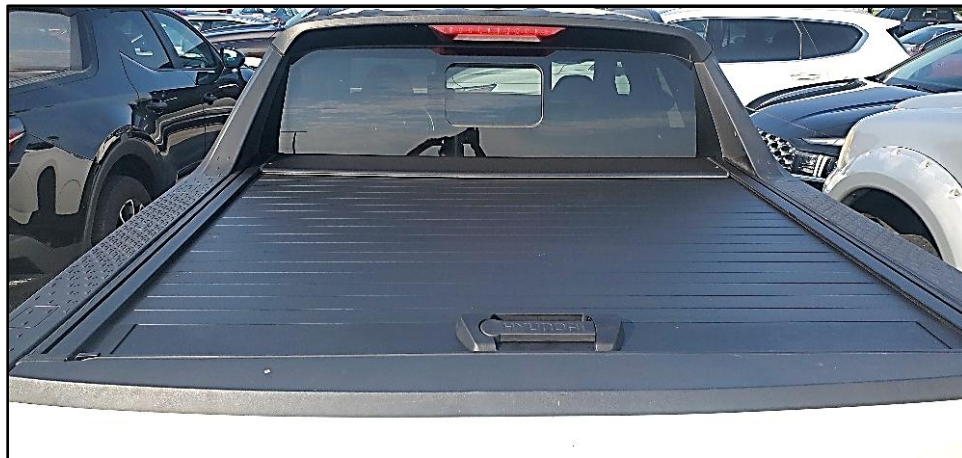
Description: Certain Santa Cruz (NXT) vehicles may exhibit a condition where the tonneau cover does not retract properly and/or a V-Gap is present when closed. This may be due to a broken or missing clip on the underside of the tonneau cover. Follow the instructions in this TSB to inspect and, if necessary, repair the tonneau cover function using the Tonneau Cover Repair Kit.

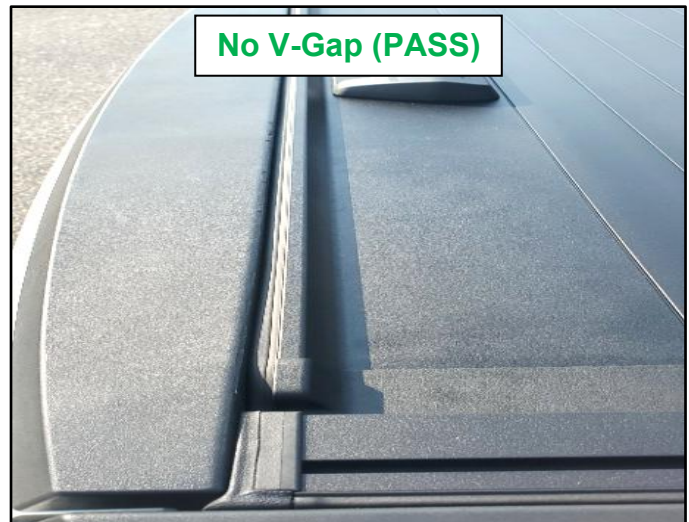
- **PASS:** If **NO** V-gap is present, this inspection is complete. Proceed to the [Retraction Inspection](#) procedure on the next page.
- **FAIL:** If a V-gap (B) is present, go to the next step to take a photo for Digital Documentation, then proceed to the [Tonneau Cover Repair](#) procedure on page 8.

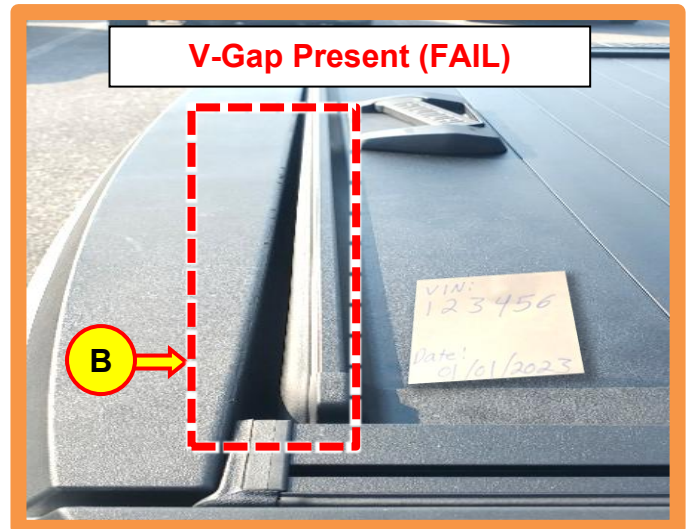
Using STUI, take a photo of the V-gap condition with the last 6 digits of the VIN and the date of repair on a piece of paper.

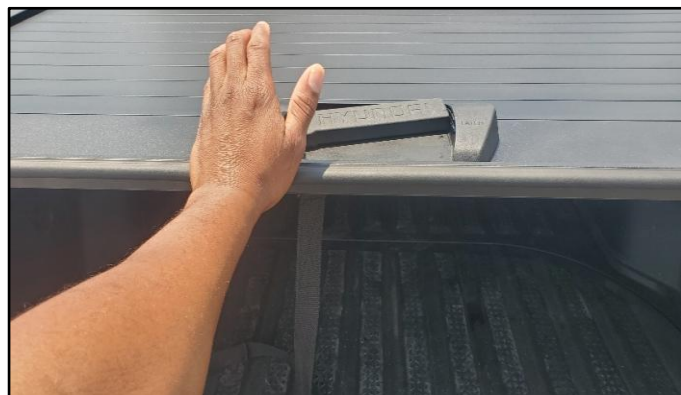
If the tonneau cover does **NOT** retract or requires excessive effort while pushing to retract, proceed to the [Tonneau Cover Repair](#) procedure on the next page.
