Technical Service Bulletin

GROUP CAMPAIGN	NUMBER 25-01-055H
DATE AUGUST 2025	MODEL(S) IONIQ 9 (ME1A EV)

SUBJECT: PAINT PEELING ON LEFT REAR BUMPER UPPER GARNISH
(SERVICE CAMPAIGN TDZ)

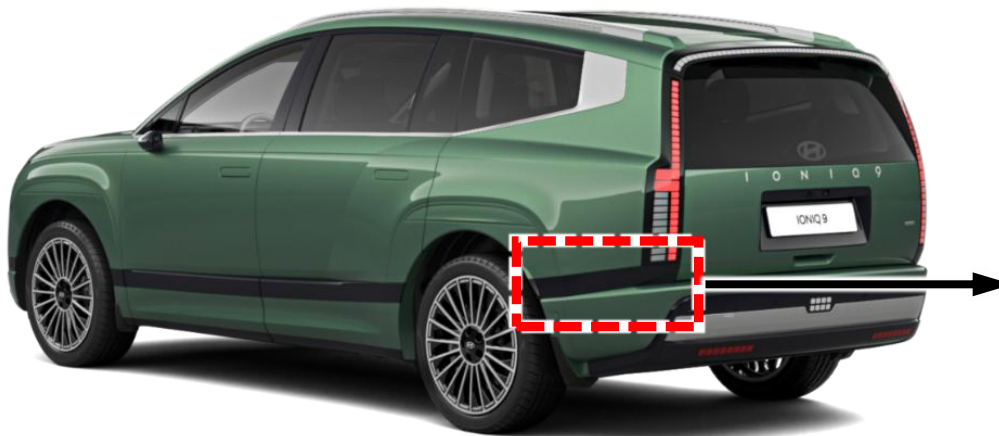
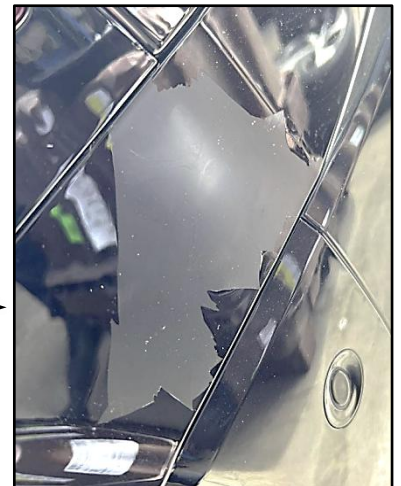
Description: Certain IONIQ 9 (ME1A EV) vehicles may exhibit paint peeling from the left upper garnish on the rear bumper. This bulletin provides instructions to replace the left upper garnish on the rear bumper.
