Service Bulletin

Bulletin No.: PIP6082

Subject: Diagnostic Tip: Engine Surge Or Misfire With One Or More Of The Following DTCs P0300 P0011 P0014 P0016 P0017 With Less Than 1000

Brand:	Model:	Model Year:		VIN:		Engine:	Transmission:
		from	to	from	to		
Buick	Encore GX	2025		All	All	1.3 L3T	All
Chevrolet	Trailblazer	2025		All	All	1.3 L3T	All

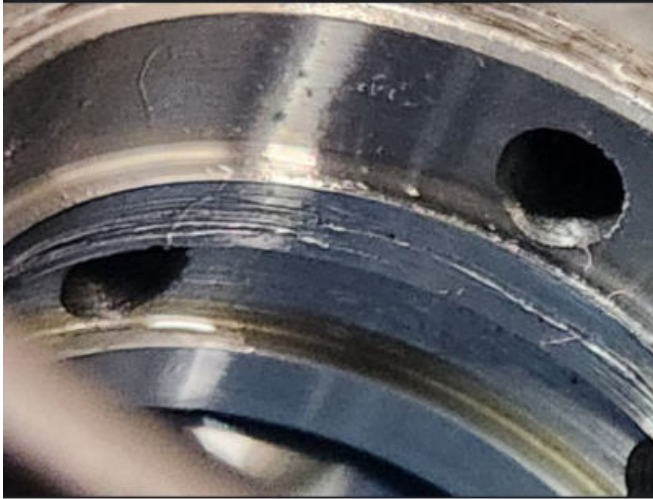
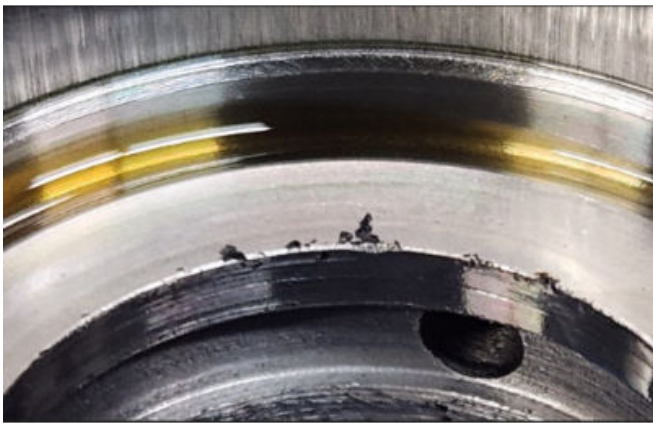
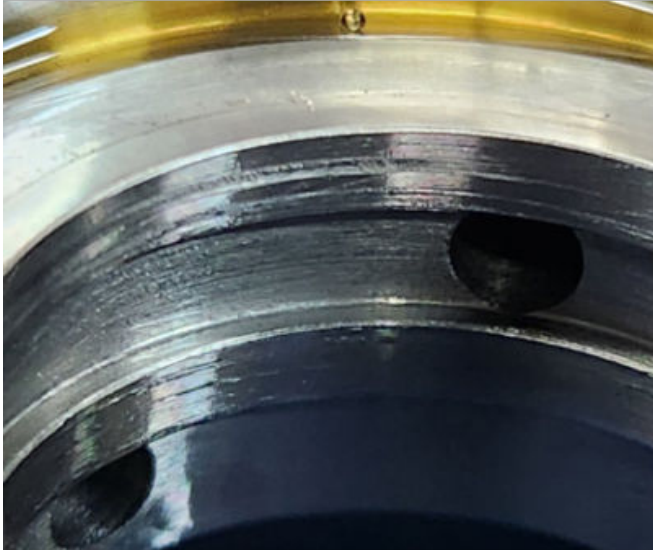
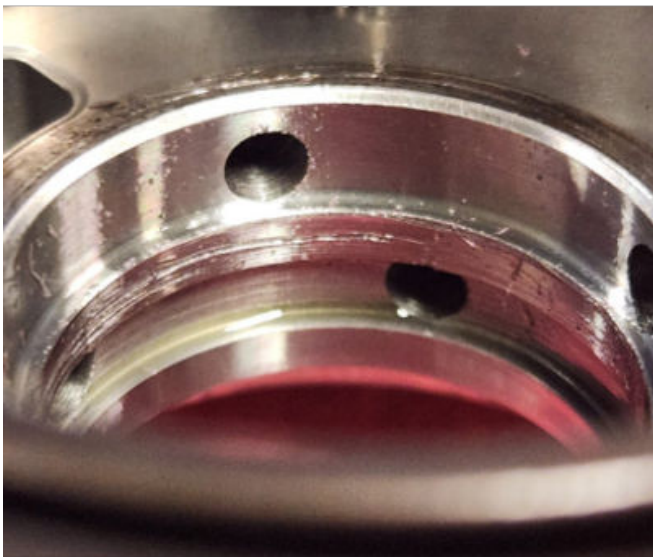
Note: DO NOT use power tools during the removal or installation of the Intake/Exhaust solenoid Valve Bolts or damage to the Cam Actuator bore could occur.

Pictures below show the damage that can occur to the Cam Actuator bores.

If metal contamination has been found in the engine oil, replace both the Intake and Exhaust cam actuators and Intake and Exhaust Solenoid Valve Bolts using latest repair procedures outlined in Service Information. Change engine oil and filter. Clear DTC's using GDS and evaluate repairs.
