GENERAL MOTORS
DCS7306
URGENT - DISTRIBUTE IMMEDIATELY

Subject: N252519310 - Customer Satisfaction Program
Thermostat Housing Low Torque

Models: 2025-2026 Cadillac CT4

N252519310 Thermostat Housing Low Torque

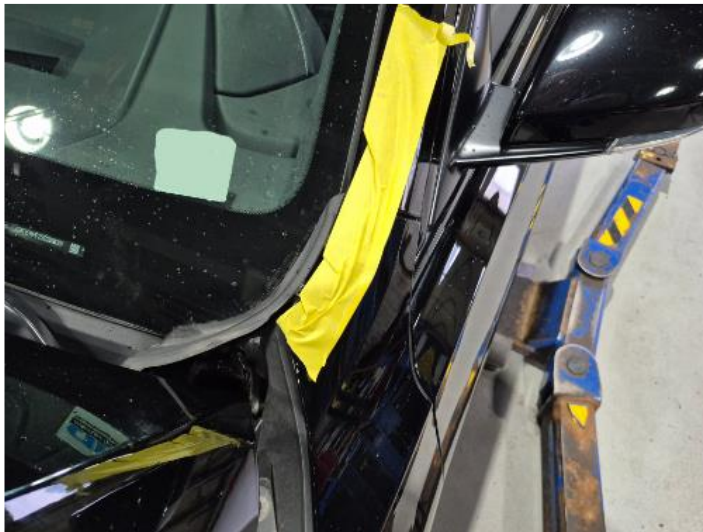
6994645

7. Remove the Air Inlet Grille Panel Extensions - Left Side and Right Side.
 - 7.1. Apply two layers of masking tape as shown to prevent paint damage.
 - 7.2. Using a suitable plastic trim tool, carefully release the air inlet grille panel extension clips.

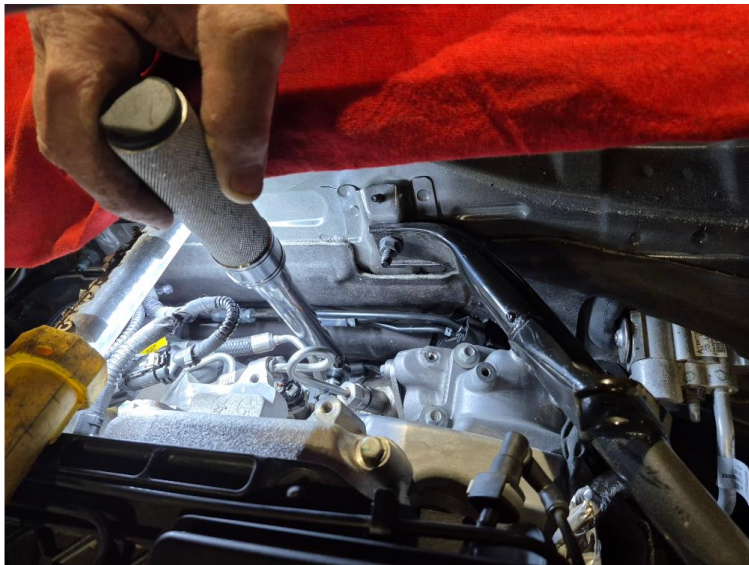
6994647

33. Remove the Engine Rear Noise Shield.
34. Verify there are no leaks coming from the thermostat housing.
