Technical Service Bulletin (TSB)
Front Wheel Disconnect Inoperative

REFERENCE:	TSB: 08-261-25 REV. A GROUP: 08 - Electrical	Date:	August 22, 2025	REVISION:	08-261-25
VEHICLES AFFECTED:	2024 (KM) Jeep Wagoneer S This bulletin applies to vehicles built on or after **May 27, 2024 (MDH 0527XX)** and on or before **September 05, 2025 (MDH 0905XX)** equipped with 400V G2500 FR/RR Elec Drive Motors (Sales Code ELD).			MARKET APPLICABILITY: <input checked="" type="checkbox"/> NA <input type="checkbox"/> MEA <input type="checkbox"/> SA <input type="checkbox"/> IAP <input type="checkbox"/> EE <input type="checkbox"/> CH NOTE: This bulletin applies to the North America market.	
CUSTOMER SYMPTOM:	Customers may experience the following: <ul style="list-style-type: none"> Switching from 2WD to AWD inoperable. Wheel hub harness connector wires will have damage. 				
CAUSE:	Manufacturing issue

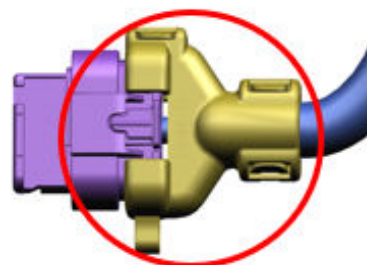
Fig. 1

1. Raise vehicle on hoist. Refer to the detailed service procedures listed in DealerCONNECT Service Library under: 04 - Vehicle Quick Reference / Hoisting / Standard Procedure.
2. Remove both front tires. Refer to the detailed service procedures listed in DealerCONNECT Service Library under: 22 - Tires and Wheels / Removal and Installation.
3. Check to see if the connector to the wheel hub has a connector cover on both sides [Fig. 1](#).

Connector Cover

4. Does the connector to the wheel hub have a connector cover?
 - YES>>> This bulletin has been completed. Use Inspection LOP (08-90-75-9E) to close the active RSU.
 - NO>>> Proceed to [Step 5](#).
5. Remove both front splash shields. Refer to the detailed service procedures listed in DealerCONNECT Service Library under: 23 - Body / Exterior / Shield / Removal and Installation.
6. Disconnect both ends of the harness [Fig. 2](#).
