GENERAL MOTORS  
DCS 7309  
URGENT - DISTRIBUTE IMMEDIATELY

Subject: REVISION: N252510321-01 - Service Update  
ECM Software Update  
Expanded Population

Models: 2021-2023 Cadillac Escalade  
2021-2023 Cadillac Escalade ESV  
2021-2024 Chevrolet Silverado 1500  
2021-2023 Chevrolet Suburban  
2021-2023 Chevrolet Tahoe  
2021-2024 GMC Sierra 1500  
2021-2023 GMC Yukon  
2021-2023 GMC Yukon XL

## N252510321 ECM Software Update

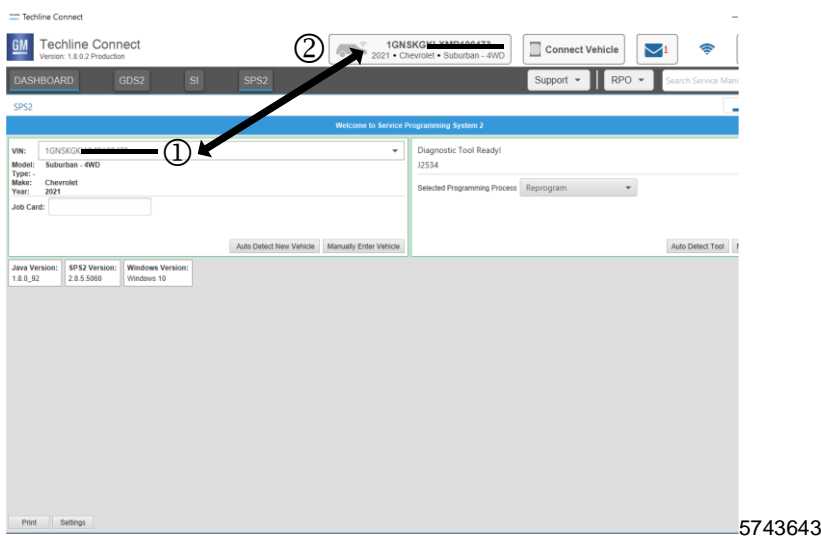
**Caution:** Be sure the VIN selected in the drop down menu (1) is the same as the vehicle connected (2) before beginning programming.

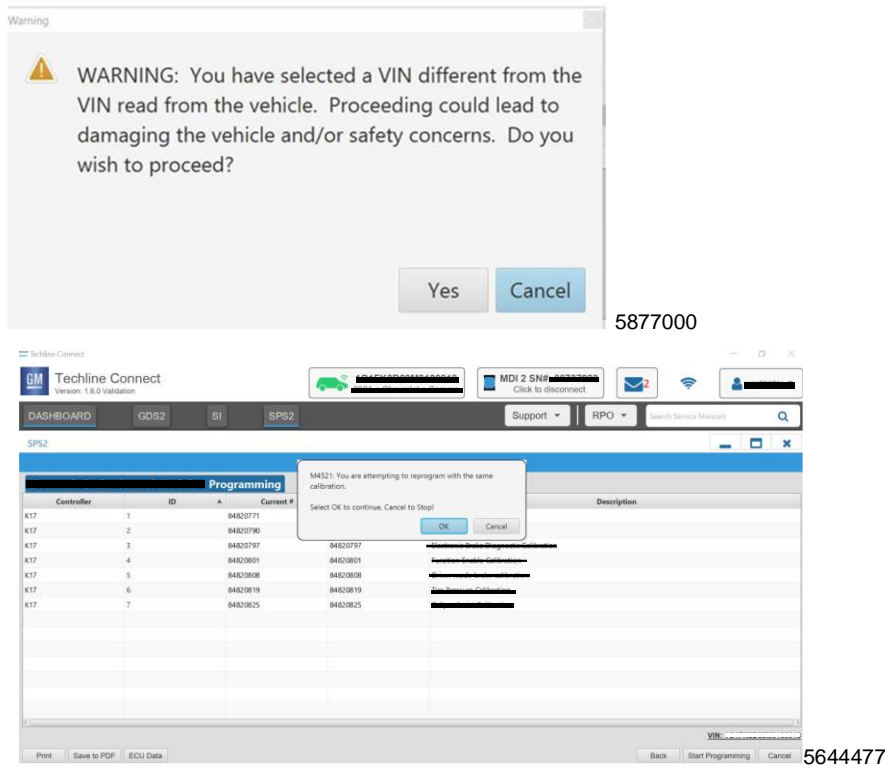
**Important:** If the vehicle VIN DOES NOT match, the message below will be shown.

**Important:** Techline Connect screens shown above.

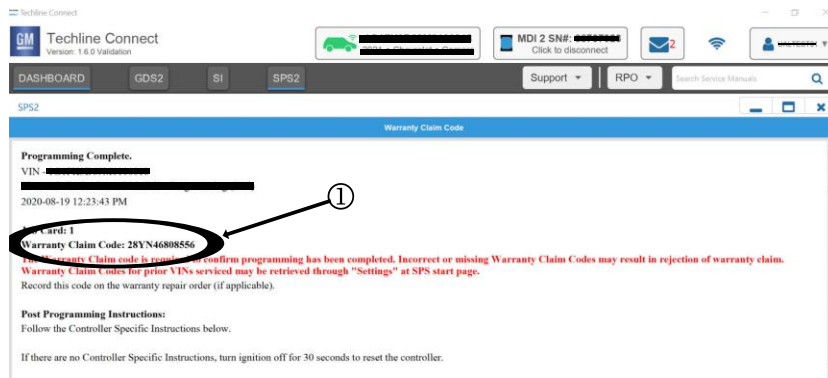
**Note:** The screenshot above is an example of module programming and may not be indicative of the specific module that is being programmed. Module selection and VIN information have been blacked out.

**Important:** To avoid warranty transaction rejections, you MUST record the warranty claim code provided on the Warranty Claim Code (WCC) screen shown above on the job card. Refer to callout 1 above for the location of the WCC on the screen.

1. Reprogram the Engine Control Module. Refer to *K20 Engine Control Module: Programming and Setup* in SI.

2. Record SPS Warranty Claim Code on job card for warranty transaction submission.
