Technical Service Bulletin

Topic	Sporadic All-Wheel Drive Warning Continental GT/GTC/Flying Spur 25-26MY
Market area	Bentley: worldwide (2WBE),China 796 VW Import Comp. Ltd (Vico), Beijing (6796)
Brand	Bentley
Transaction No.	2077545/3
Level	EH
Status	Released for publishing
Release date	Aug 11, 2025

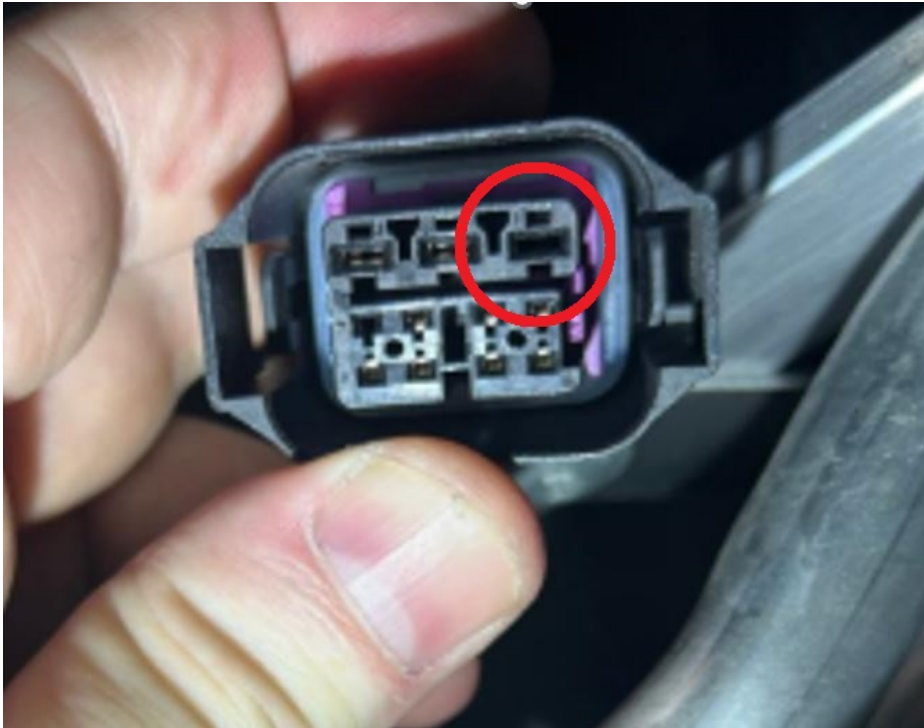
Figure 1

Potential issue with the T16-way connector at J647, causing intermittent faults in the differential lock system due to:

- Poor electrical contact
- Corroded or loose terminals
- Defective terminals.

1. Inspect the T16-way connector at J647 for any defective terminals.

3. If any terminals are found to be defective as per the example in figure 1.

- Replace all all the defective individual terminals (part number P00293586).

- If required replace the entire 16-way connector at the J647 unit (part number (P00427711)).
