<b>Topic</b>	OBC Charging Efficiency MIL HW / SW Update (NAR Only)   Bentayga (Hybrid)   24MY
<b>Market area</b>	United States E05 Bentley USA and rest America (6E05)
<b>Brand</b>	Bentley
<b>Transaction No.</b>	2077790/3
<b>Campaign number</b>	ED44
<b>Note</b>	
<b>Type</b>	
<b>US code</b>

OBC Charging Efficiency MIL HW / SW Update (NAR Only) | Bentayga (Hybrid) |  
24MY

Release date: Aug 21,  
2025

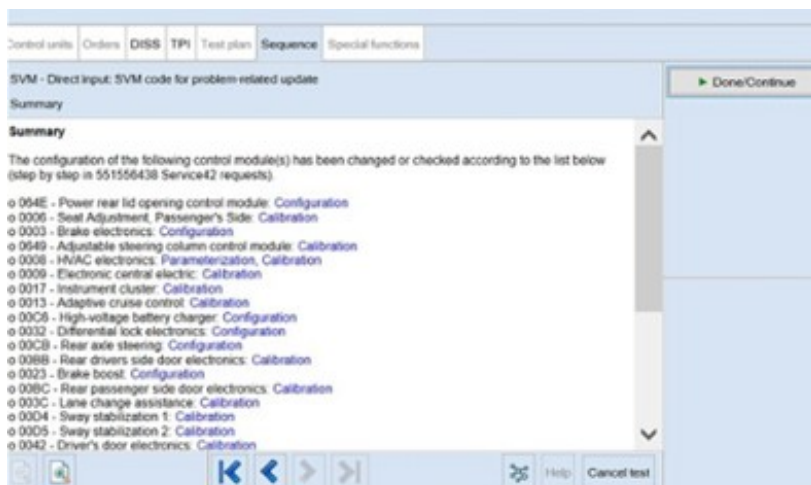
8. If the SVM code completes successfully, ODIS should display as per the image above.

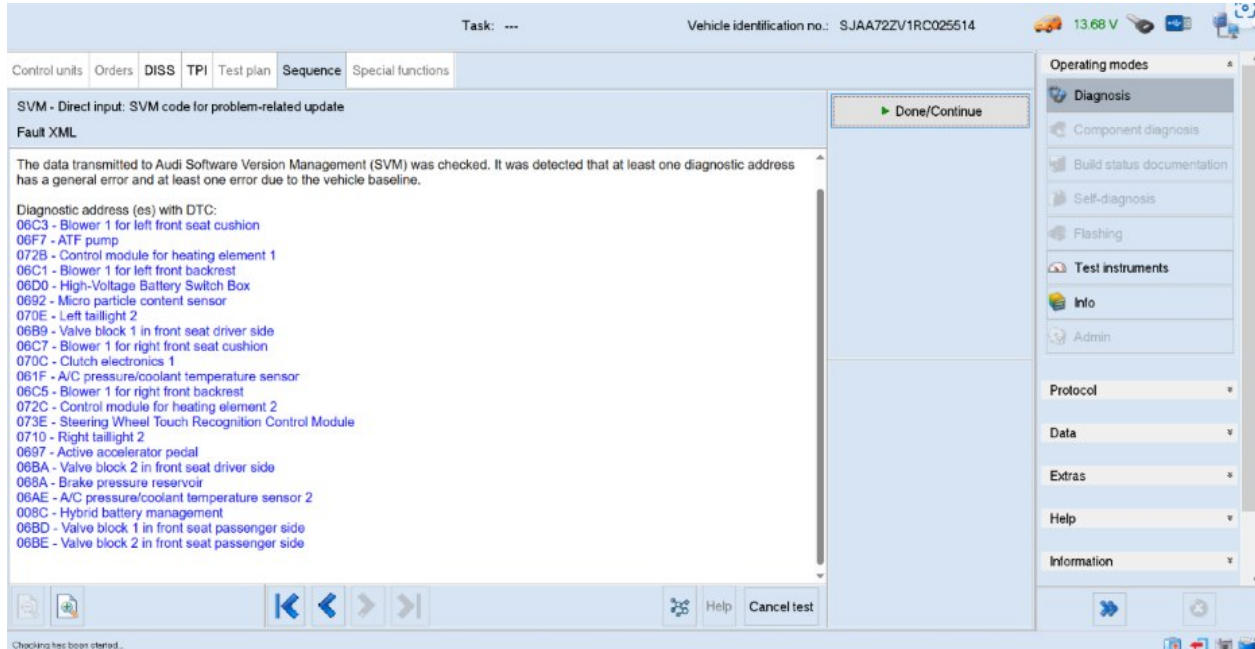
b. If you receive the error '8058' or the screen shown in the image above, please do the following:

c. Locate 00C6 in control unit list

d. Select -> Guided Functions -> Read Identification Data

e. If the software version of 00C6 is now at SW3322 then proceed to step 2.

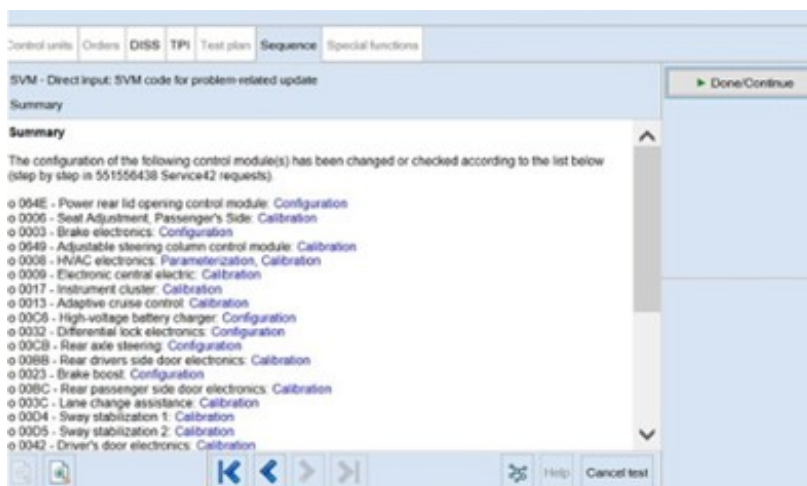
8. If the SVM code completes successfully, ODIS should display as per the image above.
