Technical Service Bulletin

Topic	ODIS Error Message – Best Practice When Performing Baseline (BiL) Updates
Market area	Bentley: worldwide (2WBE),China 796 VW Import Comp. Ltd (Vico), Beijing (6796)
Brand	Bentley
Transaction No.	2078962/1
Level	EH
Status	Released for publishing
Release date	Aug 21, 2025

24-26MY Bentayga | 25-26MY Continental GT/GTC/Flying Spur

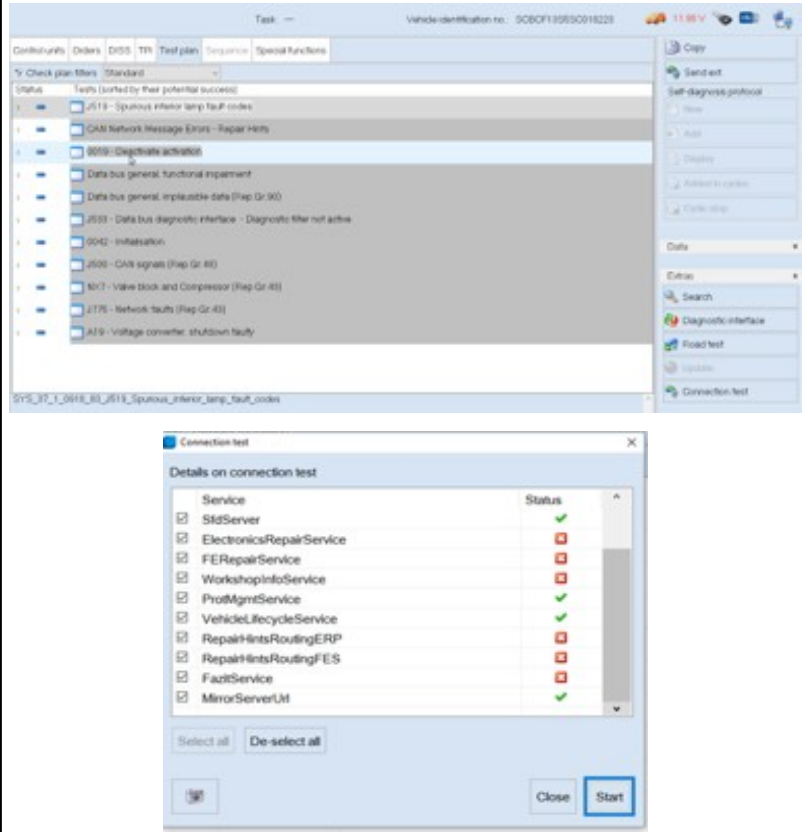
Check that the D3 Edge Box is connected

- Perform the 'connection test' within the extra menu
 - Navigate to "Extras" -> "Connection Test" -> Select "Bentley" (If Multi Brand) -> "Select ALL" -> Start
 - If the Mirror Server does not return a green ✓ -> Check your D3 setup and IP settings as per the next step.

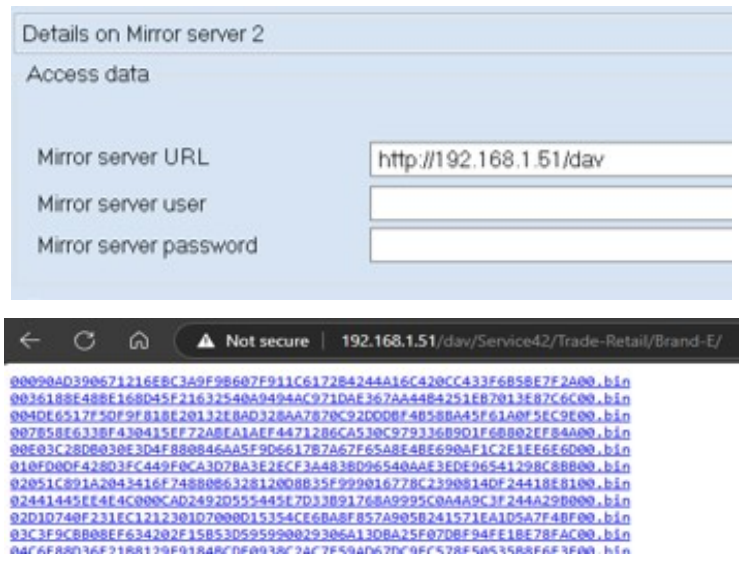
Mirror Server Settings

- Check that the URL in the Mirror Server 2 is correct for the new D3 edge box.
 - Refer to "Operating Modes" -> "Admin" -> "Connections" -> "Mirror Server 2;;.
- Ensure that the URL is http://.. And NOT https://
- Enter the mirror server URL into a web browser, and ensure that the flash files are visible on the server.
 - Copy & paste the Mirror server address into a web browser e.g Microsoft edge) -> Navigate to the flash files location: XXX.

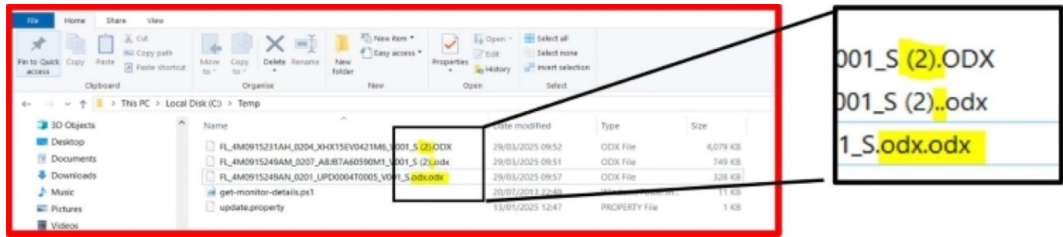
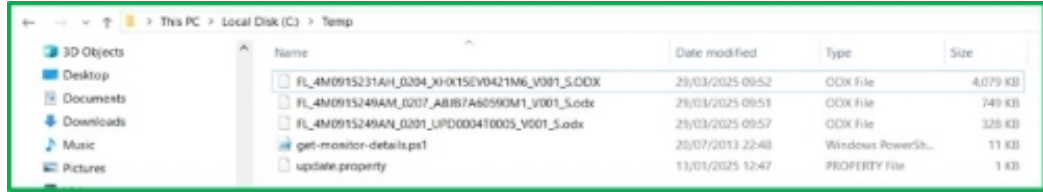
Local Flash Containers (Using files from c:/temp)

Type of Flash Container	Best Fixes
	<ul style="list-style-type: none"> If a flash file is being used locally, eg ED40, ED42 download from atheer – this means that the flash container is extracted directly form the C:/temp folder on the users ODIS tester. If the flash files are downloaded incorrectly, or not extracted from the ZIP folders correctly, this means ODIS cannot identify the correct flash file. <p>Example of Bad file structure / naming:</p>

- Duplicated Download Suffix
- Multiple or incorrect file extension types

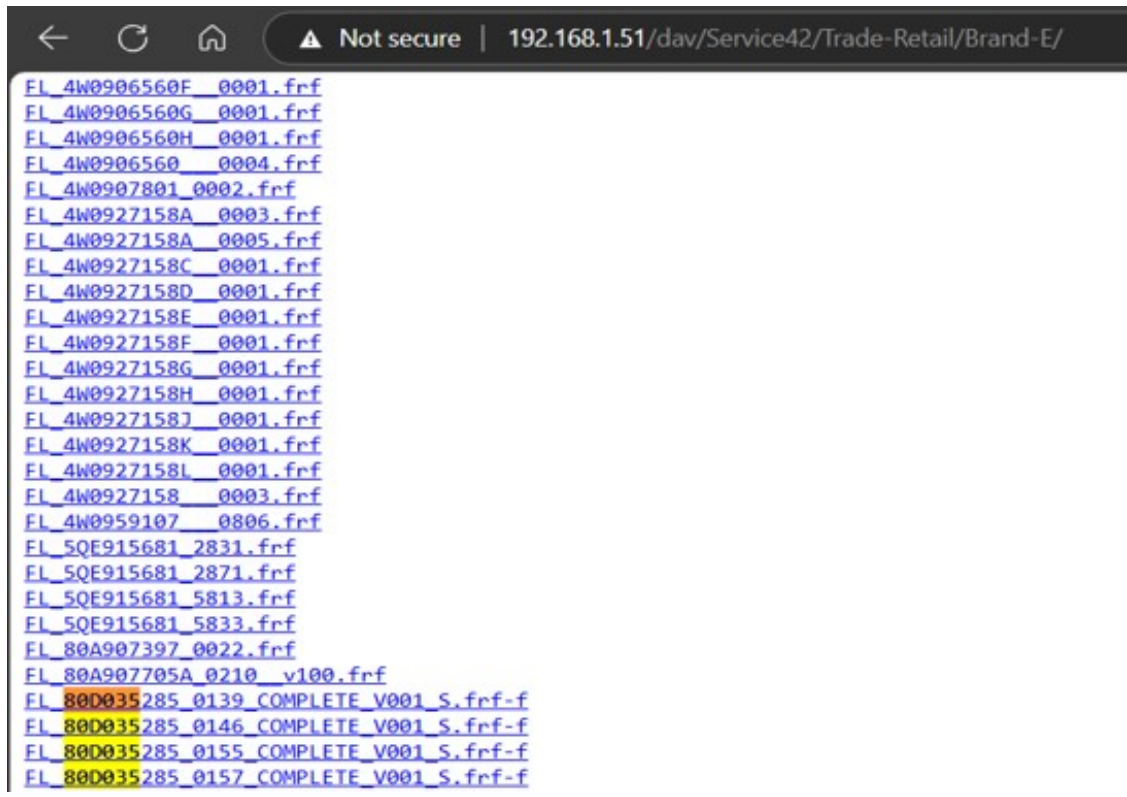
Type of Flash Container	Best Fixes
<p>Online Link Flash Containers (using an SVM Code)</p>	<ul style="list-style-type: none"> • When an ECU requires a software update through SVM, ODIS will pull the file from the mirror server/ D3 edge box. • If the Flash Container can not to be linked, check if the files is present on the mirror server • To do this: <ul style="list-style-type: none"> – Enter the mirror server URL into a web browser, and ensure that flash files are visible on the server. – Copy & paste the mirror server address into a web browser (eg Microsoft edge) -> Navigate to the flash files location: XXX.XXX.X.XX/dav/Service42/Trade-Retail /Brand-E/ • Then press 'ctrl' + 'f' and search the Mirror Server for that flash container. • In this example, the FRF file is available to be flashed with ODIS:
