# Technical Service Bulletin

<b>Topic</b>	Rear Door Blind Inoperative   Bentayga Series
<b>Market area</b>	Bentley: worldwide (2WBE),China 796 VW Import Comp. Ltd (Vico), Beijing (6796)
<b>Brand</b>	Bentley
<b>Transaction No.</b>	2077256/3
<b>Level</b>	EH
<b>Status</b>	Released for publishing
<b>Release date</b>	Aug 21, 2025

Rear door blind is inoperative.

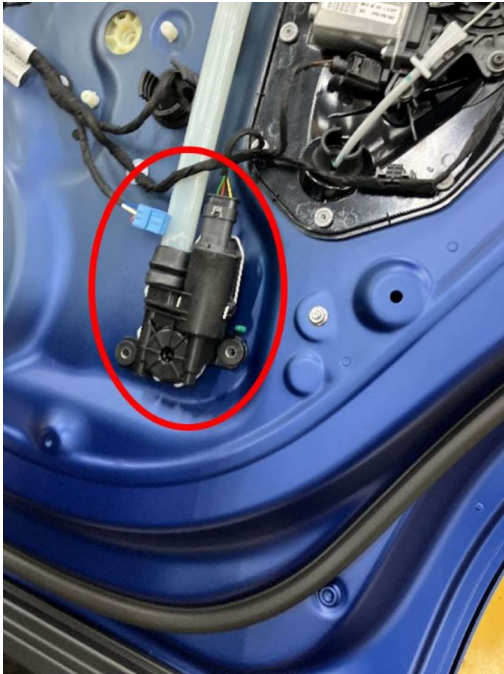
Figure 2 – A close up of detail A from figure 1

- To disconnect the motor, first unplug the connector and unscrew the fixings from the motor (Figure 2)

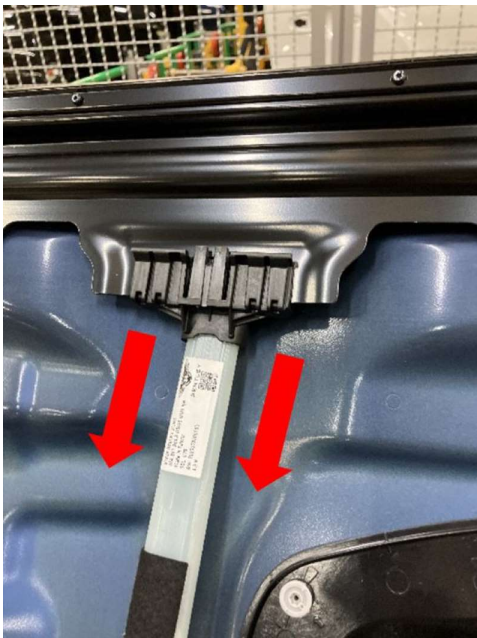
Figure 3 – A close up of detail B from figure 1

4) Remove the motor only (Figure 3) and actuate the rear door blinds through the switch and through ODIS.
