SERVICE PROGRAM BULLETIN

APPLICABILITY: 2017 MY Forester (turbo) **NUMBER:** WRA-25R
 2017 MY WRX **DATE:** 06/27/25

SUBJECT: Rear Catalyst (Center Exhaust Pipe) **REVISED:** 08/11/25
 Non-Compliance

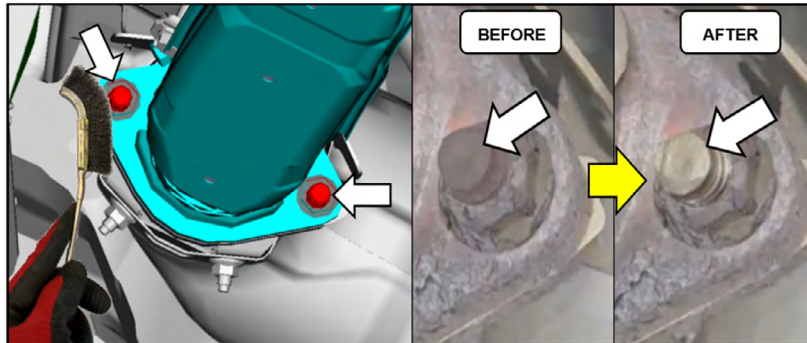
NOTE: The amount of rust may vary depending on the vehicle. The example image below is to be used as reference.

STEP 5: Using a wire brush, remove all rust located on both nuts and studs of the front center exhaust pipe connection.
