**Date: 8/1/2025
CAL FTL 54-038**

Subject: Wiring Support Bracket Reroute

Model: 5th Generation Cascadia

Build Date Range: Selected Vehicles Built Between June 2, 2025, and July 1, 2025

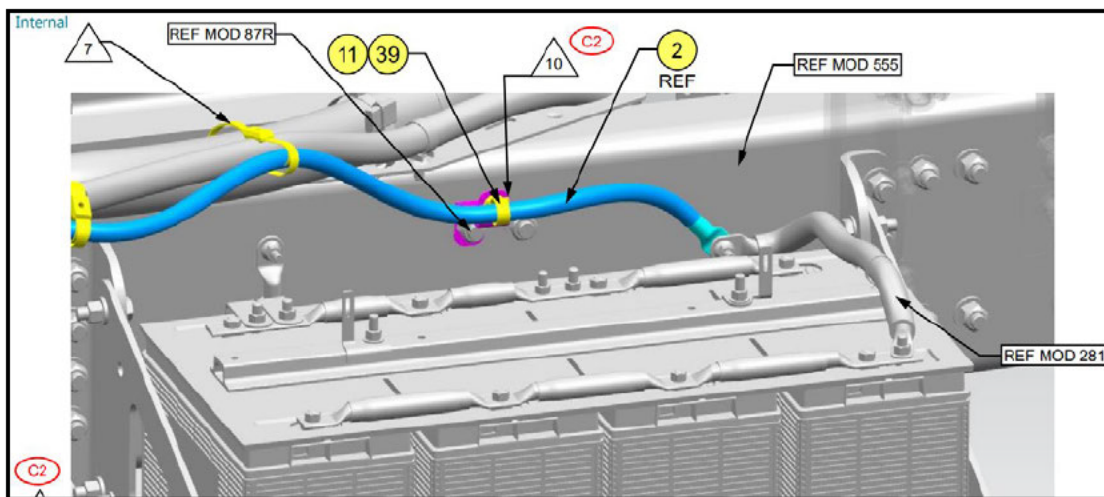
Your vehicle may have a bracket that is positioned downward. This procedure will help you position the bracket upward to ensure the proper wiring routing on the unit.

Fig. 1 Wiring Support Bracket Rerouting

1. Park the vehicle on a level surface, shut down the engine, and apply the parking brakes. Chock the tires.
2. Disconnect the negative battery cables from the batteries.
3. Locate the bracket on the frame rails near the positive auxiliary cables.
4. Position the bracket upward (a 180-degree rotation) using a diagram D66-22650-001 as reference and complete the installation according to the R&C guidelines. See Fig. 1.
