## SERVICE BULLETIN

**APPLICABILITY:** 2019-23MY Forester w/ Gen 3.1  
 2019-23MY Impreza & Crosstrek w/ Gen 3.1  
 2019-21MY WRX/STI w/ Gen 3.1  
 2022-23MY WRX w/ CP1  
 2019-22MY Ascent w/ Gen 3.1  
 2019MY Outback & Legacy w/ Gen 3.1  
 2020-22MY Outback & Legacy w/ CP1

**NUMBER:** 15-322-25R

**SUBJECT:** CP1 & Gen 3.1 Head Unit Warranty Extension

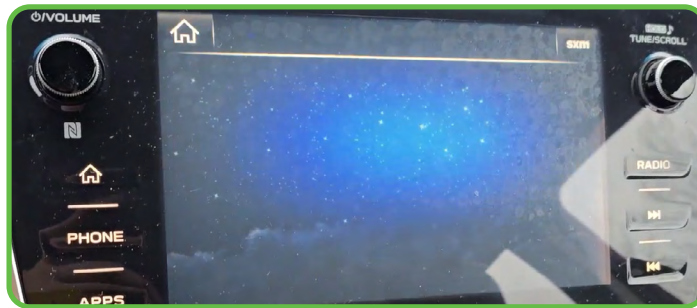
Display ON

**BUBBLED SCREEN SCENARIO (COVERED)**

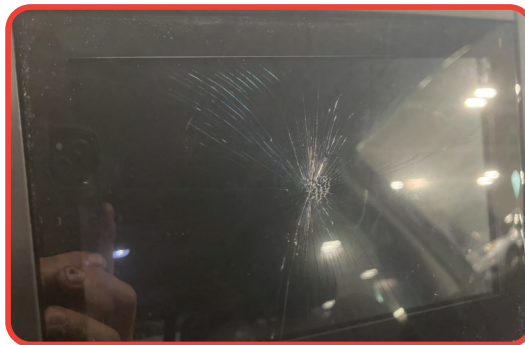
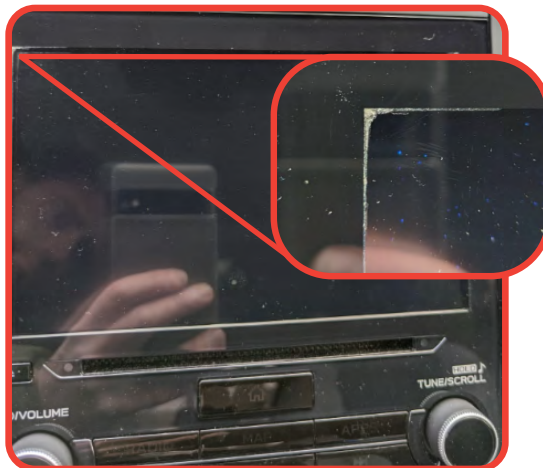
**PHYSICAL DAMAGE (NOT COVERED)**
