# Heater Return Pipe

# TSB-83-164-FTL

- ▶ New Cascadia
- ▶ Business Class M2-Plus
- ▶ 108SD Plus/114SD Plus

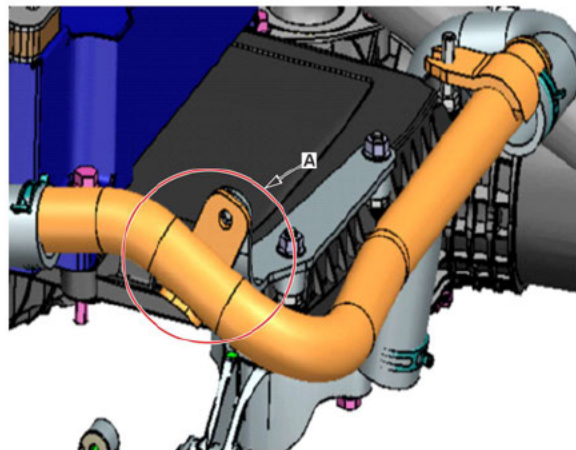
Fig. 1, Coolant Leak Location

The field received complaints about obvious coolant leaks on the heater return pipe from the weld-on bracket that attaches to the engine bracket. This condition is observed most often on vehicles equipped with DD13 engines. This service bulletin is applicable when there is visible coolant leakage from the tubes and engine side.

1.  Inspect the front right-hand side of the DD13 engine heater return pipe for coolant leakage. See Fig. 1.

A. Check this area for coolant leaks from the heater return pipe.

2.  If coolant leaks are found, drain or adjust the coolant level as required.

3.  Replace the old heater return pipe with the updated part. **Do not** replace the right-hand side bracket.
