Removing Odometer Pause Wiring Modifications

TSB-54-375-FTL

- ▶ Business Class M2-Plus
- ▶ 108SD Plus/114SD Plus

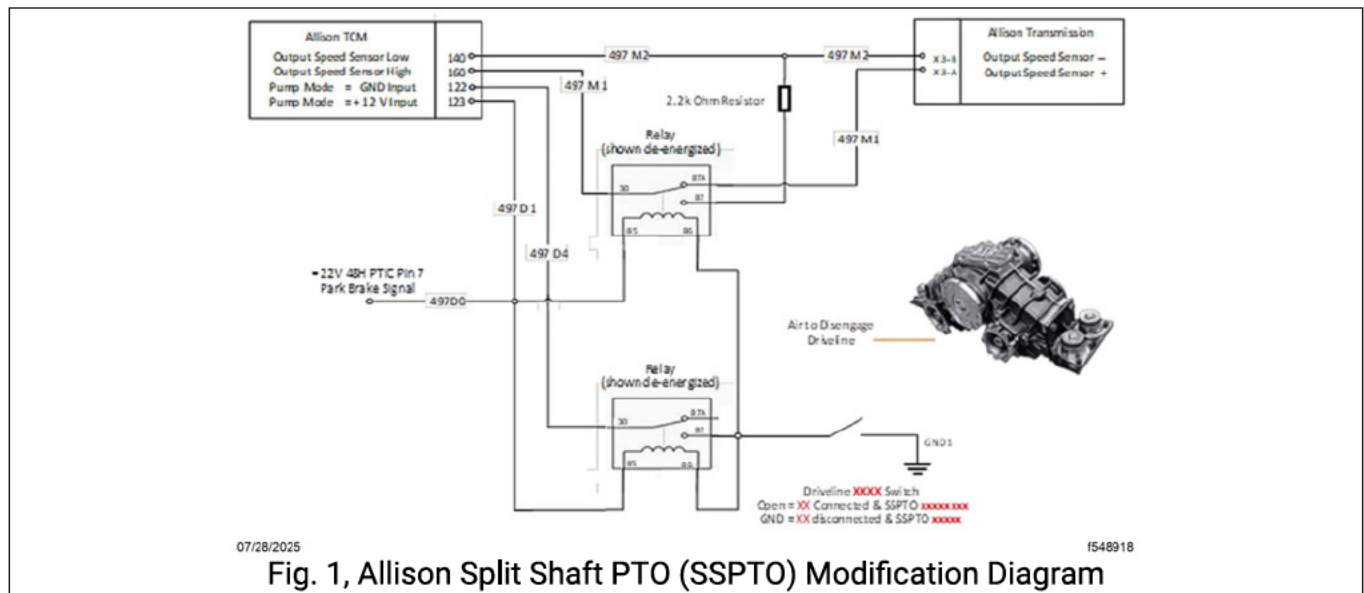
Fig. 1, Allison Split Shaft PTO (SSPTO) Modification Diagram

Figure 1 shows the modification diagram for the system to be removed.

⚠ Note: With the relays removed, the control signals, directed to the park brake signal node, and the driveline disconnect switch are to be connected to the Allison Transmission Control Module (TCM) pins 122 and 123. Control signals to TCM 123 and 122 are to be re-established. The two relays no longer sequence signals to the TCM.

1. Remove the 2.2K ohm resistor. Leave the circuit 497M2 intact.

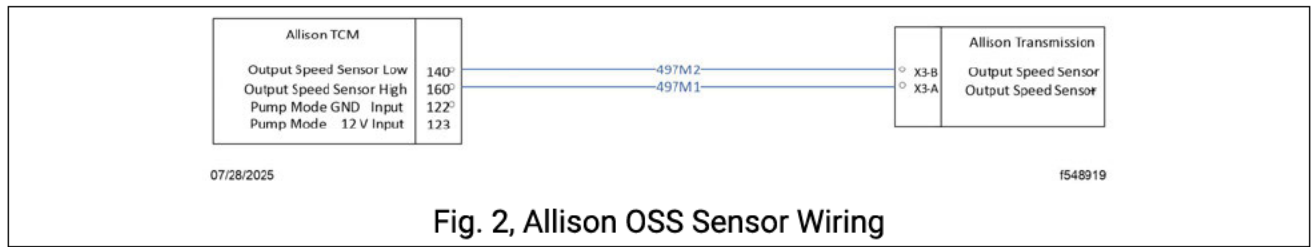
- Remove both ends of 497M1 from the relay and connect 497M1 again. Leave the TCM pin 160 and the output speed sensor pin X3-4 intact. The final configuration is shown in Fig. 2.

- Remove the remaining relay for the driveline status. Keep the wires 497D1 and 497D4 intact. These wires connect to the TCM pins 122 and 123 and are re-used.
- After the relay circuits are removed, the fourth gear lock-up function needs to be enabled by sending power to TCM 123 and a switch to ground for TCM 122 when the driveline is disengaged, and the SSPTO is engaged.
 - TCM 123 reflects the selection of pump mode by the operator and the application of the park brake.
 - TCM 122 indicates that the split shaft PTO is fully engaged, and the driveline is disengaged.
- After removing the relay circuits, for instructions to set the Single Signal Detect and Actuation Module (SSAM) and CPC5 parameters for the odometer pause function, see **TEM-54-00012: Odometer Pause for SSPTO**.
