## HVAC Stops Cooling

## TSB-83-163-FTL

► New Cascadia

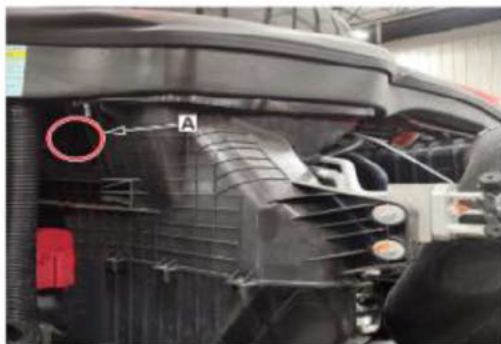
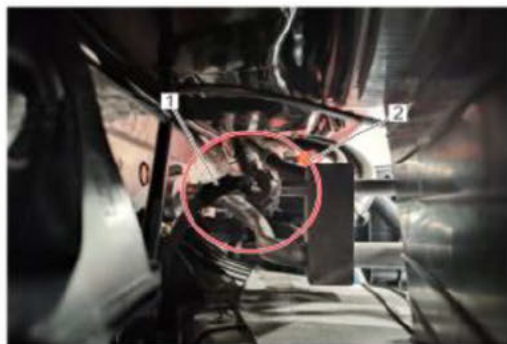
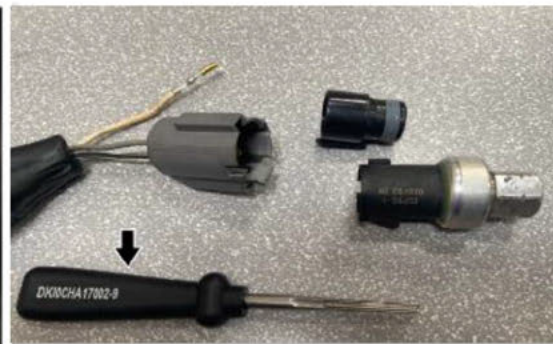
The field received numerous complaints about air conditioning (A/C) systems not cooling. In most cases the fault code 25/522510/3- high side Pressure - Voltage above normal or shorted to the high source or open circuit, is present. After investigation, it has been determined that the terminals (23-13211-440) are loose on the pins of the pressure transducer. Loose terminals at the pressure transducer can affect the A/C functionality, resulting in the A/C not cooling. Vehicles built from June 2022, through December 2024 or any vehicle receiving replacement terminals that do not fit properly on the pressure transducer pins, can be affected.

Starting on November 18, 2024, production started receiving new terminals attached to the harness with A66-14821-000 that addresses the 'loose terminal' issue. Also the aftermarket started receiving updated terminals in Parts Distribution Centers (PDC's) on December 6, 2024. The new terminals may not receive a new part number, however all aftermarket terminals that have been updated, did have the terminals marked with a black marker. See Fig. 1.
