SF715 A-B

Subject: Stalk Switches

On behalf of the entities listed below, Daimler Truck North America LLC (DTNA) is initiating Field Service Campaign SF715 to modify the affected vehicles.

PROBLEM: At initial key-on, certain stalk switches may experience power supply issues leading to various symptoms. Common indicators may include the engine/powertrain failing to start as well as unintentional activation of wipers and hazard lights.

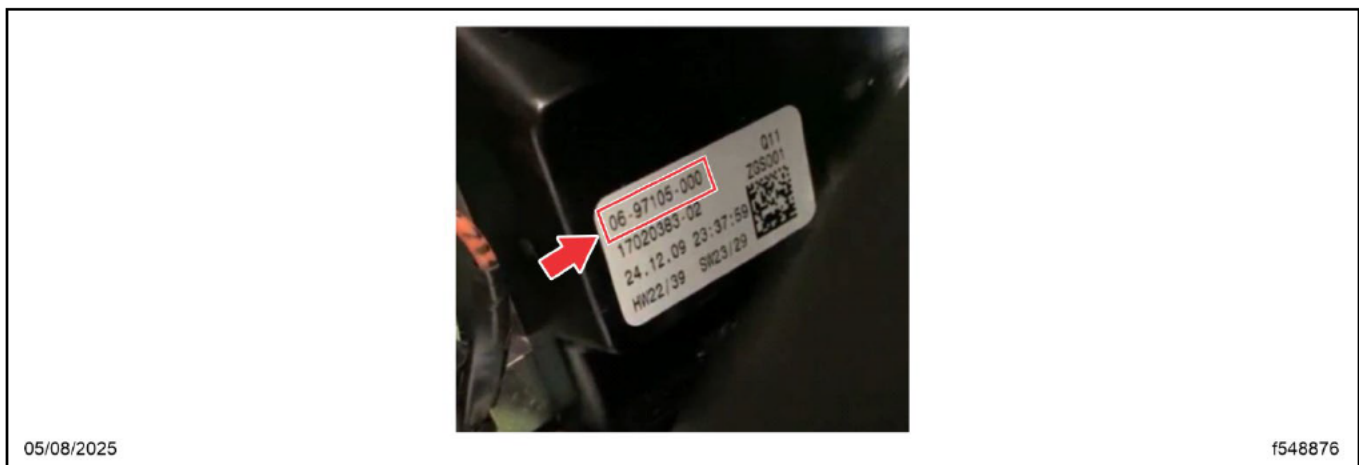
Fig. 1, Stalk Switch Part Number on the Manufacturer's Label

5. Inspect the left-hand stalk switch part number on the manufacturer's label. See [Fig. 1](#).

6. Compare the stalk switch part number on the manufacturer's label to the part numbers listed in **Table 1**.
Is the installed part number listed in the 'Bad Part #' column?
YES → Follow steps 7 through 10 to replace it with the 'Replacement Part #' listed on the same row.
NO → Go to step 11.

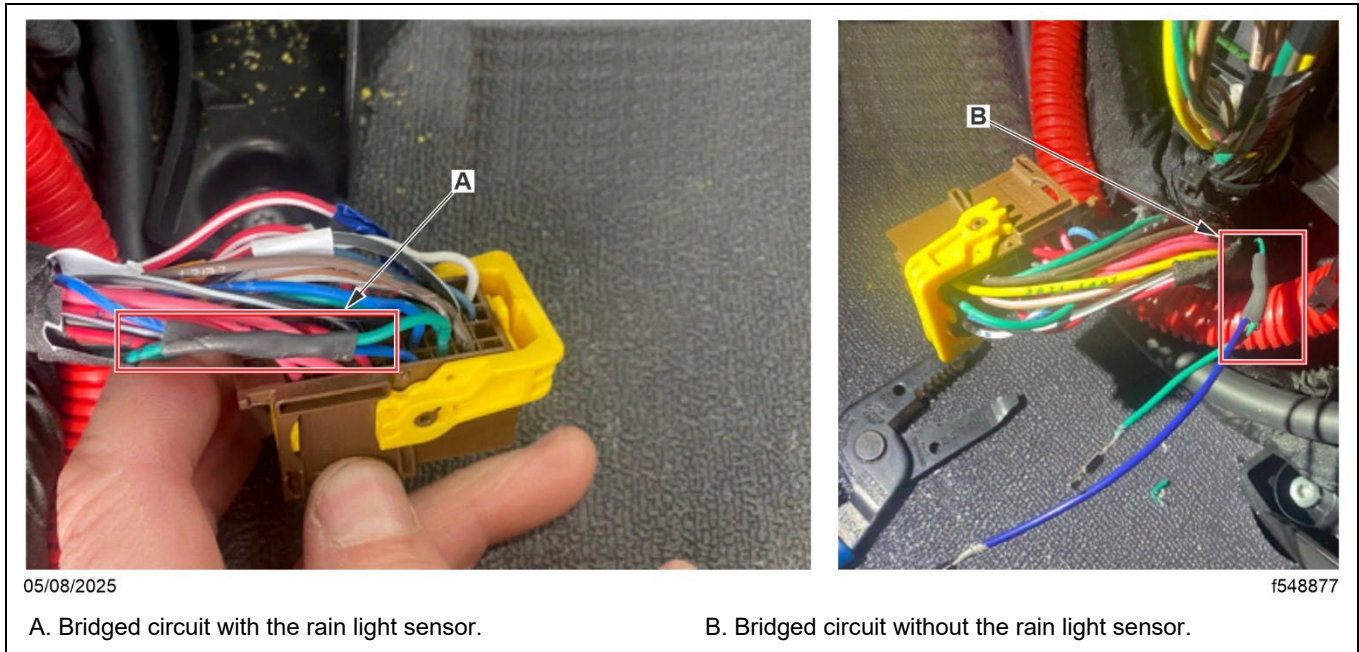
Fig. 2, Examples of Vehicle Modifications Done at Plant

15. Inspect the wire harness and terminal cavities X5-6 and X5-7 for modifications that may have been done at the vehicle plant, as shown in **Fig. 2**, or based on the information in **Service Solution SS 3162-FTL** or **SS 775-WST**, as shown in **Fig. 3**. The modification is expected to be within 6 inches of the X5 harness connector.

16. Repair the harness.
 - For service solution-style modifications, cut the bridge (jumper) and turn the cut wires back on themselves. Use heat shrink lined with adhesive to seal and isolate the conductor.
 - For plant-style modifications, separate the bridge between the two conductors and repair the individual wires using DTNA approved methods.
17. Secure the harness repair with loom tape, as needed, to protect it from potential damage.
18. Install the X5 connector onto the sSAM.
19. Secure the individual wire bundles to the sSAM, as original.
20. Install the dash covers. For detailed instructions, see **Group 60: Cab** in the applicable workshop manual.
21. Install the ground cable connections at the batteries.
22. Clean a spot on the base label (Form WAR259), and attach a campaign completion sticker for SF715 (Form WAR261).

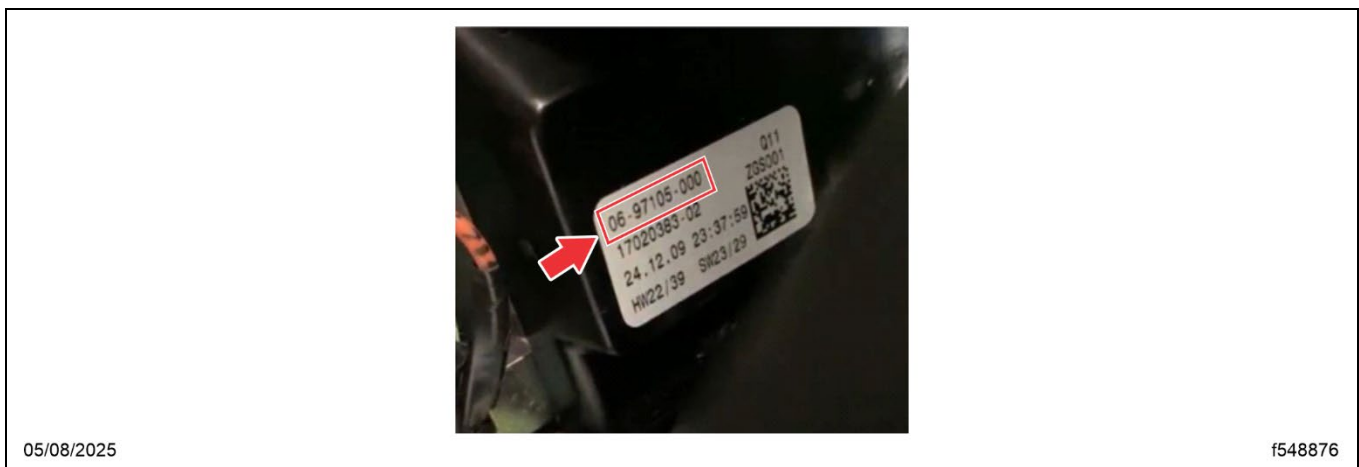
Fig. 1, Stalk Switch Part Number on Manufacturer's Label

5. Inspect the left-hand stalk switch part number on the manufacturer's label. See [Fig. 1](#).

6. Compare the left-hand stalk switch part number on the manufacturer's label to the part numbers listed in [Table 1](#).

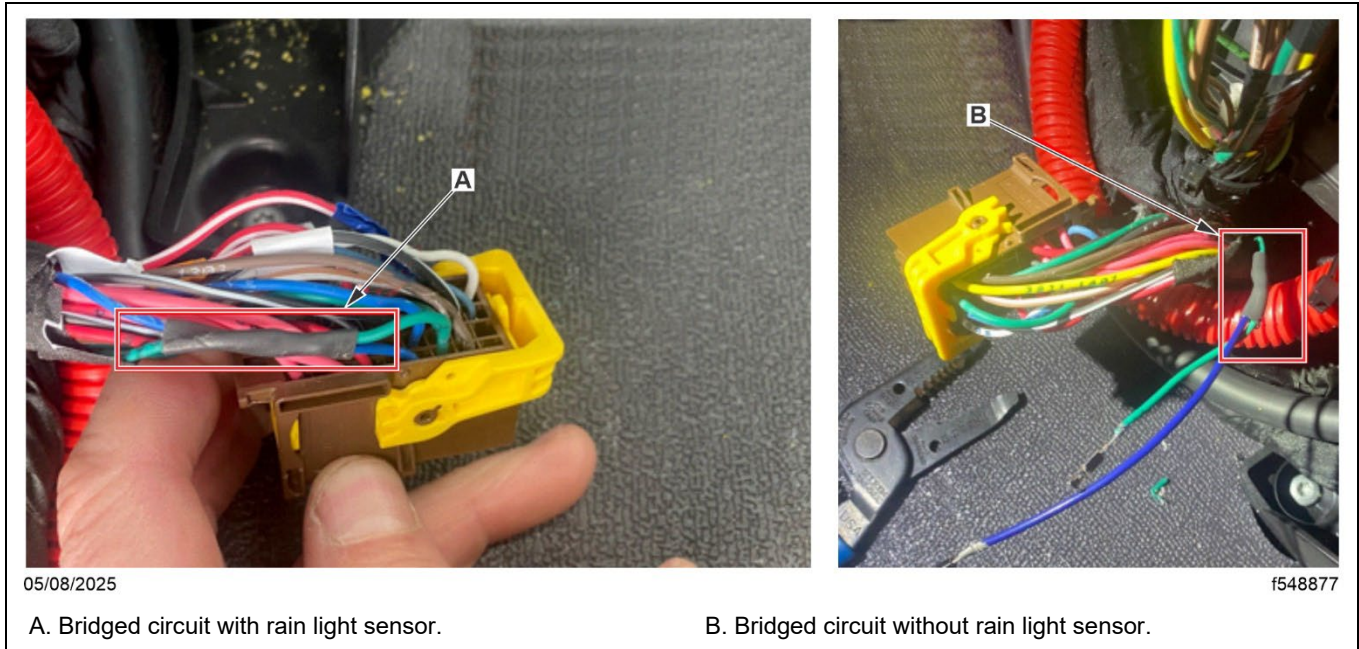
Fig. 2, Examples of Vehicle Modifications Done at Plant

21. Inspect the wire harness and terminal cavities X5-6 and X5-7 for modifications that may have been done at the vehicle plant, as shown in **Fig. 2**, or based on the information in **Service Solution SS 3162-FTL** or **SS 775-WST**, as shown in **Fig. 3**. The modification is expected to be within 6 inches of the X5 harness connector.

22. Repair the harness.
 - For service solution-style modifications, cut the bridge (jumper) and turn the cut wires back on themselves. Use heat shrink lined with adhesive to seal and isolate the conductor.
 - For plant-style modifications, separate the bridge between the two conductors and repair the individual wires using DTNA approved methods.
23. Secure the harness repair with loom tape, as needed, to protect it from potential damage.
24. Install the X5 connector onto the sSAM.
25. Secure the individual wire bundles to the sSAM, as original.
26. Install the dash covers. For detailed instructions, see **Group 60: Cab** in the applicable workshop manual.
27. Install the ground cable connections at the batteries.
28. Clean a spot on the base label (Form WAR259), and attach a campaign completion sticker for SF715 (Form WAR261).
