# TECHNICAL SERVICE BULLETIN

## Back Window Liftgate Seal Corner(s) Falling/Sagging

**25-2387**

<b>Ford</b> 2025 Expedition
<b>Lincoln</b> 2025 Navigator

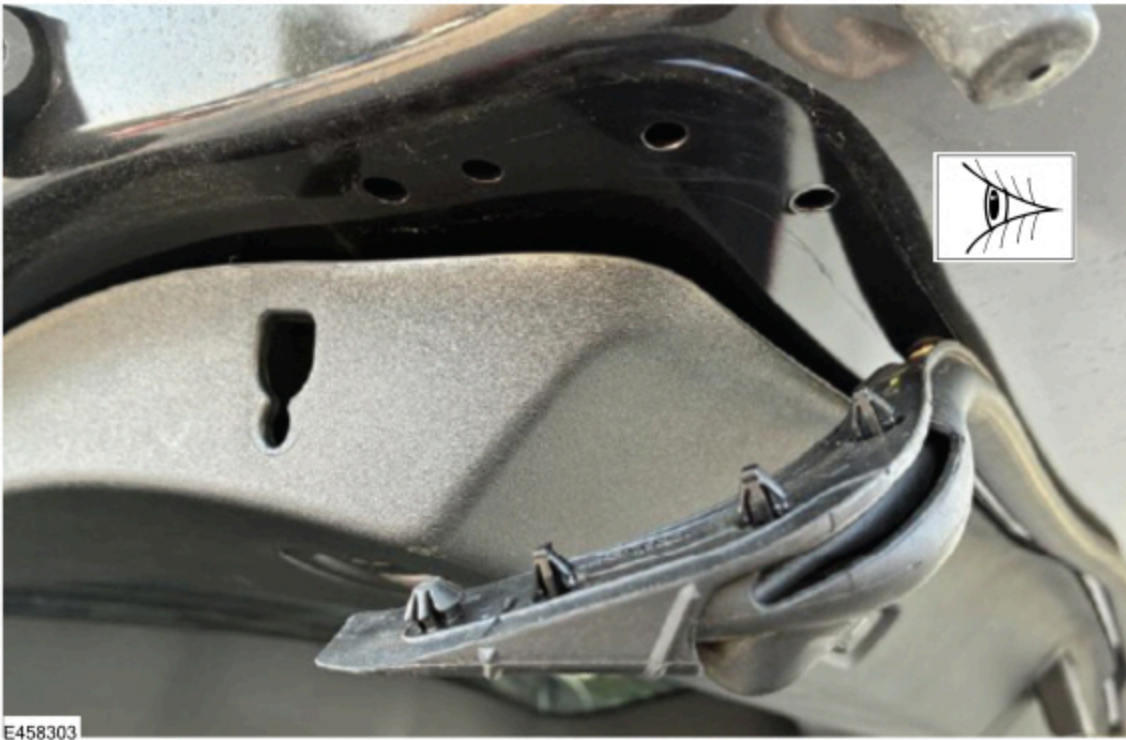
Figure 1 - left side shown, right side similar

**Issue:** Some of the vehicles listed in the Model statement above may exhibit a condition where the back window liftgate seal corner(s) are falling or sagging. This may be due to the seal insert not holding the seal in place.

1. Open the liftgate. Is the corner of the back window liftgate seal hanging down on one or both sides as shown in Figure 1 or Figure 2?
