**UPDATE PRIOR TO SALE NOTICE**

Global Service Action  
Number: H537 UPS0525-2

<b>Subject:</b>  <b>Junction Box Repair</b>	Publication No.: H537 UPS0525-2
	Model: F-TYPE (X152)
	Model Year: 2016 - 2024
	Date of Issue: 11 August 2025
	Expiry Date: 30 April 2027

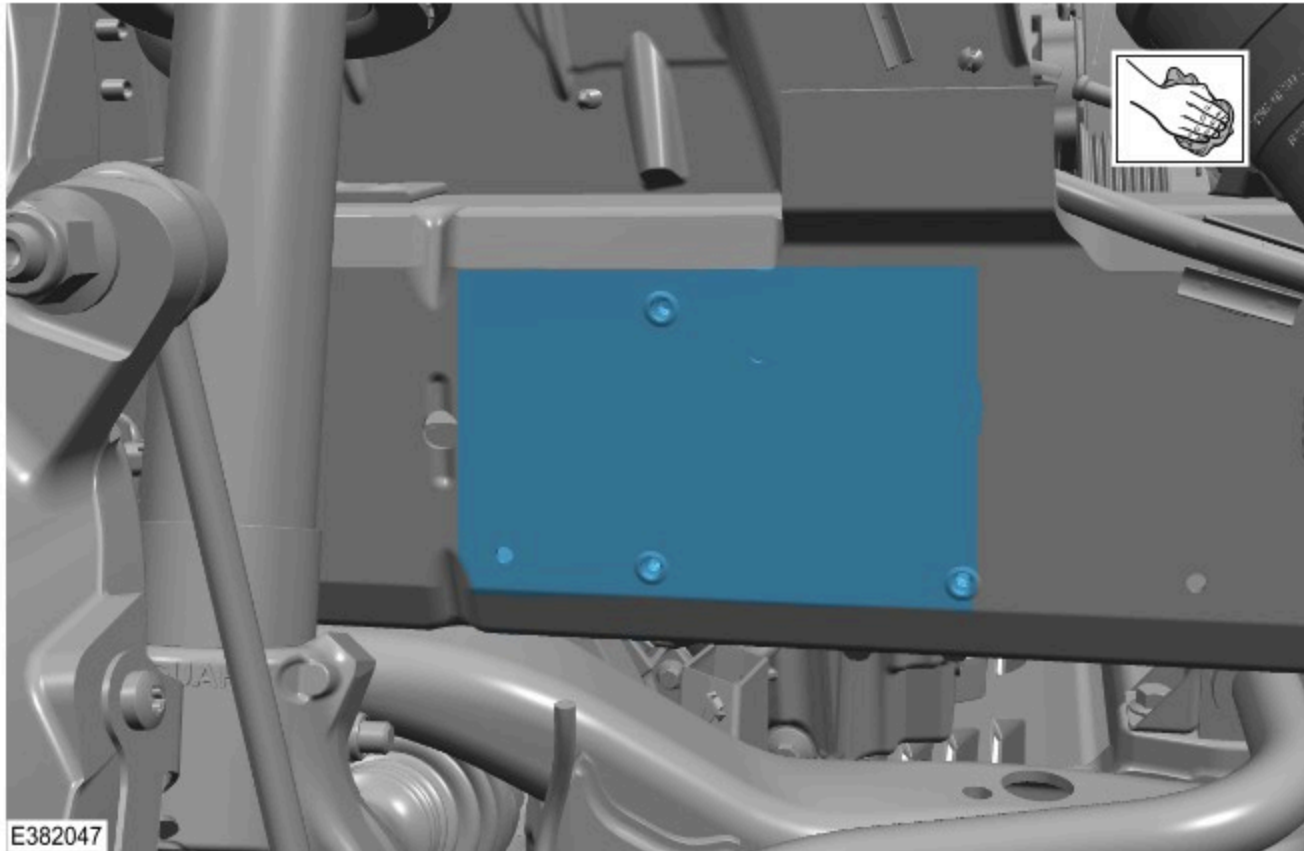
10.

The highlighted area **must** be dry and free from contamination.

Using a suitable method, clean the area highlighted in the illustration.

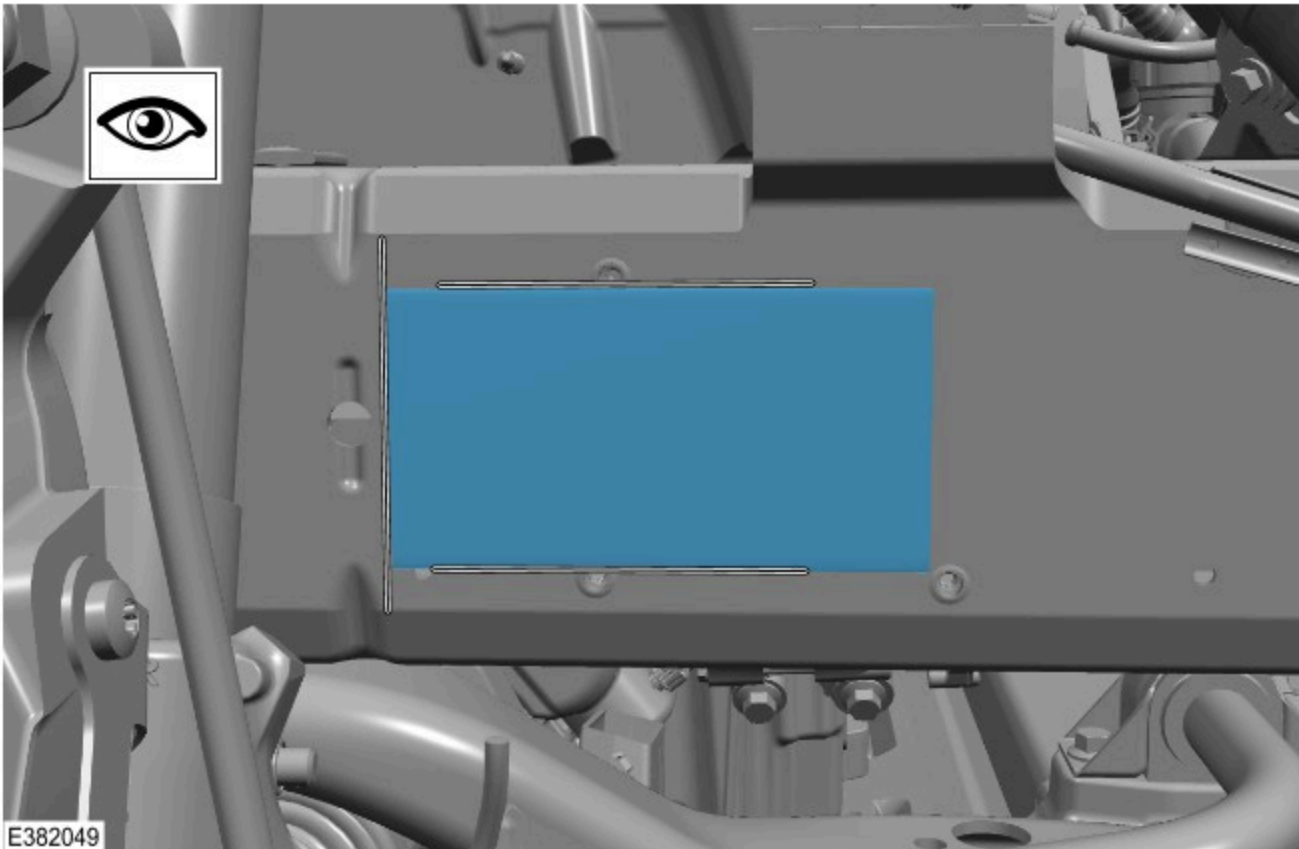
13.

The Mylar® based patch must not cover / obstruct the 2 [EPAS](#) wiring harness junction box mounting bolt holes.

Install the Mylar® based insulator patch.

- Align the rear edge of the Mylar® based insulator patch to the mark made in step 11.
- Install the Mylar® based insulator patch between the 2 [EPAS](#) wiring harness junction box mounting bolt holes.
