UPDATE PRIOR TO SALE NOTICE

Global Service Action
Number: H557 UPS3925-2

Subject: SVR Rear Bumper Valance not fully retaining to bumper	Publication No.: H557 UPS3925-2
	Model: F-PACE (X761)
	Model Year: 2026
	Date of Issue: 05 August 2025
	Expiry Date: 05 August 2027

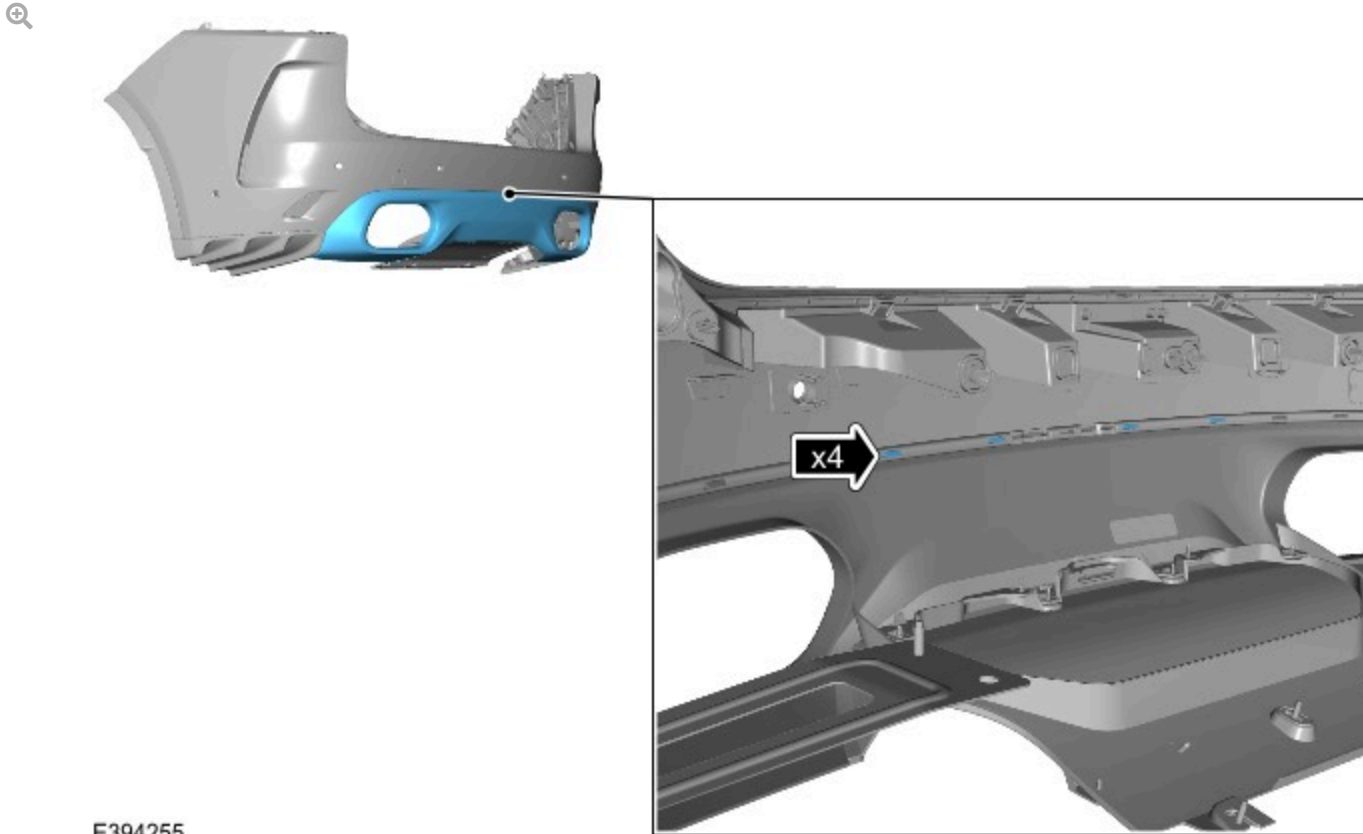
E394255

The rear bumper cover on certain 2026 model year SVR F-PACE vehicles may have been manufactured where clips required to provide the rigidity of the bumper cover have not been installed. As a result, the bumper cover will be overly flexible and away from the intended, permissible amount of flexibility.

1. The illustration shows the 4 rear bumper valance center clips which may not be securely installed to the rear bumper cover.

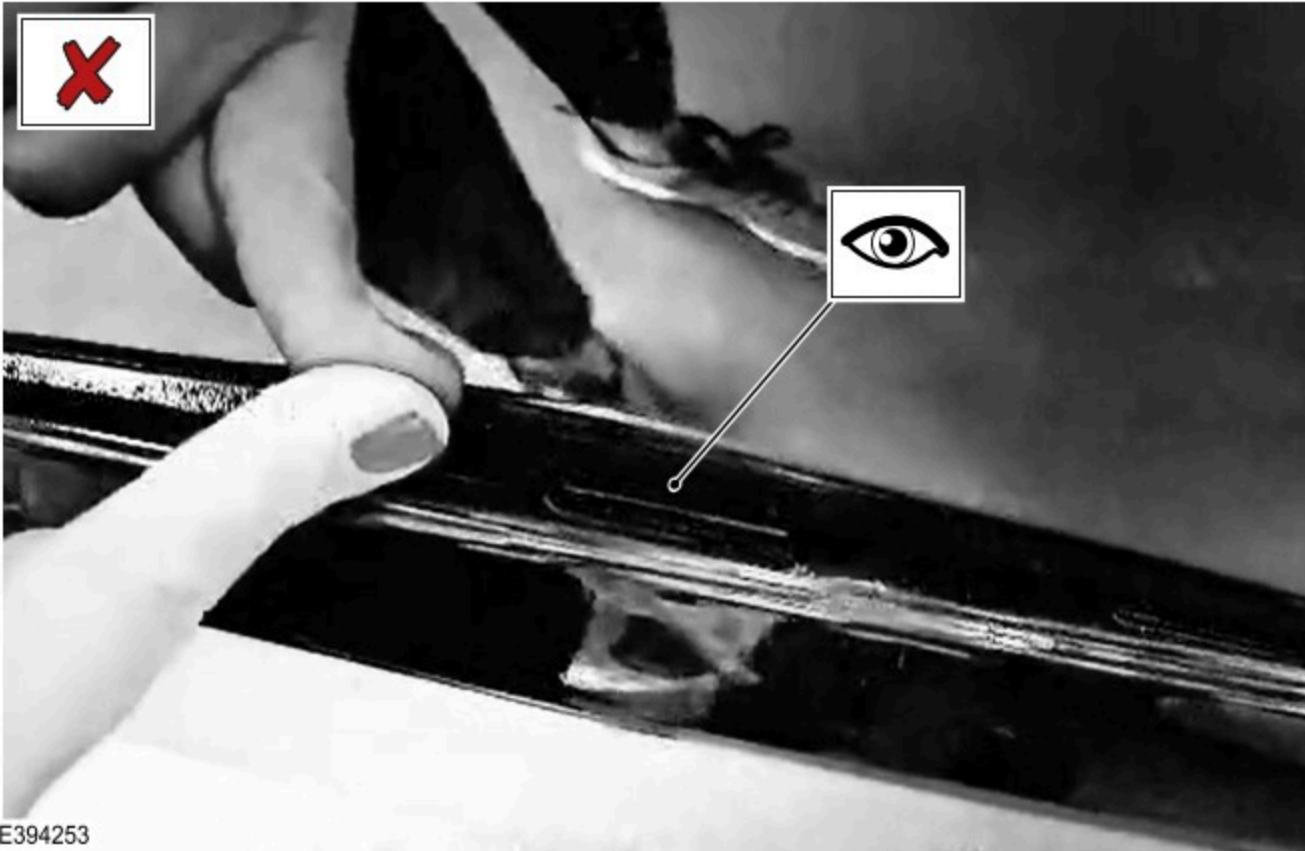
E394253

1 or more of the 4 rear bumper valance center clips will be visibly detached from the rear bumper cover.

- If a visible gap **is** present between the rear bumper valance and the rear bumper cover, as shown in the illustration with the **RED X**, **continue to hold the vehicle**.
- If a visible gap **is not** present between the rear bumper valance and the rear bumper cover, as shown in the illustration with the **GREEN ✓**, **release the vehicle**.
