Global Service Action  
Number: H557 UPS3925-3

<b>Subject:</b> <b>SVR Rear Bumper Valance not fully retaining to bumper</b>	Publication No.: H557 UPS3925-3
	Model: F-PACE (X761)
	Model Year: 2026
	Date of Issue: 28 August 2025
	Expiry Date: 31 August 2027

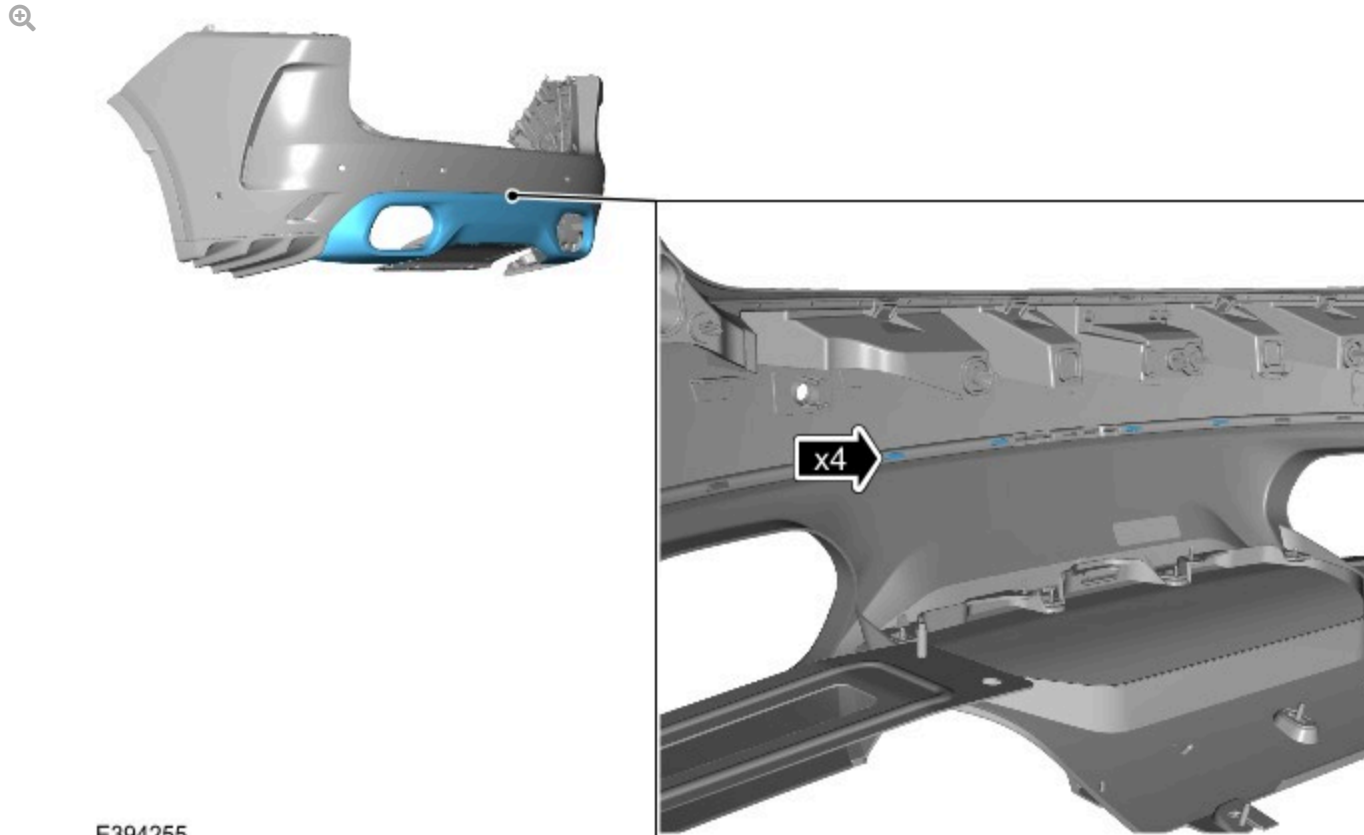
E394255

1. The illustration shows the 4 rear bumper valance center clips which may not be securely installed to the rear bumper cover.

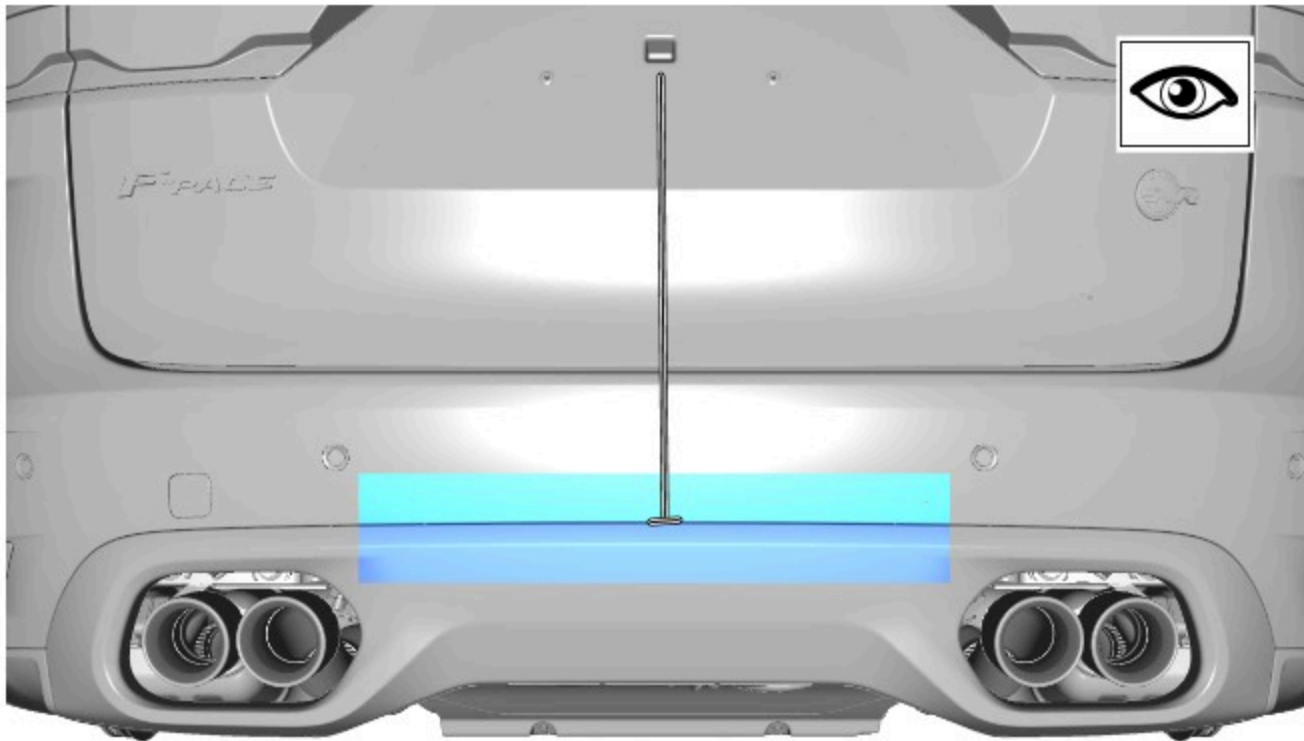
E394252

1. Locate the center point of the rear bumper valance to rear bumper cover, as shown in the illustration.

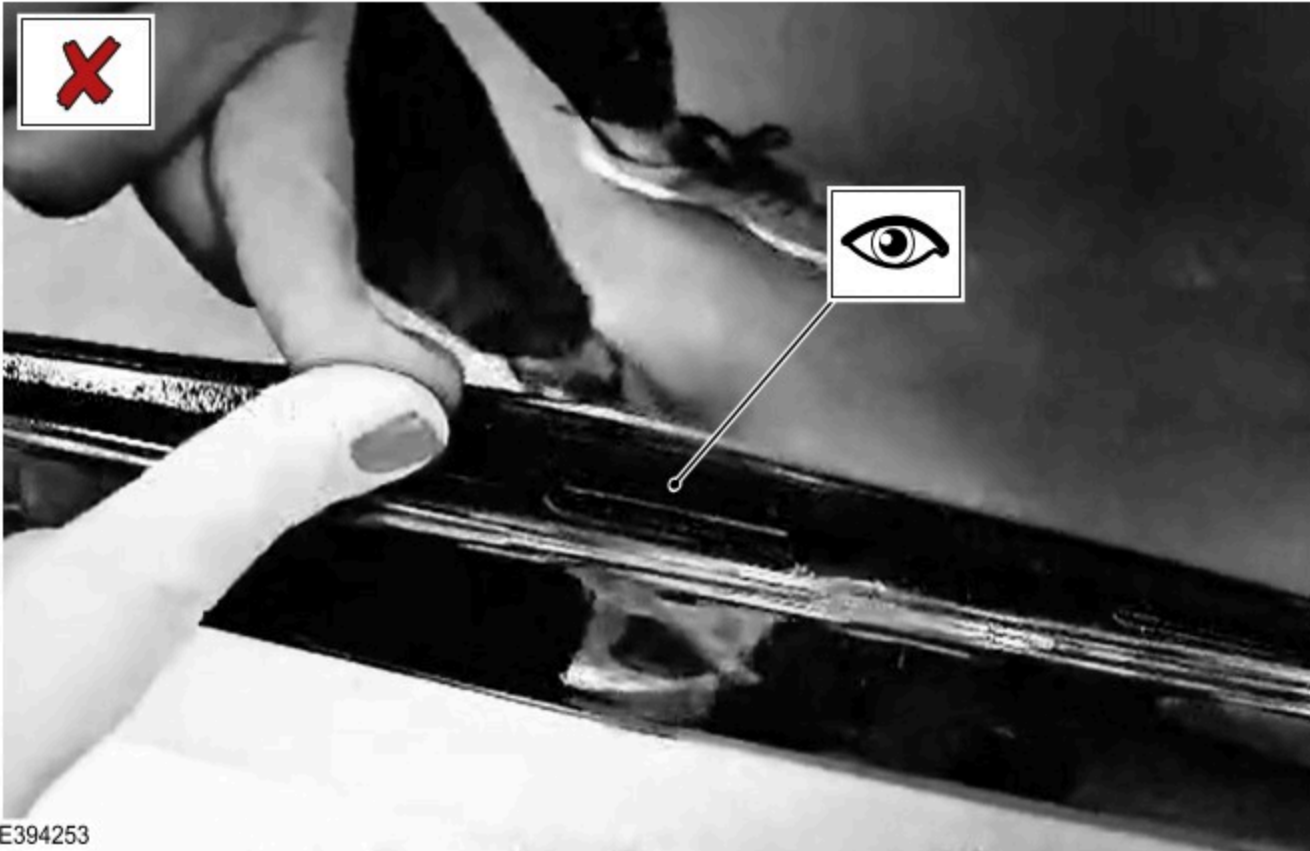
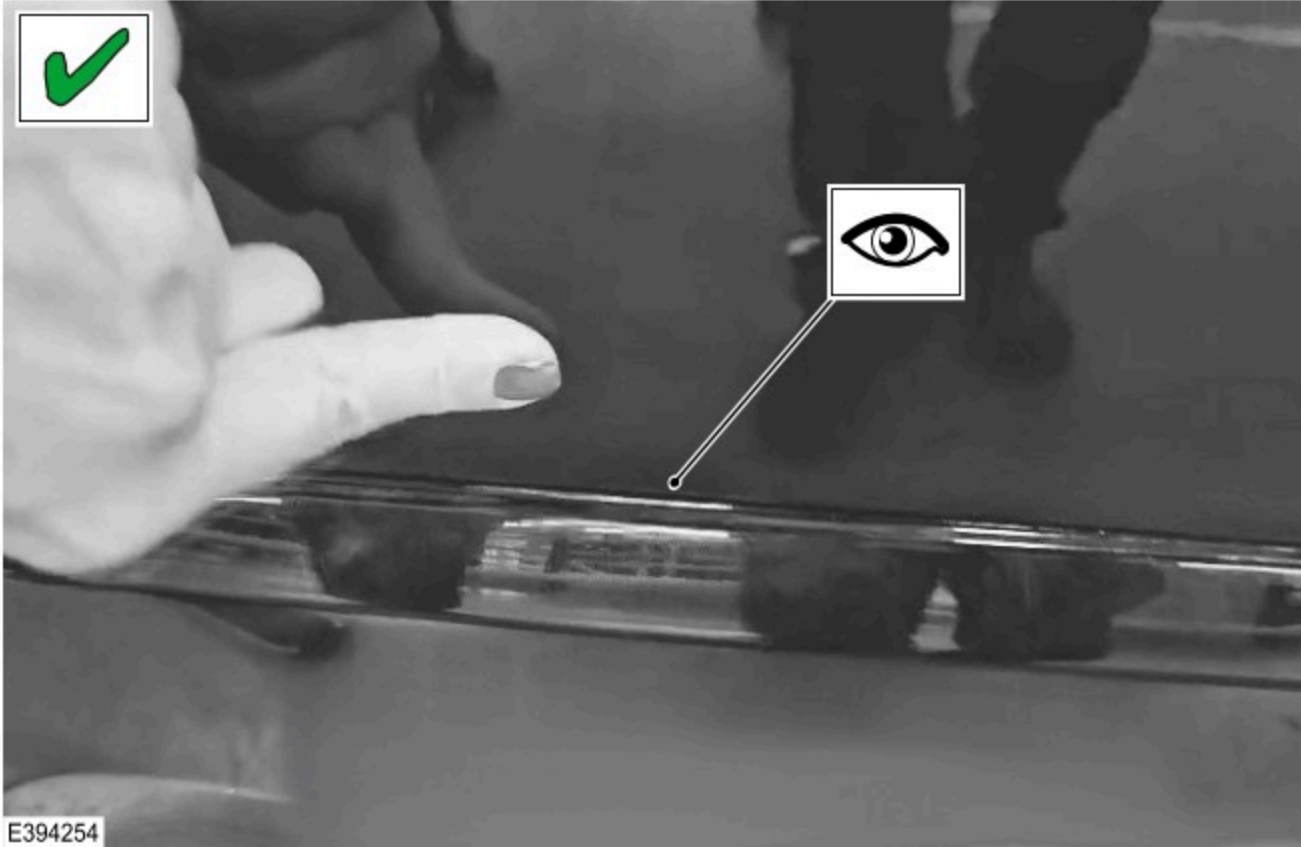
E394253

1 or more of the 4 rear bumper valance center clips will be visibly detached from the rear bumper cover.

- If a visible gap **is** present between the rear bumper valance and the rear bumper cover, as shown in the illustration with the **RED X**, **continue to the SERVICE INSTRUCTION**.
- If a visible gap **is not** present between the rear bumper valance and the rear bumper cover, as shown in the illustration with the **GREEN ✓**, **release the vehicle**.

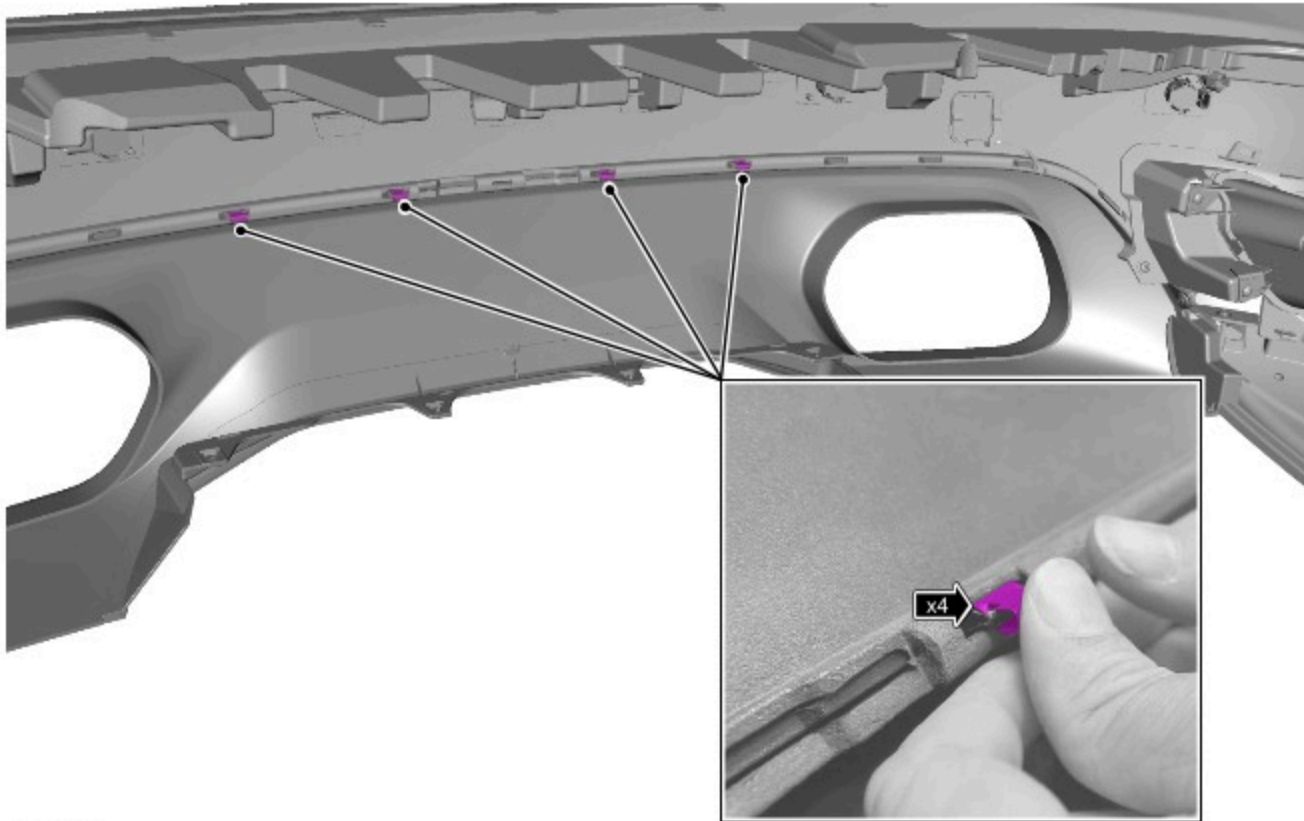
E394256

The 4 clips must be fully installed, with the locking features engaged behind the 4 rear bumper valance tabs.

Install 4 clips to the 4 rear bumper valance tabs, as shown in the illustration.
