**SERVICE CAMPAIGN 75-11 Generator Door Panel Attachment
AFFECTED MODELS: 2022-2024 Journey**

Generator Door Panel Attachment

Journey

2022 - 2024

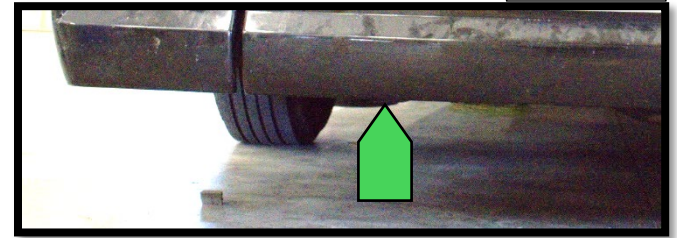
- Refer to Figure 1 - Green Arrow for the front view location of the handle.
- The pull handle will be found under the hood panel.

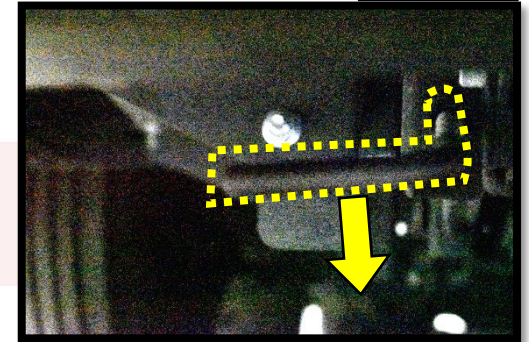
Figure 2

B. Pull the handle out towards you (See Figure 2, highlighted with yellow dashes for the location of the pull handle under the front hood).

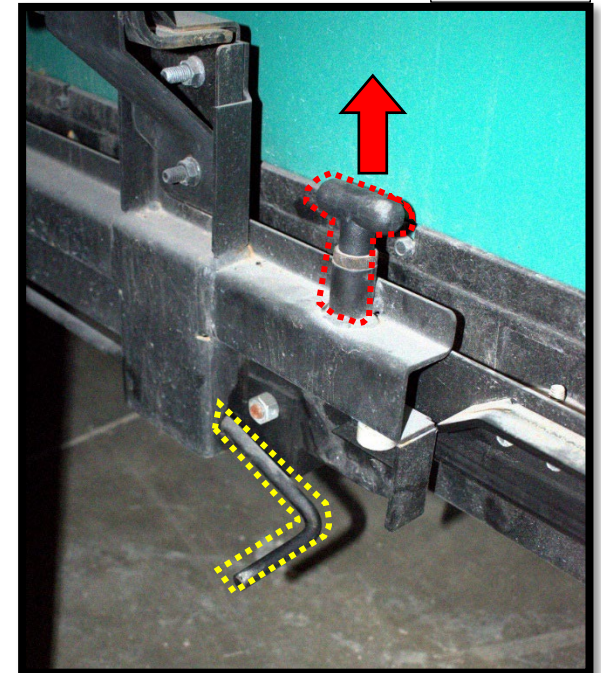
C. Pull this T-handle on the side of the slide assembly up. (See Figure 3 – Outlined in Red)

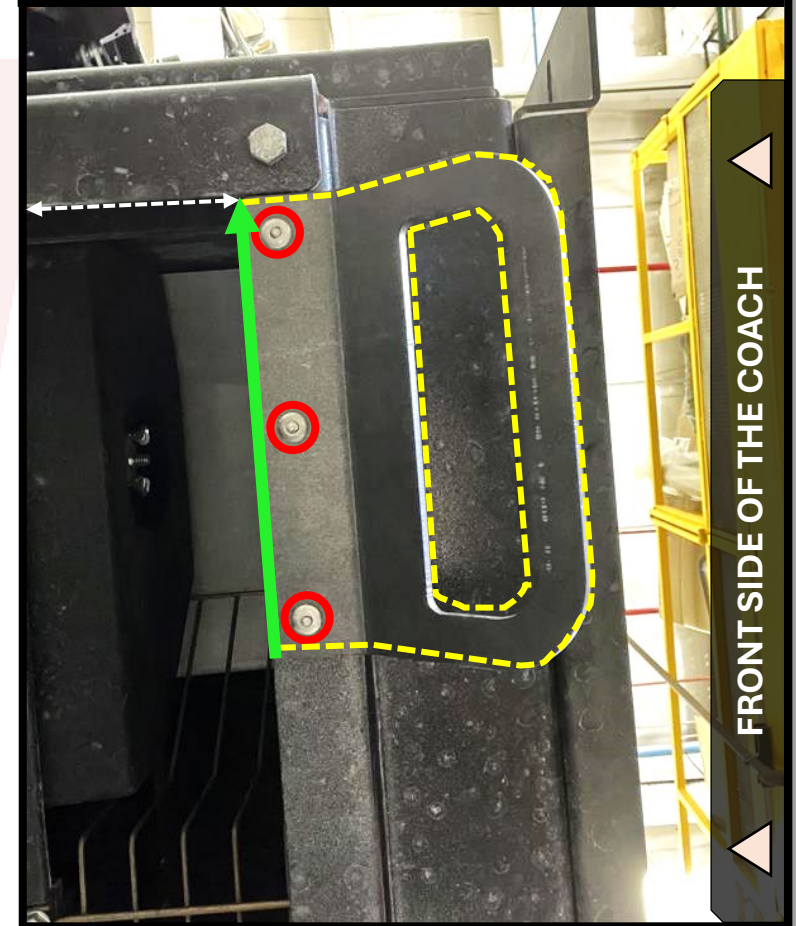
Under Coach View of Generator Hood Slide Out (Passenger Side Corner)

- Align the bracket with the flange on the generator slide (See Figure 19 – White Dashed Double headed Arrow). The bracket should be angled down and as far to the passenger side as possible. (See Figure 20 – Green Arrow)
- Using the new bracket as a guide, drill three holes with a 3/16" drill bit through the flange.
- Install 3/16" steel rivet 087718-01-000 into each hole. (See Figure 20 – Red Circles)
