TECHNICAL SERVICE BULLETIN

25-2413

Transmission Downshift When In Drive (D) And Shifting To A Higher Gear Will Be Unavailable In The Instrument Panel Cluster (IPC)

Ford 2021-2024 F-150	Non-Lightning
-------------------------	---------------

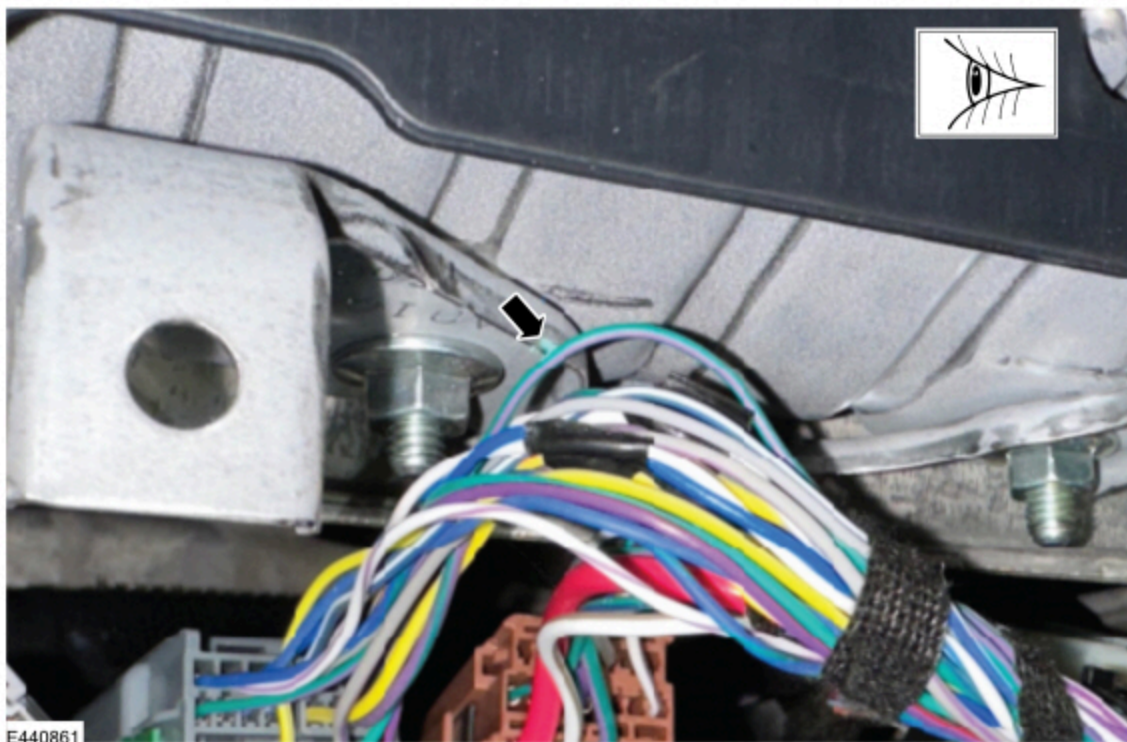
Figure 1

1. Remove the right side insulation panel as outlined in WSM, Section 412-00, Removal And Installation, Blower Motor Control Module.
 - (1). It is not necessary to remove the blower motor control module.
2. Remove the glove compartment storage bin assembly as outlined in WSM, Section 501-12, Removal And Installation, Glove Compartment.
3. Inspect CET42 pin 14, from connector C210 behind the glove compartment and further inspect surrounding wires and harness for a rub/pinch condition against the instrument panel frame. (Figure 1)

4. Is any damage present to CET42 or the surrounding wires? (Figure 1)
 - (1). Yes - proceed to Step 5.
 - (2). No - proceed to Step 6.
5. Repair the damaged wiring. Refer to Cell 005, page 5 of the Wiring Diagram.
6. Wrap Coroplast Electrical Wire Harness Tape or equivalent around the 12A581 harness starting 1 in. (25 mm) from back side of the connector to the harness retainer.
7. Position the harness and secure it to the connector bracket utilizing a wiring strap to prevent future contact/damage against the instrument panel frame. (Figure 2)
