TECHNICAL SERVICE BULLETIN

Oil Consumption And Blue Smoke From Tailpipe

25-2415

29 August
2025

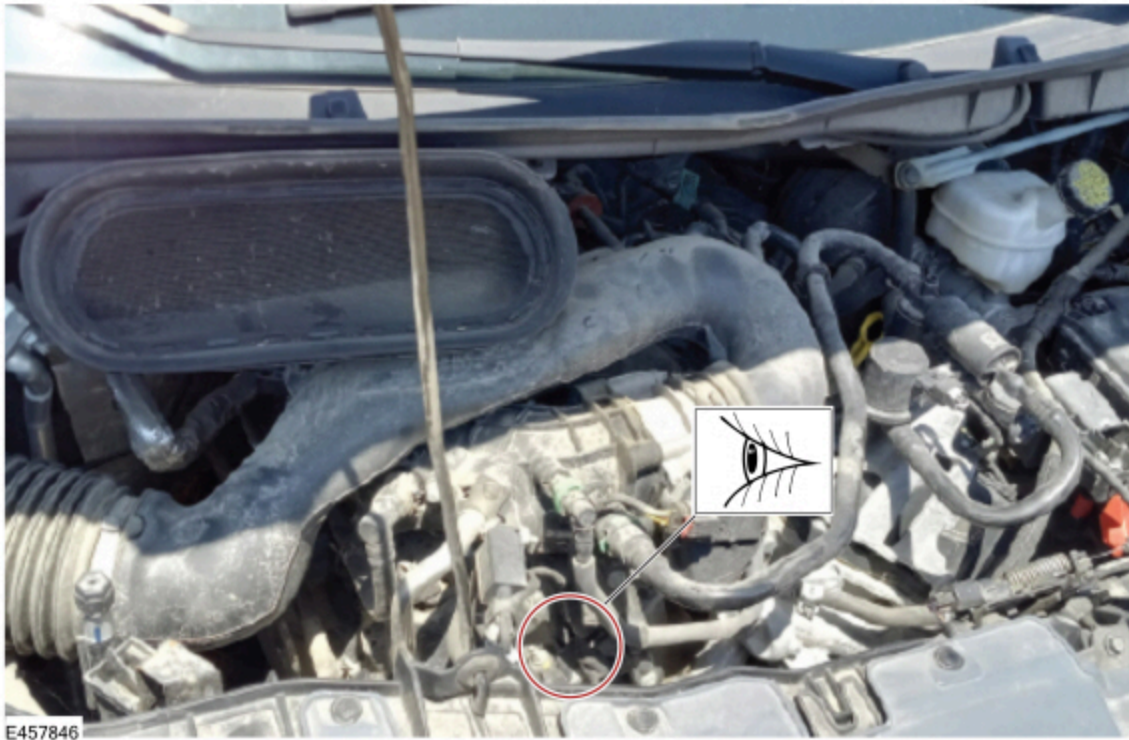
Figure 1 - Showing the zoomed-out location of the date on the 3.5L engine valve cover RH.

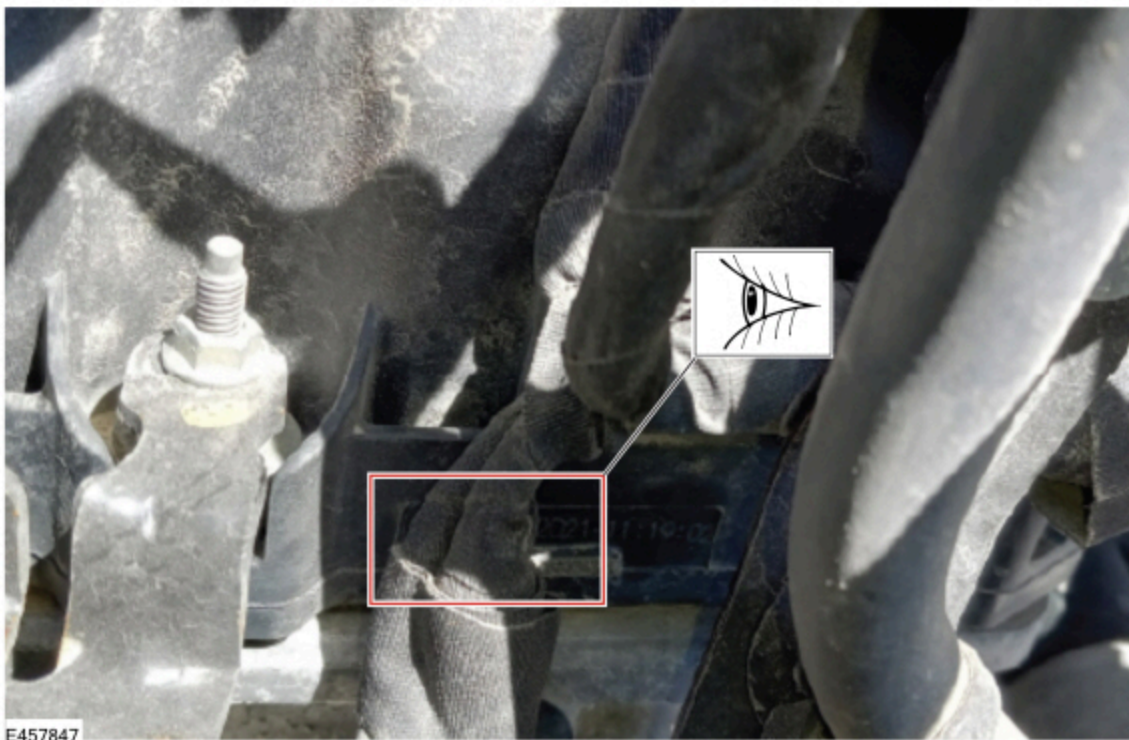
NOTE: The harness shown in Figure 2 needs to be slightly pushed aside to view the entire date.

NOTE: Date displayed on engine valve cover **RH will show as: 12/09/2024 (09-Dec-2024) or 12/10/2024 (10-Dec-2024).**

Figure 2 - Showing the zoomed-in location of the date on the 3.5L engine valve cover RH. Date is shown on the engine valve cover RH as Month/Day/Year.

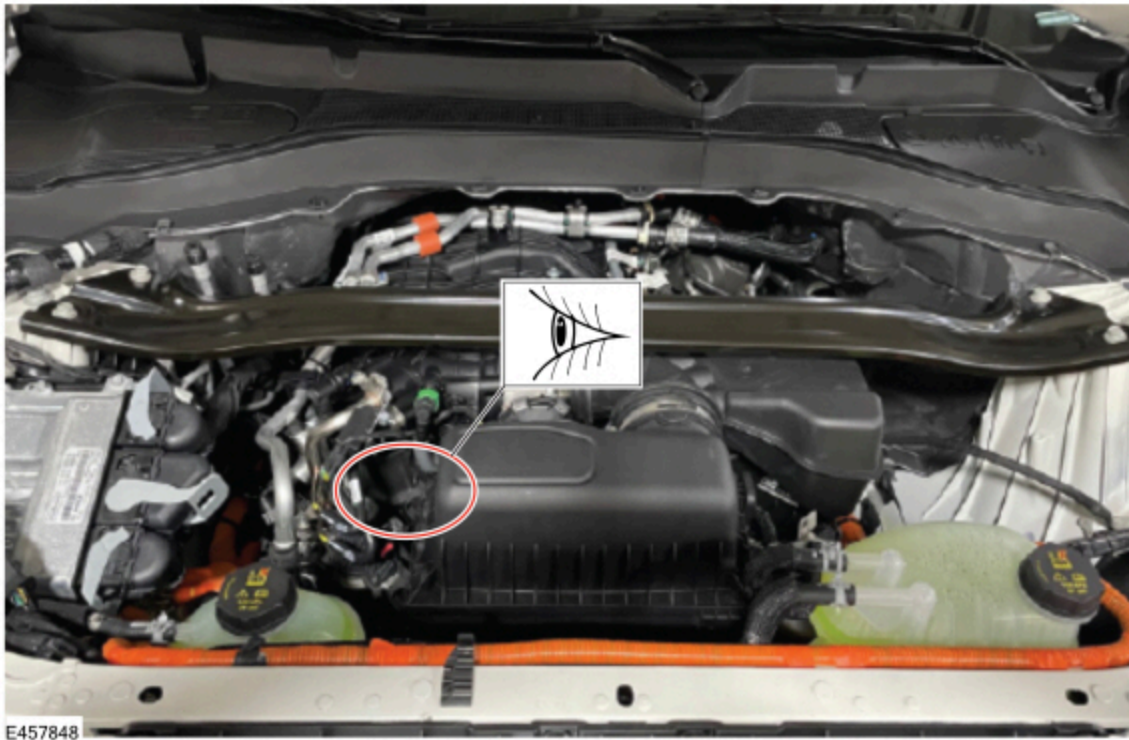
NOTE: The harness bracket shown in Figure 3 may require temporary removal to view the entire date.

Figure 3 - Showing the zoomed-out location of the date on the 3.3L engine valve cover RH.

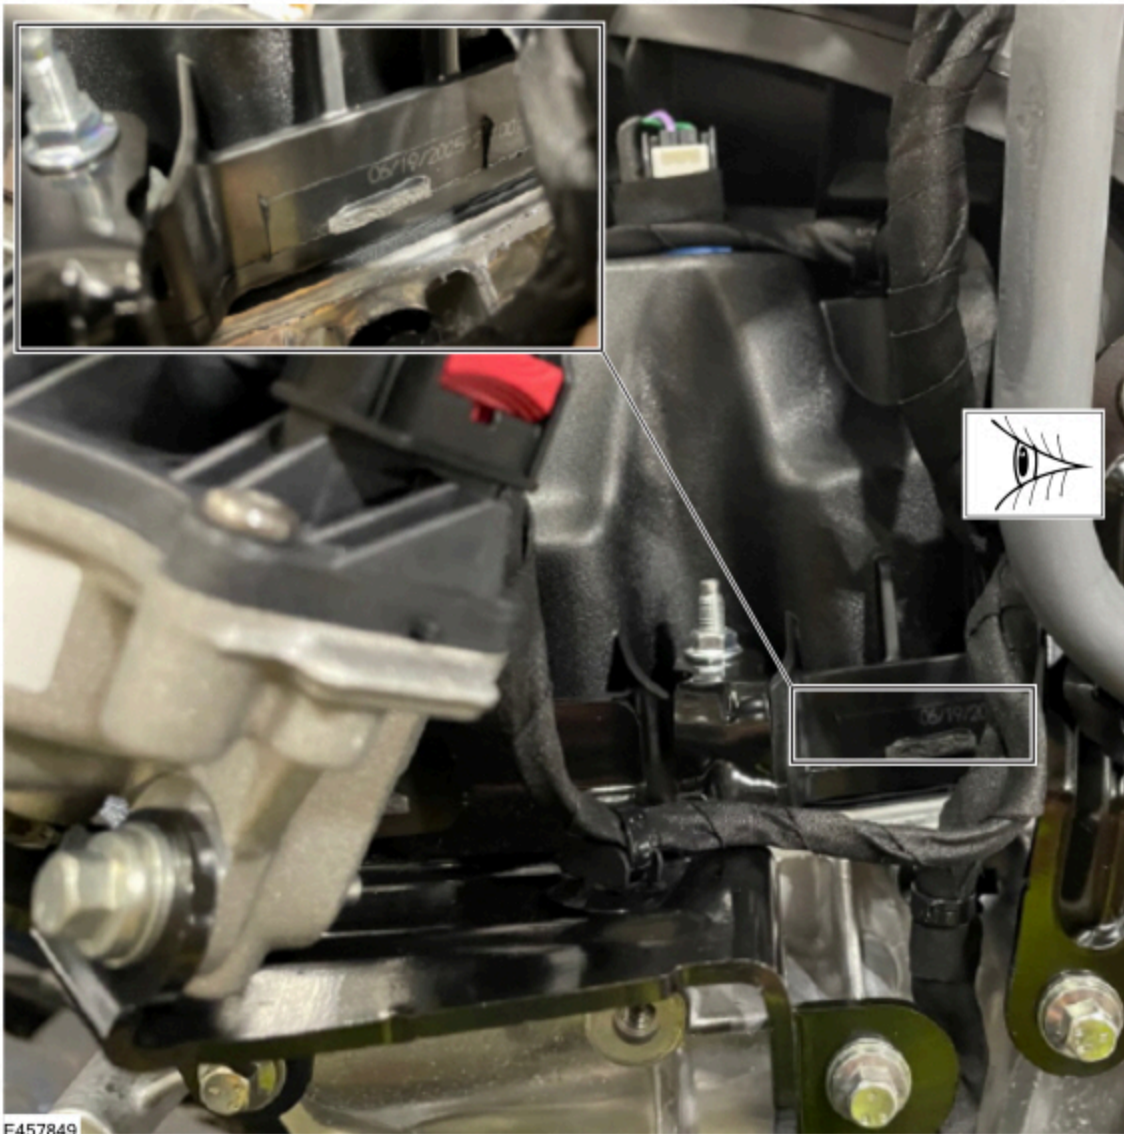
Figure 4 - Showing the zoomed-in location of the date on the 3.3L engine valve cover RH. Date is shown on the engine valve cover RH as Month/Day/Year.
