TECHNICAL SERVICE BULLETIN

Instrument Panel Upper Section Speaker Grille Is Lifting, Warped, Or Not Seated Flush With The Instrument Panel

25-2417

Lincoln 2019-2024 Navigator

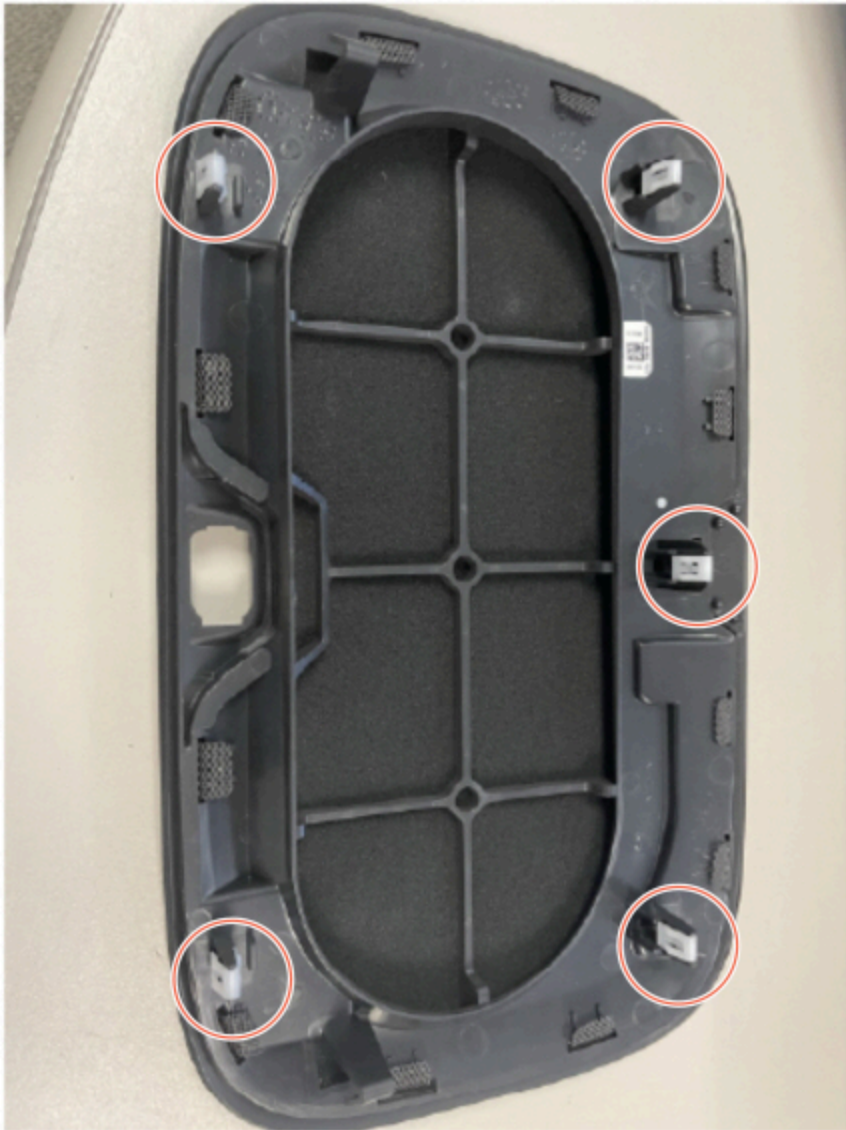
Figure 1

Issue: Some of the vehicles listed in the Model statement above may exhibit an instrument panel upper section speaker grille that is lifted, warped, or not seated flush with the instrument panel. This may be due to upper section speaker grille clips that are not seating.

1. Remove the instrument panel speaker grille. Refer to WSM, Section 501-12 Instrument Panel and Console > Instrument Panel Upper Section > Removal and Installation, Step 13.
2. Replace the clips on the instrument panel speaker grille with the new clips. (Figure 1)
