## INTERMITTENT LOW COOLANT WARNING DISPLAYED, BUT LEVEL OKAY

SSM 76361

### Range Rover

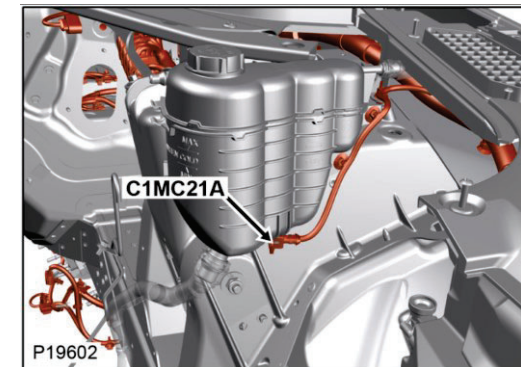
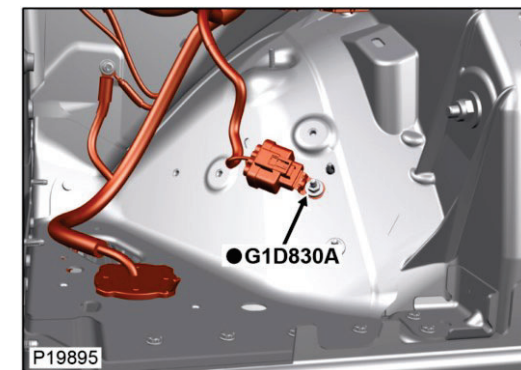
- Intermittently displaying low coolant level warnings on the instrument cluster, despite coolant level being within the correct range and no visible leaks in the cooling system.

- JLR Engineering is investigating electrical connection issues at the sensor and or ground.

- Please check connector C1MC21A for water ingress/corrosion/loose or damaged terminals.
- Inspect wiring harness for chafing, abrasion, incorrect routing.
- Ensure a clean, secure, and corrosion-free ground at G1D830A
- Perform a Continuity test : Measure resistance: Pin 1 (C1MC21A) → G1D830A  
Expected: < 0.5 ohms and record the value
- Perform a Sensor function test by measuring resistance across the sensor terminals tank full and empty, record both values.
- Please raise an EPQR with any photographs of concerns found and reference this SSM.
