OIL LEAK FROM THE TRANSFER CASE

SSM 76344

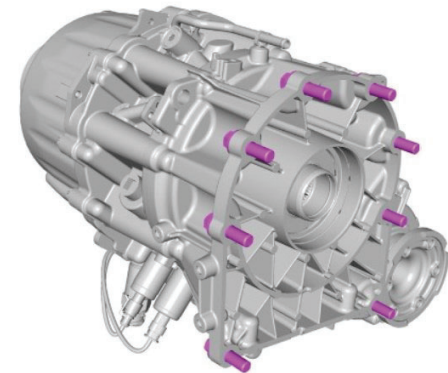
- Oil leaks from the transfer case area of the vehicle.

- Damage to front input shaft seal or rear output shaft seal.

- If an oil leak is present at either seal:
 - Do NOT clean any oil from the transfer case.
 - Do NOT remove or disturb the oil seals.
 - Replace the transfer case following: TOPIx Workshop Manual section 315-00C General Procedures – Removal and Installation – Transfer Case.
 - Please submit an EPQR with pictures of the leak and reference to this SSM where engineering will arrange collection via the Parts Return Process(PRR).
