**DEFENDER**

- 20MY-On Defender
- Discovery
- 17MY-On Discovery

## FRONT LOWER CONTROL ARM REMOVAL AND INSTALLATION REPAIR PROCESS

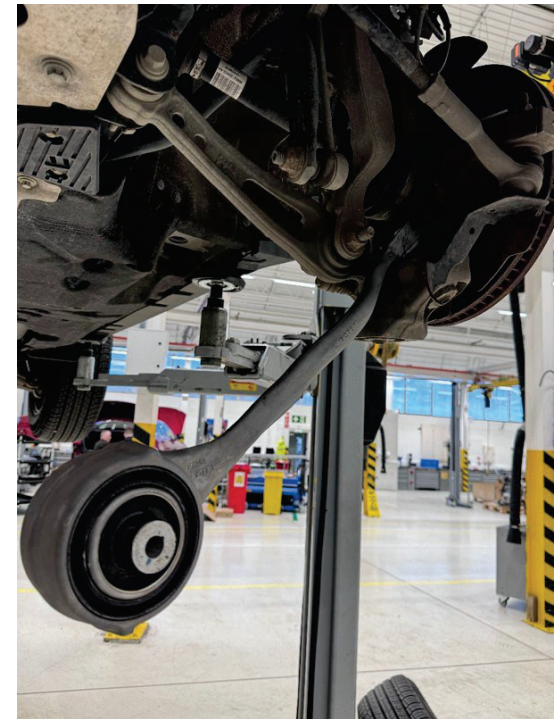
- This may be caused by damage to the lower ball joint due to over-articulation of the arm during removal/installation.

- Engineering investigations on returned warranty parts have identified damage caused by improper repair methods being used.
- **SSM 76376** has been published to address this concern, providing correct repair instructions/ process.
- Please ensure this SSM is referenced when performing service work that includes partial removal of the lower control arm.
