**Technical Service Bulletin (TSB)**  
**Flash: Electronic Vehicle Control Unit (EVCU) Updates 11A2**

<b>REFERENCE:</b>	<b>TSB:</b> 08-206-25 REV. C <b>GROUP:</b> 08 - Electrical	<b>Date:</b>	August 30, 2025	<b>REVISION:</b>	08-206-25 REV. B
<b>VEHICLES AFFECTED:</b>	<b>2024 (KM) Jeep Wagoneer S</b> This bulletin applies to vehicles equipped with 400V G2500 FR/RR Elec Drive Motors (Sales Code ELD).			<b>MARKET APPLICABILITY:</b> <input checked="" type="checkbox"/> NA <input checked="" type="checkbox"/> MEA <input checked="" type="checkbox"/> SA <input checked="" type="checkbox"/> IAP <input checked="" type="checkbox"/> EE <input checked="" type="checkbox"/> CH  <b>NOTE:</b> This bulletin applies to North and South America, Enlarged Europe, Middle East & Africa, India & Asia Pacific and China markets.	
<b>CUSTOMER SYMPTOM:</b>	<b>Customers may experience a Malfunction Indicator Lamp (MIL) illumination and the vehicle may exhibit/set one or more of the following Diagnostic Trouble Codes (DTCs):</b> <ul style="list-style-type: none"> <li>• C10FA-00 - Wheel Hub disconnect Actuator Performance Left.</li> <li>• C10FB-00 - Wheel Hub disconnect Actuator Performance Right.</li> </ul> <b>Cu

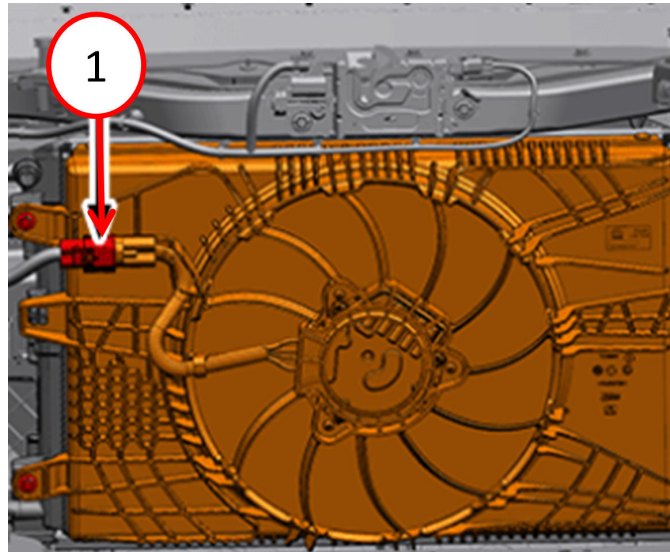
**Fig. 1**  
Cooling Fan Assembly

1 - Wire Harness To Disconnect/Connect

4. Disconnect the cooling fan wire harness connector [Fig. 1](#).\*\*

**NOTE: If the Wheel End Disconnect Position Learn routine is not successful, roll the vehicle slightly forward so that the wheel end disconnect actuators can align on the spline before attempting to perform the routine again.**
13. \*\*Connect the cooling fan wire harness connector [Fig. 1](#).
14. Install the front storage bin. Refer to the detailed service procedures available in DealerCONNECT/ ServiceLibrary under: Service Info> 23 - Body / Exterior / Bin, Storage / Installation.\*\*
