| REFERENCE: | TSB: 08-205-25 REV. C GROUP: 08 - Electrical | Date: | August 30, 2025 | REVISION: | 08-205-25 REV. B |
| VEHICLES AFFECTED: | 2025 (LB) Dodge Charger This bulletin applies to vehicles built on or before April 25, 2025 (MDH 0425XX) equipped with 400V G2500 FR/RR Elec Drive Motors (Sales Code ELD). | | | MARKET APPLICABILITY: <input checked="" type="checkbox"/> NA <input checked="" type="checkbox"/> MEA <input checked="" type="checkbox"/> SA <input checked="" type="checkbox"/> IAP <input checked="" type="checkbox"/> EE <input checked="" type="checkbox"/> CH NOTE: This bulletin applies to North and South America, Enlarged Europe, Middle East & Africa, India & Asia Pacific and China markets. | |
| CAUSE: | EVCU software update | | | | |

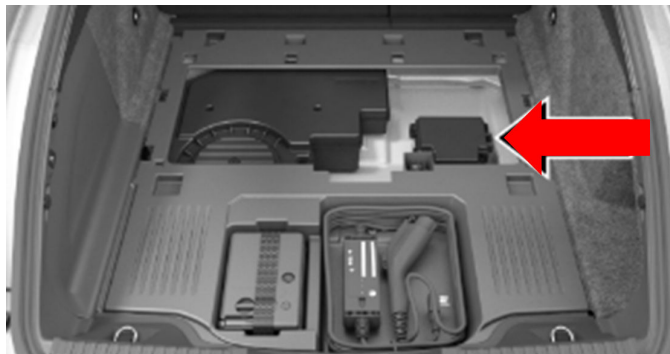
Fig. 2
Rear PDC Location

5. From the rear of the vehicle, pull back the carpet to access the rear Power Distribution Center (PDC) [Fig. 2](#).

16. Install the #38 AGSM fuse [Fig. 3](#) and the PDC cover [Fig. 2](#).
17. Position the rear carpet in place.
18. **Connect the cooling fan wire harness connector [Fig. 1](#).
