Technical Service Bulletin

Subject: CLICKING NOISE FROM LIFTGATE LOCK STRIKER WHEN DRIVING ON BUMPY ROADS	Bulletin No.: 09-032/25
	Last Issued : 08/08/2025

2024 CX-90 with VINS lower than JM3KK*****152546 (produced before Decemeber 6, 2023)

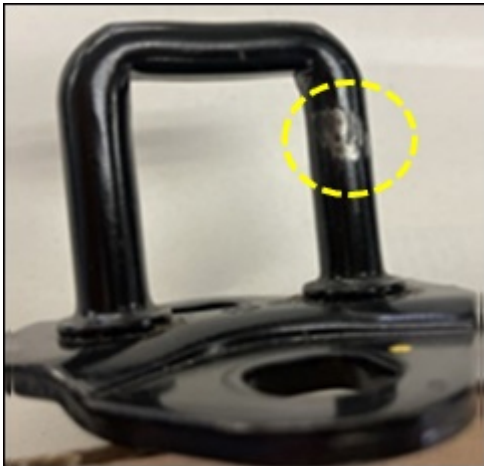
Some vehicles may exhibit a clicking noise from the liftgate lock striker when driving on bumpy roads. This may be caused by stick-slip friction between the lock striker and the lock actuator due to the electrodeposition layer peeling off from the friction between them.

To eliminate this concern, the lock striker coating has been changed to prevent coating wear.

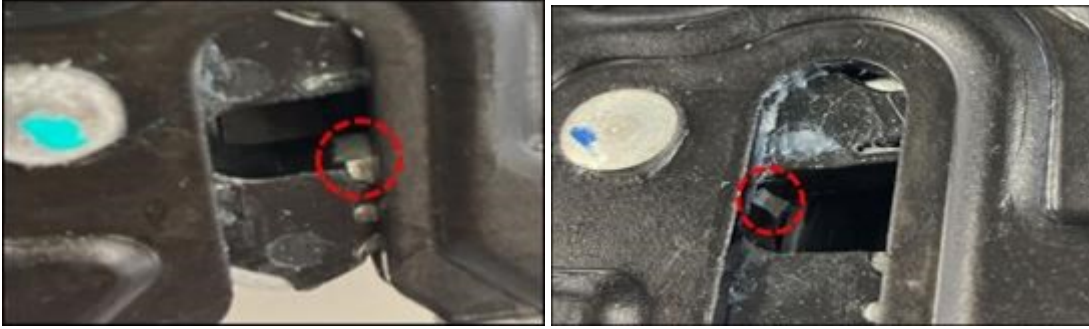
NOTE: There are areas without coating as shown in the following images. However, it is normal and DOES NOT cause the clicking noise.
