Technical Service Bulletin

A5, A6 e-tron, and Q5

Transaction No.: **2078650/1**

64 Noise from windscreen/dash panel area

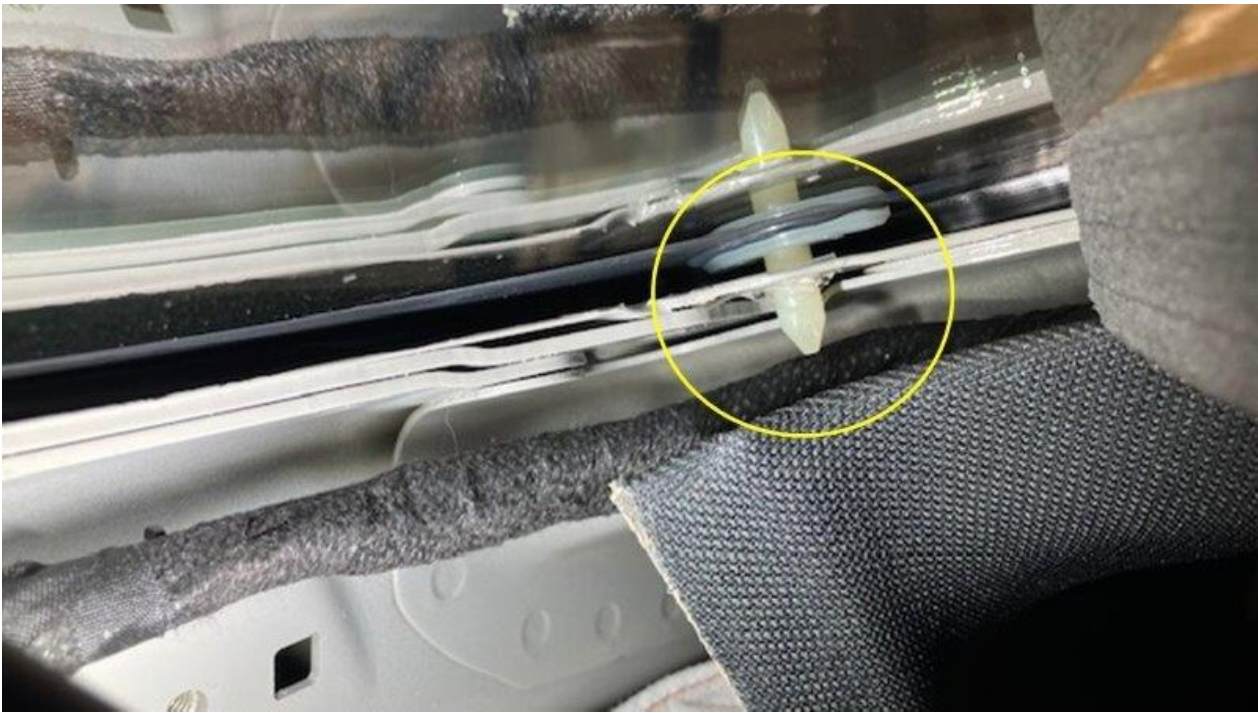
The noise is caused by the left and right windscreen pins due to movement relative to the vehicle body.

Figure 1. The windscreen pin.
