## Technical Service Bulletin

<b>Topic</b>	93 Electric charging flap does not open, does not close or actuator is locked
<b>Market area</b>	United States 444 Volkswagen of America, Inc. (6444)
<b>Brand</b>	Audi
<b>Transaction No.</b>	2078133/2
<b>Level</b>	EH
<b>Status</b>	Released for publishing
<b>Release date</b>	Aug 22, 2025

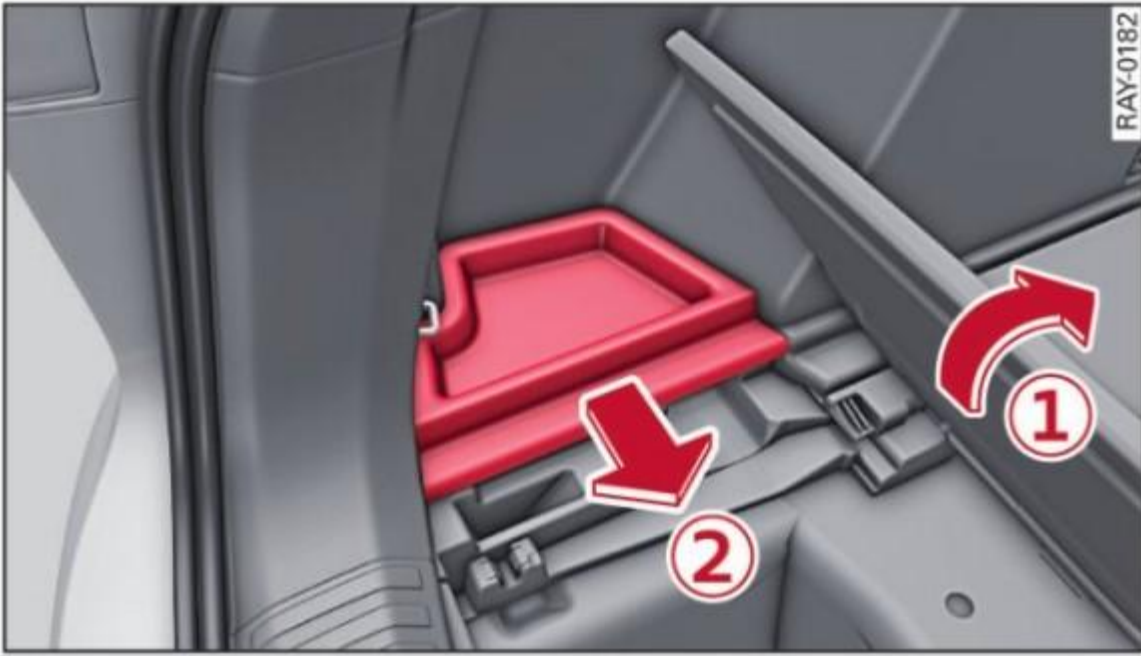
**Figure 1:** Fuse carrier cover.

- If the charging flaps are not in the closed position, push them carefully into the end position.
- Open the cover on the left in the luggage compartment to access the fuse carrier (see Figure 1).
- Remove the charging flap fuses (39, 43) for about 10 seconds (see Figure 2).
- Refit the fuses and close the fuse holder cover.
- Check whether the charging flap works.

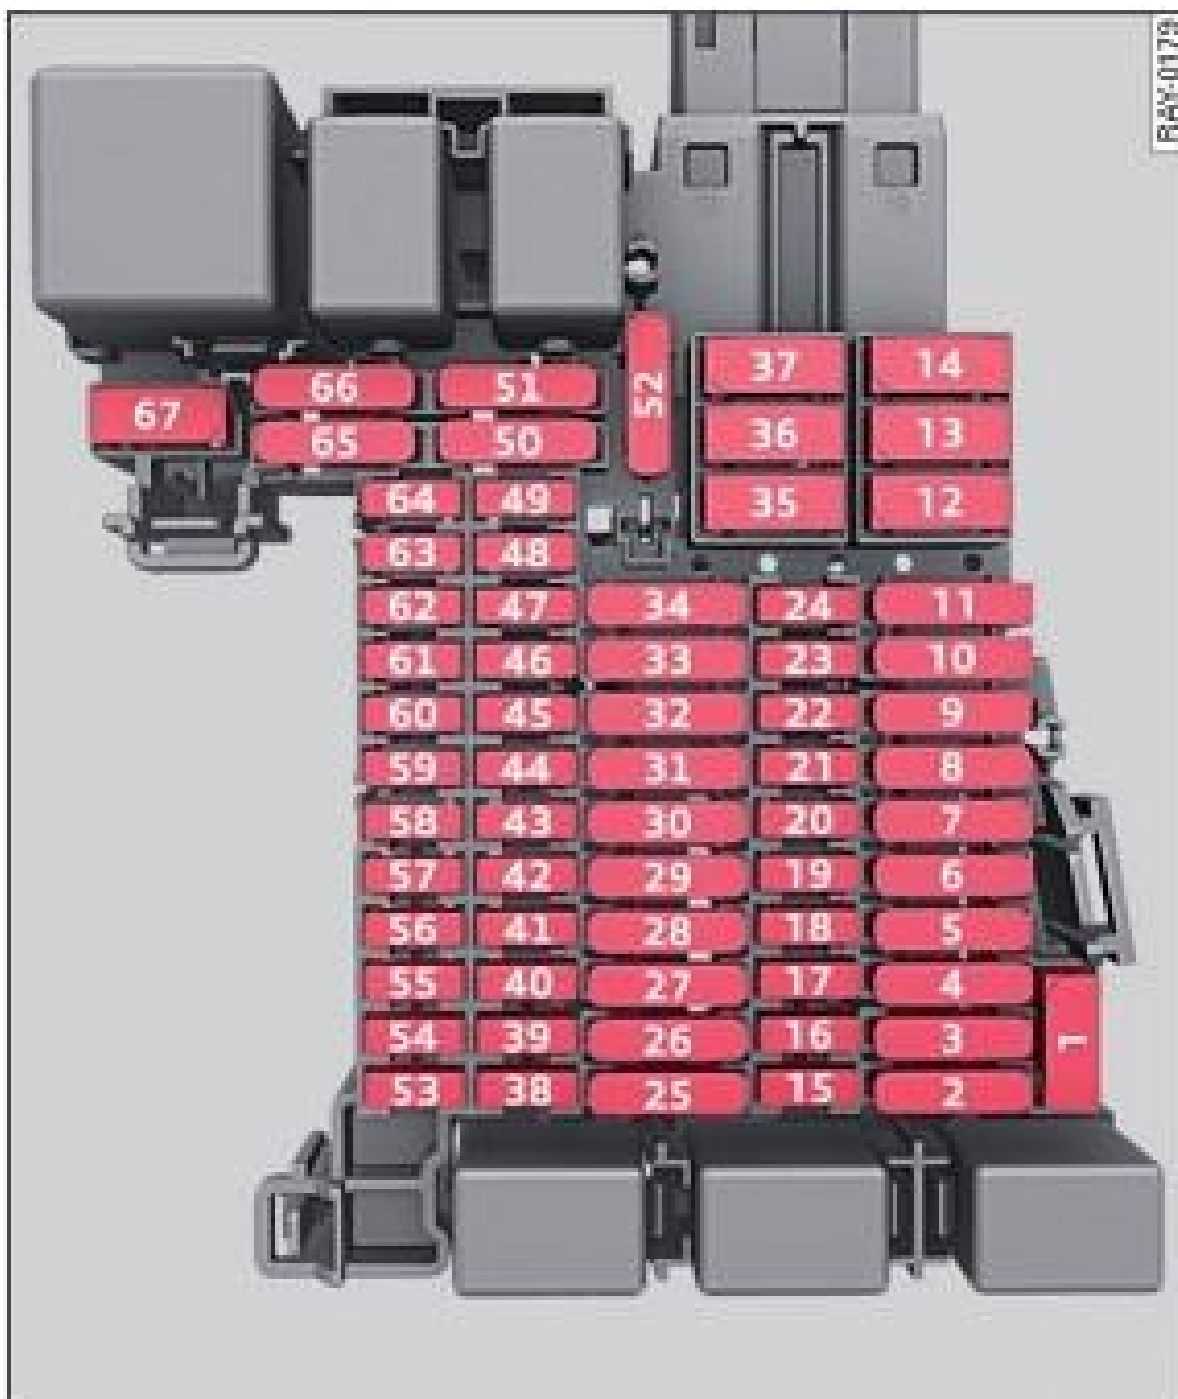
**Figure 2:** Fuse carrier.

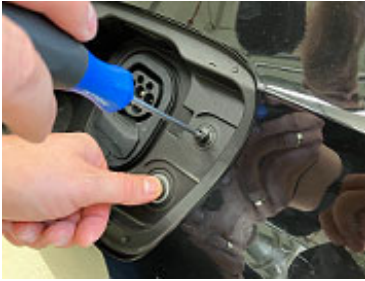
Improper use may cause the actuator to be locked even though the charging flap is not closed. In this case, it can be released using the following procedure (see Figure 3 and attached video):

**Figure 3:** Releasing actuator.

- Use a screwdriver to carefully push in the actuator signal pin as far as it goes.
- Then press the button on the button module for approx. 2 seconds and release the button again.
- The actuator will be unlocked.
- Remove the screwdriver.

- Carefully push the charging flap into the end position.
- Check whether the charging flap works.
