Technical Service Bulletin

Transaction No.: **2078875/1**

27 Service info: A5/Q5 - Charging system: fault! AC charging not possible - U01E400 in diagnostic address 0019

Release date: Aug 1, 2025

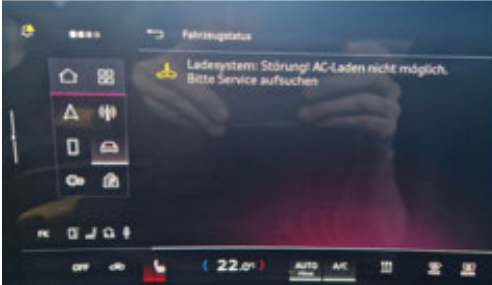
The message "Charging system: fault. AC charging not possible. Please contact workshop" is shown in the instrument cluster, although the vehicle has a combustion engine.

Figure 1. A message appears in the instrument cluster.

This is a software-related issue during the vehicle start-up phase which may cause the message described above to be displayed in the instrument cluster in rare cases. It has no effect on the normal operation of the vehicle and the sporadic warning message usually doesn't appear after completely switching the ignition off and on again.

There is no reason to attempt any further repairs.
