Technical Service Bulletin

Topic	55 Rear lid opens approximately 70% and then stops
Market area	United States 444 Volkswagen of America, Inc. (6444)
Brand	Audi
Transaction No.	2079016/1
Level	EH
Status	Released for publishing
Release date	Aug 19, 2025

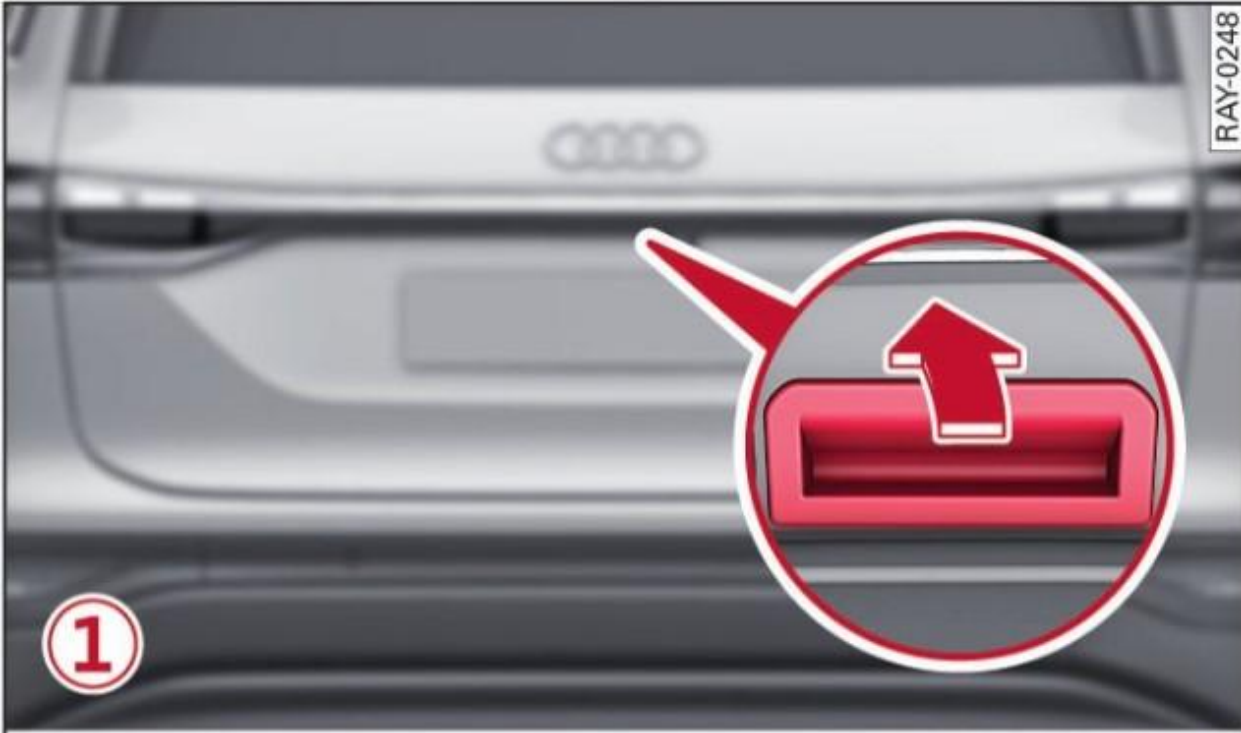
Figure 2. Rear lid outside button.

- Open the rear lid approximately halfway so that you can easily access the electric rear lid lock actuation buttons on the inside (refer to figure 2, item 3) and on the outside (refer to figure 1).

- Press and hold the electric rear lid lock actuation button on the outside (refer to Figure 2) and the electric rear lid lock actuation button on the inside (refer to Figure 3, item 3) simultaneously for at least 5 seconds. An audible signal will be given.
- Then close the rear lid and wait 2 seconds.
- Open and then close the rear lid 3 times using only the two buttons (refer to Figure 3 and Figure 3, item 3). Make sure that the rear lid reaches the end positions each time.
- The initialization process is now complete.

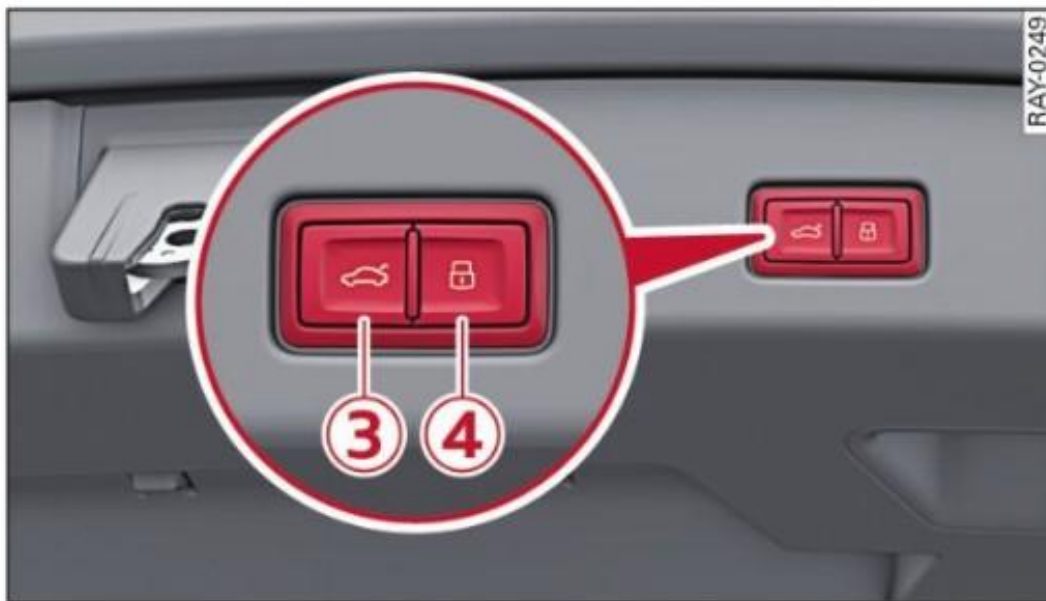
Figure 2. Rear lid interior buttons.
