## Technical Service Bulletin

### Audi Q5

97 Air conditioner does not cool the interior

Transaction No.: **2079080/1**

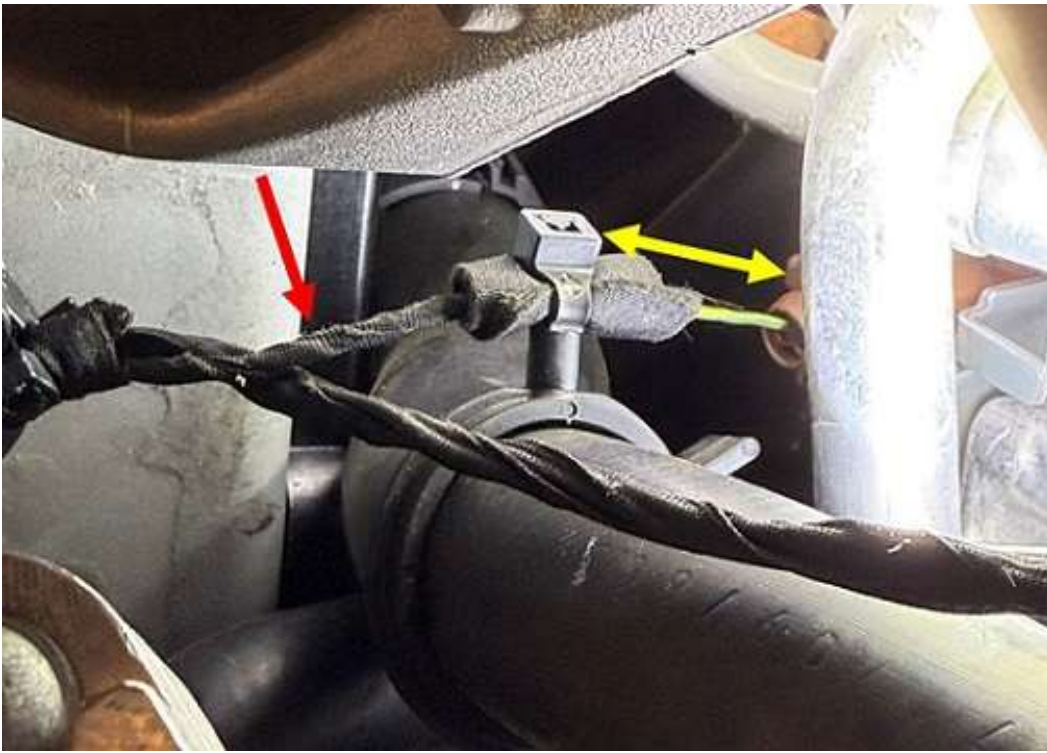
On vehicles manufactured within a specific period, the wiring for N280 (brown connector for N25) (air conditioning system magnetic clutch) is too short.

The complaint can be reproduced. A discrepancy is found at the wire leading to the brown connector (N25) on N280.

*Figure 1. The position for the crimp connector is marked with the red arrow.*

Repair the damaged wire using wiring harness repair set VAS 1978 B/C.

Place the crimp connector in the position marked with the red arrow (refer to Figure 1).

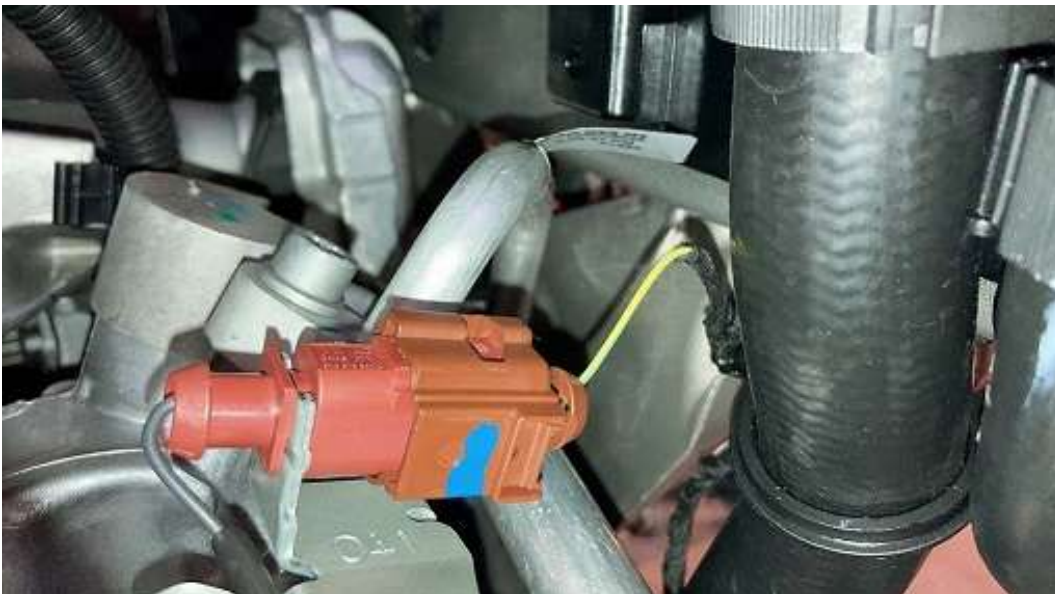
*Figure 2. Connector in its repaired state.*

The length of the wire between the cable tie and the brown connector (yellow arrow in Figure 1) **must be 60mm** (refer to Figure 2). This ensures that the wire is not too short again.

Wrap the repaired wire in fabric adhesive tape N10649702 almost as far as the connector so that it overlaps (refer to Figure 2).

Wrap the fabric adhesive tape at least 2.5 times underneath the area of the cable tie of the omega clip to ensure the wire can be secured in the cable tie.
