| <b>Topic</b> | 91 PSS myAudi app: auxiliary air conditioning starts in vehicle but negative response in app |
| <b>Transaction No.</b> | 2077207/3 |

### Q6 e-tron and A6 e-tron

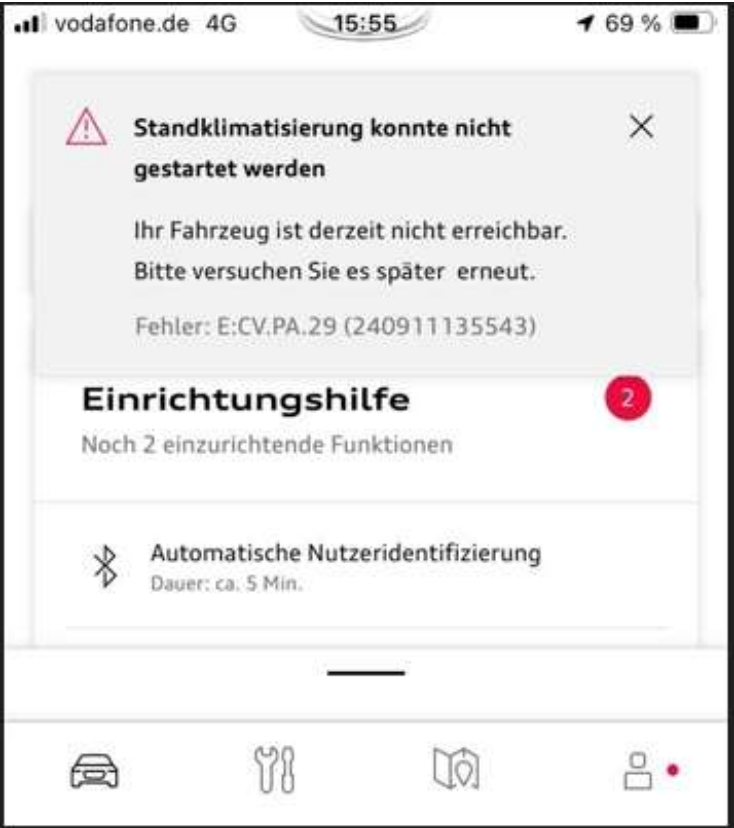
- The auxiliary air conditioner is started via the myAudi app. However, the myAudi app displays a negative response.
- After 1 to 2 minutes, the myAudi app also indicates that the auxiliary air conditioner is running.
- This issue occurs intermittently.

Auxiliary air conditioner could not be started.

Your vehicle currently cannot be reached.

Please try again later.

Error: E:CV.PA.29

1. Explain to the customer that a solution is expected to be available by the end of the third quarter of 2025 (subject to change) and that no repairs are necessary at this point.
2. Do not replace any components for this condition since this will not resolve the customer's concern.
3. Create a PSS record in the PSS application through the Pending Service Solutions (PSS) link in AccessAudi (under *Related Links >> Service*).
