Technical Service Bulletin

2074273/5

91-24-05 - Car Net® 2.0 - Emergency Call Module and Communication Unit -J949-
Vehicle is Offline (Not Connected)

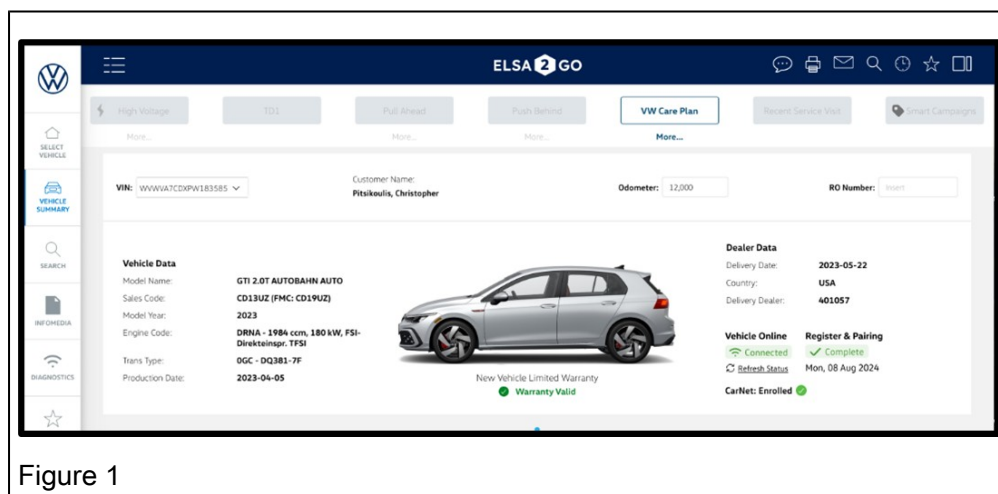
Figure 1

Once you take the vehicle out of transport mode, it may take up to 30 minutes for the system to come online. The green LED in the overhead console is an indicator that the vehicle has made a good connection; however, the definitive status can be found in Elsa2Go. On the figure below, verify that the vehicle is “**Connected**” and Register & Pairing is marked “**Complete**”. Any other status, in either of these spaces, indicates that the system is not operating correctly and requires intervention.

An incorrect status indicates that no connection was established. All vehicles equipped with myVW® need the status indicators in Elsa2Go to be as shown above; prior to being delivered to the customer.

In order for myVW® to successfully complete the R&P process, perform the transport mode removal test plan titled “**Perform service work for vehicle handover**”, auto populated under Guided Fault Finding (GFF) which includes activation & registration of the OCU. Once the test plan is completed, check the Elsa2Go status. If it still is not correct, take the vehicle outside and let it run for approximately 15-20 minutes.
