**DIAGNOSIS OF SYMPTOMS WHEN THE "TRAFFIC SIGN RECOGNITION (TSR) SYSTEM PERFORMANCE REDUCED" OR "CHECK NAVIGATION" MESSAGE IS DISPLAYED**

**Service Alert No.: SA-035/25**

**Last Issued : 08/06/2025**

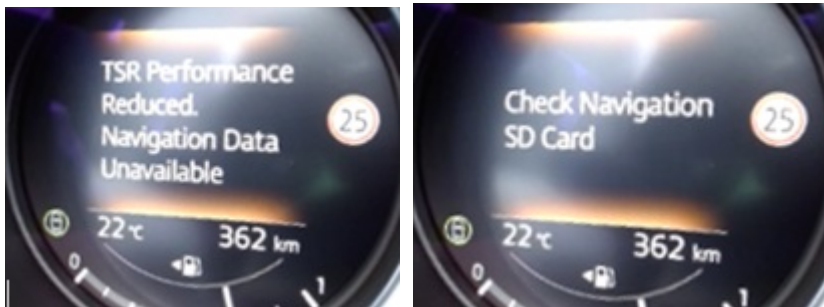
Some vehicles may show "TSR system performance is reduced. Navigation Data Unavailable" or "Check Navigation SD Card" in the meter while driving.
