Service Alert

Subject: MELTED OR WARPED MIRROR COVER OR OUTSIDE TRIM	Service Alert No.: SA-039/25
	Last Issued : 08/21/2025

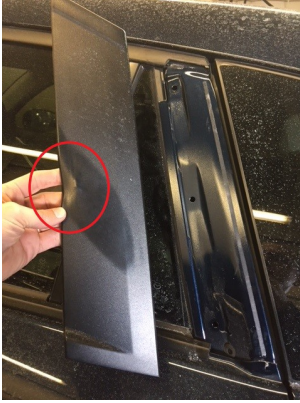
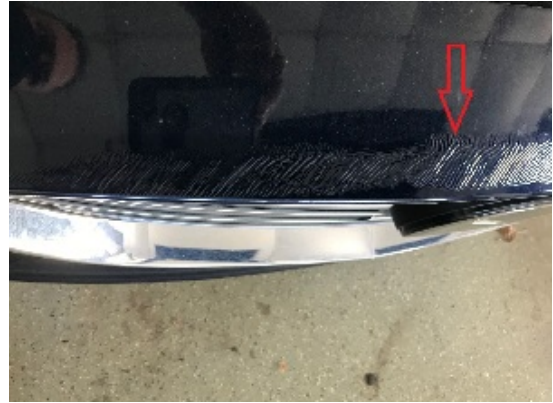
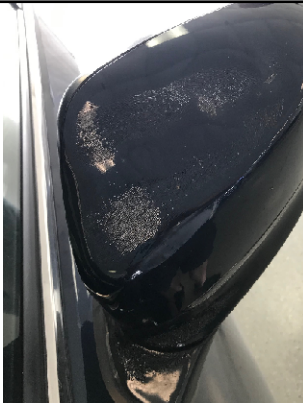
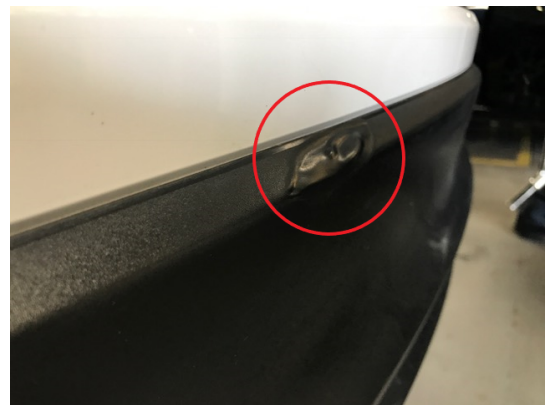
If a structure's windows create enough of a curve, the concave glass can focus the sun's rays onto a small area and acting like magnifying glass direct the sunbeams into a hot pinpoint of light. This magnification of the sun's rays can cause damage to vehicle trim (see examples). Additional information and exemplar images regarding this phenomenon can be found by performing a google search.

Examples of heat damaged trim:

Repair or replace the affected part(s) as needed. If the customer regularly parks the vehicle where there is exposure to such conditions as described in the description above, explain to the customer that parking location may need to be reconsidered.
