Service Bulletin

Bulletin No.: PIT5854D

Subject: Service Leveling System / Speed Limited Message / Noise Due to Aftermarket Modifications

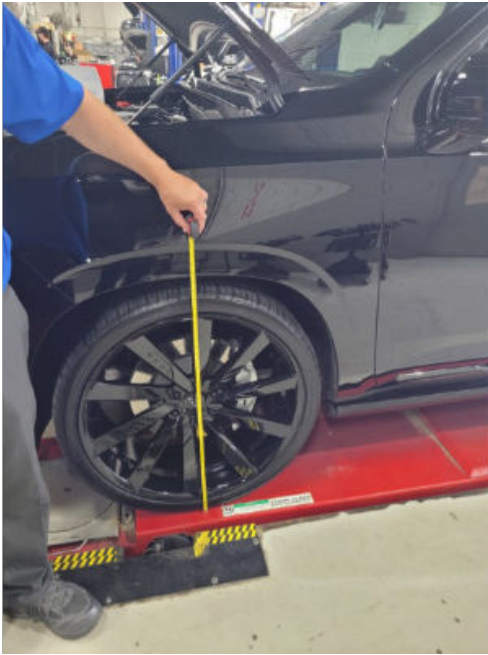
5873369

Vehicle Ride Height lowered

Note: Decreased distance between top of tire and fender well.

Inspect for vehicle ride height being altered by performing the Trim Height Inspection (example Document ID # 5568651.)

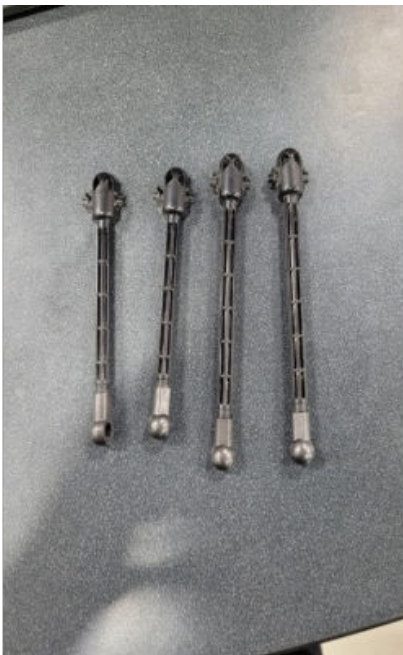
5873364

Factory suspension height sensor links are not adjustable. As shown below:

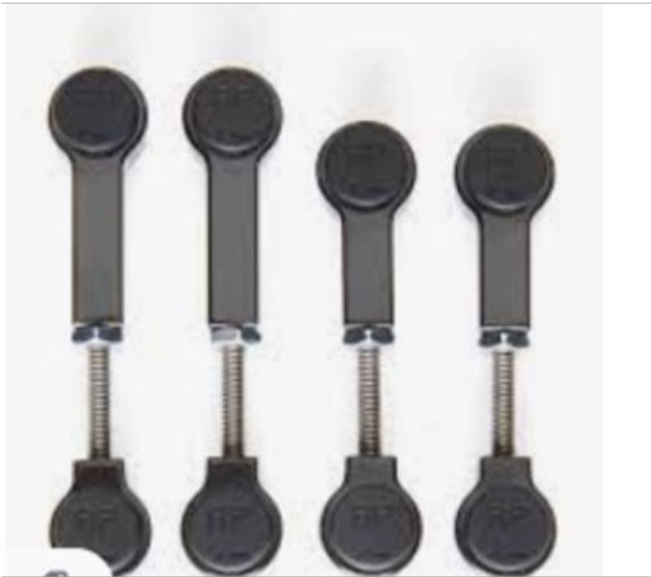
5873363

Aftermarket Adjustable suspension height sensor links. As shown below:

If the suspension has been found to be lower than factory settings, inspect for aftermarket adjustable suspension height sensor links being installed.

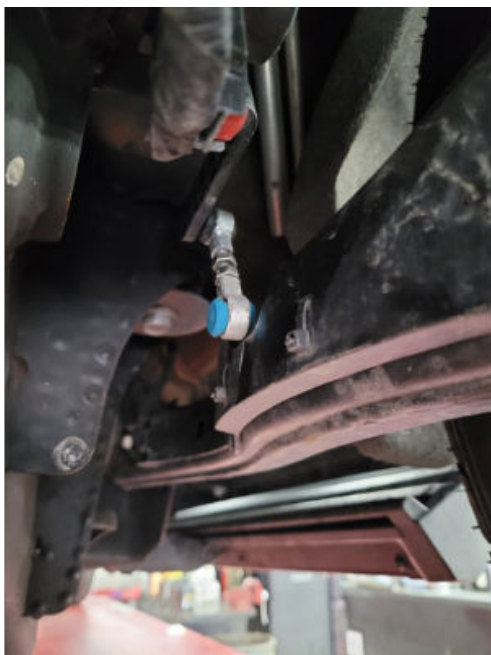
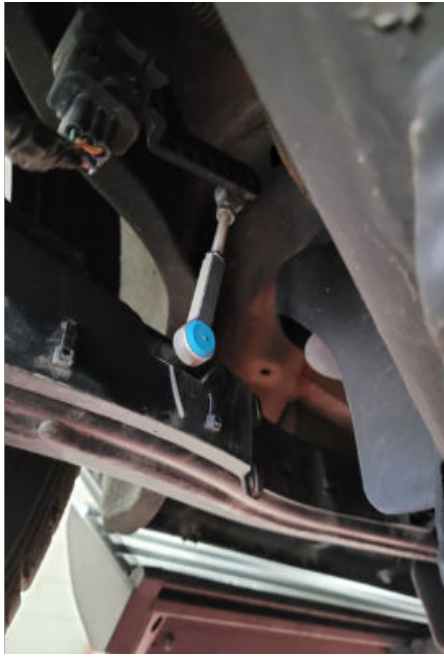
Aftermarket Adjustable Height Sensor Linkages incorrectly adjusted side to side.

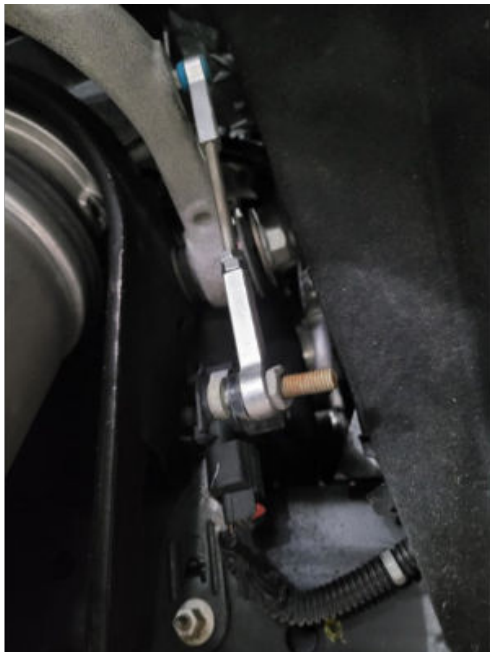
5873365

Aftermarket Adjustable Height Sensor Link not secured properly, preventing accurate height sensor readings.

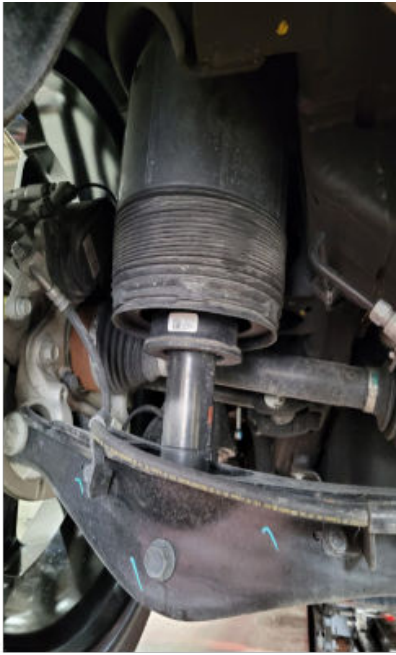
5873368

Notice Angle of Rear Axle Drive Shaft due to suspension being lowered.
