Service Bulletin

Bulletin No.: PIP5845B

Subject: Engine Coolant Reservoir Overfilled With Discolored Coolant Possible Engine Overheat Transmission Shake Shudder Vibration Shift Performance Or Slipping

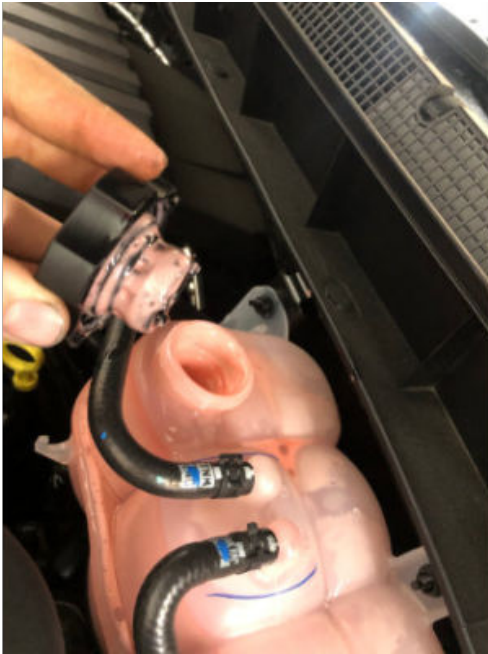
6017604

Involved Region or Country	North America
Condition	<p>Some customers may comment of the following conditions:</p> <p>Engine coolant reservoir is discolored with a strawberry milkshake appearance and may be overfilled to the point where coolant is being expelled from the overflow.</p> <p>See photo below (coolant is not bright orange and translucent).</p> <p>In addition to above, engine, and/or transmission may experience an overheat condition.</p> <p>In addition, possible degraded transmission performance including any of the following: Shudder, vibration, shake, shift performance and slipping.</p> <p>The transmission fluid level may be low when checked.</p> <p>Transmission may have overheat/burnt fluid, with or without any DTC setting, and/or without showing the strawberry milkshake appearance.</p> <p>Any transmission related concern found with vehicle built between the build dates listed above, should have the fluid tested for possible glycol contamination.</p>

Cause	The Automatic Transmission Fluid Cooling Exchanger may have an internal leak allowing transmission fluid and engine coolant to intermix contributing to and of the above conditions.

Confirm the presence of coolant in the transmission fluid using Service Bulletin # 08-07-30-035 (Information on Water Ethylene Glycol in Transmission) in SI.

Using 08-07-30-035 as a guide repair or replace the transmission assembly following SI. Replace the Automatic Transmission Fluid Cooling Exchanger.

Thoroughly Flush the Engine Coolant System to remove the contaminated engine coolant following SI.

Refill the engine coolant system following SI.
